281. Catastrophic deformations of Weller endoprosthesis heads

Keywords: Weller endoprosthesis, catastrophic wear of metal endoprosthesis heads

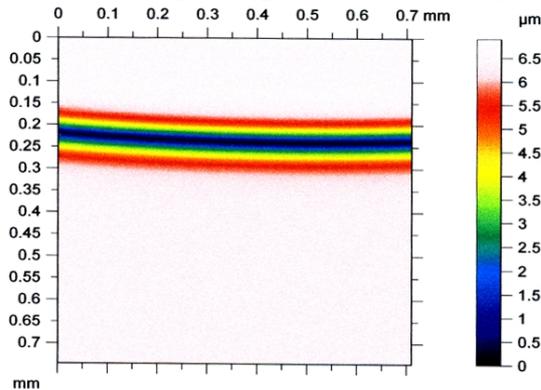
The characteristic picture of deep and continuous scratch on the surface of Weller endoprosthesis head exploited by 12 years is shown on the contour plot (Fig. 1).

Fig. 1. Contour plot of a deep and thin scratch on the surface of Weller endoprosthesis head

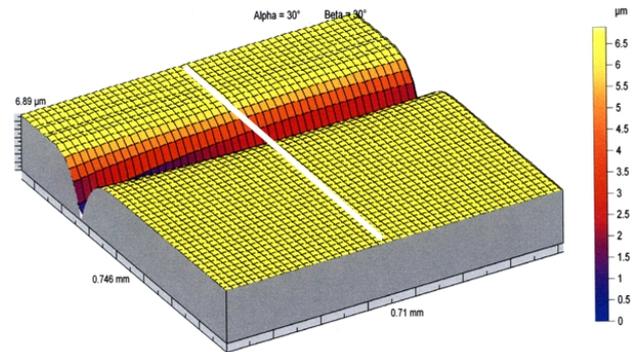
The picture of irregularities of metal head surface is presented on the figure 2.

The presented scratch is deep and has steep edge. The depth of the scratch has about 6 μm . Intersection of the scratch, in the pointed place visible on the figure 2, is

Fig. 2. Structure of a deep and continuous scratch on the surface of Weller endoprosthesis head with pointed place of intersection

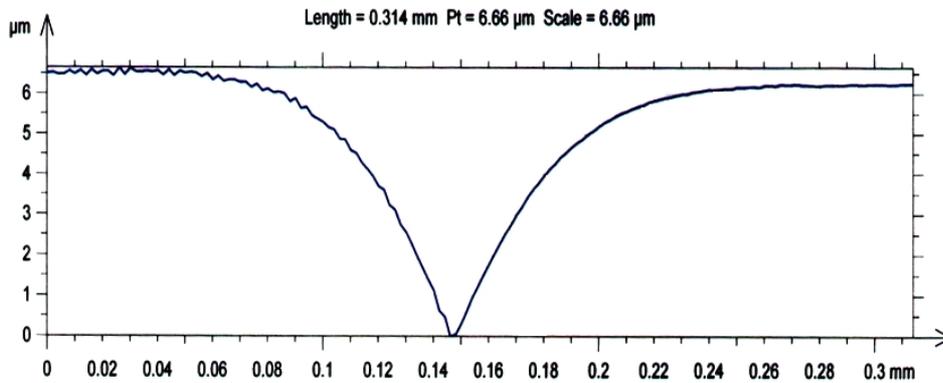
illustrated on the figure 3.

Fig. 3. Intersection of a deep and continuous scratch on the surface of Weller endoprosthesis head at the pointed place on figure 2

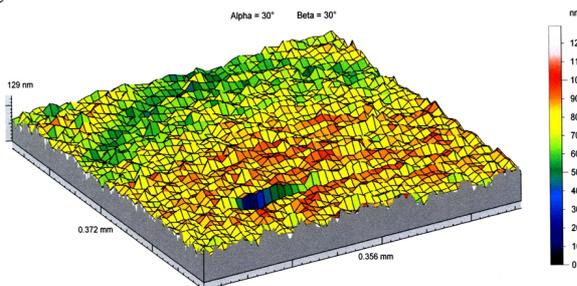
The geometry of surface of exploited Weller endoprosthesis head, outside scratch limits, presents a picture of ideal smoothing surface. The parameter St has value about 120 nm.

Fig. 4. Geometrical configuration of a surface of Weller endoprosthesis head outside scratch limits

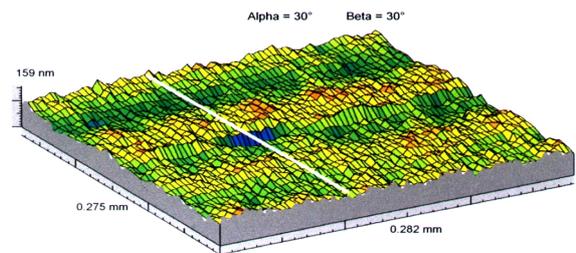
The characteristic picture of not very deep and discontinuous scratch on the surface of Weller endoprosthesis head exploited for 8 years is shown on the figure 5. Moreover intersection of the scratch is illustrated on the figure 6. The presented scratch was a few times deep in compare with the biggest high of surface irregularities of Weller endoprosthesis head, but it was considerable shallower from the scratch shown on the figures 1-3.

Fig. 5. Picture of not very deep and discontinuous scratch on a surface of Weller endoprosthesis head at the pointed place of intersection

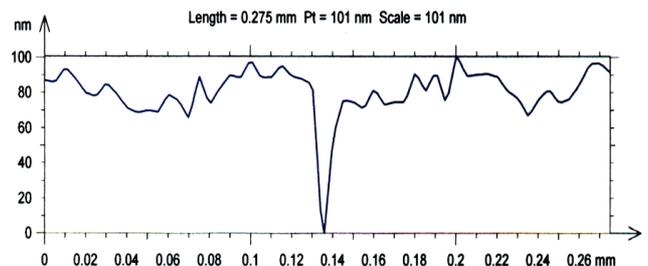
Fig. 6. Intersection of discontinuous and not very deep scratch on the surface of Weller endoprosthesis head at the pointed place on figure 5
