# Analysis of fatigue fracture incident of centrifugal compressor blades in a small turbojet engine

**Abstract.** In this study, performance verification tests were conducted on a small turbojet engine, during which a failure occurred at the root of the centrifugal compressor blades, which are made of aluminum alloy. A detailed disassembly and inspection was carried out to reveal the reason of the failure. It was found that the failure of one blade at the root led to jamming of other blades. Then the jammed blades experience sever rubbing and contact with the intake duct. Experimental measurements of material properties and a retrospective examination of the manufacturing process revealed that the yield strength of the material was lower than the design value, and the fillet radius at the blade root was smaller than specifications. The root cause of the fatigue failure of the compressor blades in this incident was attributed to substandard machining quality and material properties, which leads to crack initiation and fatigue propagation until failure occurred. The experience of identifying the root cause would provide engineering guidance for other small turbojet engines.

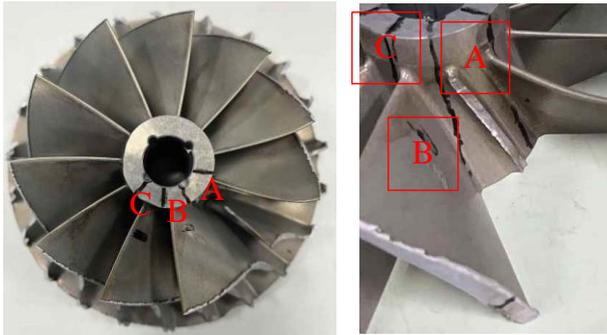
**Fig. 1.** Sampling and Inspection Illustration

revealing the fracture of one of the large blades at the root of the centrifugal compressor. Additionally, other blades exhibited clear signs of wear and tear, as depicted in Fig. 1. Moreover, traces of impact were observed on the turbine rotor, indicating contact with the fractured blade from the compressor rotor.

For better observation, linear cutting was performed at the fracture site of the centrifugal compressor and assigned sample labels accordingly. Sample A represents the fractured blade, and adjacent to sample A, two other large blade roots exhibited small cracks. The relative positions of these three large blades are illustrated in the right side of Fig. 1.

Visual inspection revealed that there were scattered cracks on the surface of the blade roots of samples B and C while no cracks were found on other blades, only wear traces were observed. At the fillet of sample B, cross-sectional slices were prepared along the crack's radial direction, resulting in Slice 1 and Slice 2, as shown in Fig. 2.

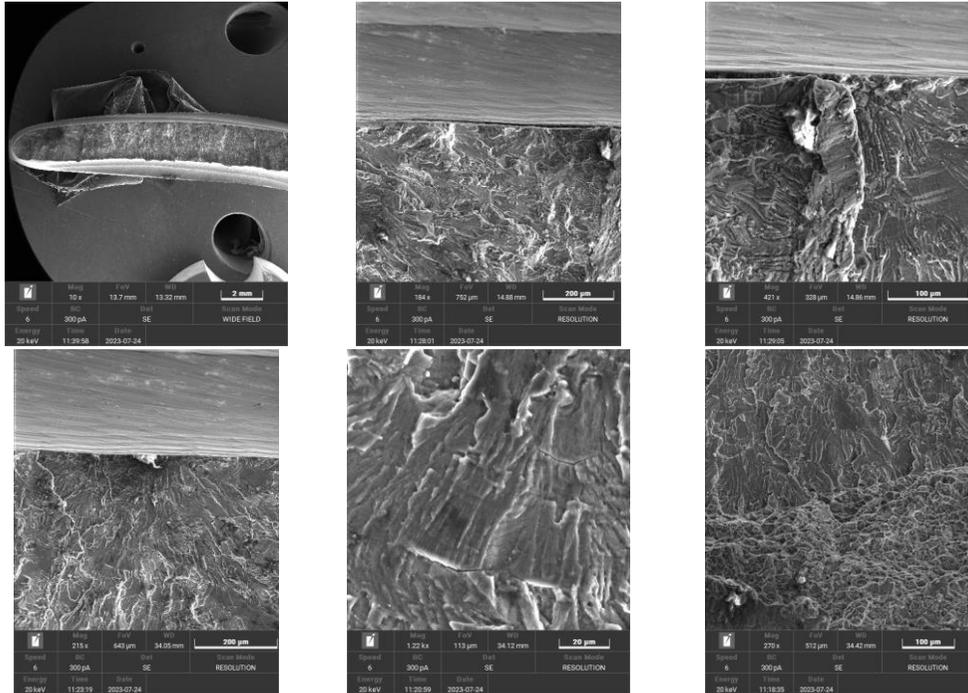
Fig. 3. Microscopic morphology of sample a fracture surface

Microscopic observations of the blade fracture surface were conducted using a scanning electron microscope (SEM). As shown in Fig. 3(a), (c) and (d), the fracture lines on sample A converge at various locations on the blade's concave side, exhibiting characteristics of multiple crack origins. No apparent metallurgical defects were observed in these origin regions. Energy dispersive X-ray spectroscopy (EDS) analysis revealed that the oxygen content in this area was significantly higher than in other regions, with no abnormal concentrations of other elements.

Fig. 3(b) illustrates the presence of an unusual machining mark on the concave side of the blade, with a depth of approximately  $5.3\ \mu\text{m}$ . In the expansion zone, as shown in Fig. 3(e), distinct fatigue striations were observed.

As depicted in Fig. 3(f), the boundary between the fatigue propagation region and the instantaneous fracture region was evident, with features of dimples observed in the instantaneous fracture region. Multiple crack initiation sites occurred on one side of the blade, and they propagated through the blade until penetrating completely.

Macroscopic and microscopic analysis results indicate that the area of the fracture region, particularly the instantaneous fracture zone, is relatively large. The failure mode of the blade can be attributed to fatigue fracture under high stress. Multiple crack sources are observed, distributed on both the concave side and the convex side of the blade root, suggesting a correlation between crack initiation and fatigue failure with high stress.

3) Manage the manufacturing process strictly: During the manufacturing process, adherence to design requirements is essential, especially in the fabrication of blade root fillets. Special attention should be paid to the abnormal machining marks.

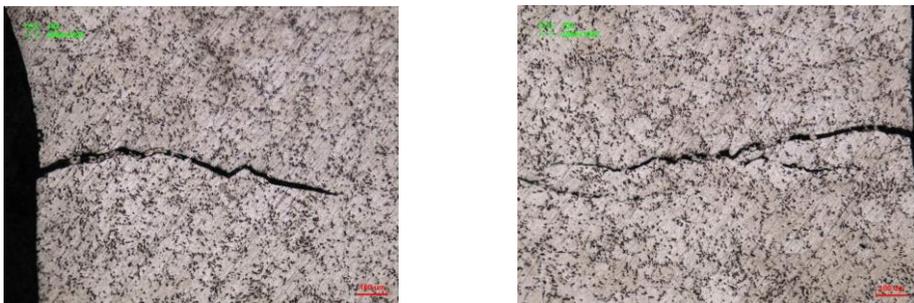
Fig. 4. Cracks along the thickness direction of sample B blade

Microscopic examination of slice B revealed that: Observations on Slice 1 indicated that the crack length had reached approximately 50 % of the blade's thickness. Furthermore, in the vicinity of the primary crack in slice 2, secondary cracks were observed.

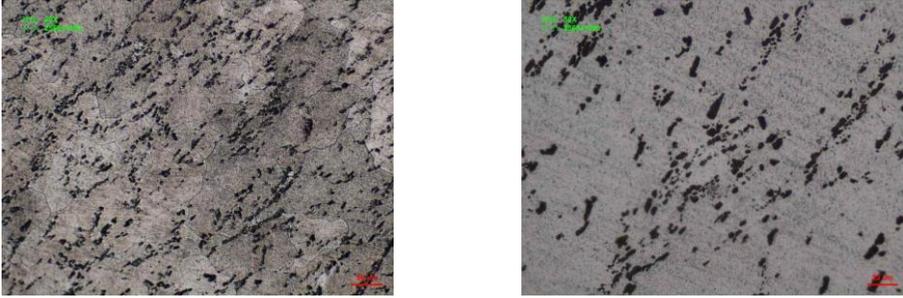
**Fig. 5.** Metallographic image of sample B

For samples B and C, metallographic samples were prepared and polished, followed by etching with a corrosion agent. Subsequently, structural analysis was performed using a metallographic microscope. As shown in Fig. 5, the grain boundaries are clear, and no signs of overheating or burning are observed.

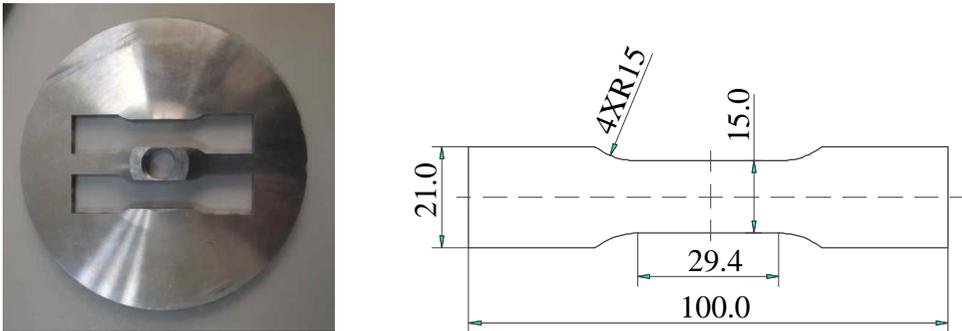
**Fig. 6.** Sampling region and geometric dimensions of tensile test specimens

For the mechanical property testing, samples were obtained from unused centrifugal compressor of the same batch. Due to the limitations of raw material size, four sheet-shaped tensile specimens were taken. The testing method followed the GB/T 228.1-2010 standard. An electronic tensile testing machine was used to measure the mechanical properties of the material. Three specimens were used for data measurement, and one was used as a compensation piece during the measurement process. Table 2 presents the test results, with an average yield strength of 267 MPa and an average tensile strength of 370 MPa.

Mechanical test results reveal that the material used in the centrifugal compressor rotor has a yield strength of 267 MPa and a tensile strength of 370 MPa. However, the yield strength of the material is 11 % lower than the design requirement of 300 MPa, indicating that the margin of strength is smaller than the design value by 11 %.

2) Enhancing material mechanical property requirements: Raise the mechanical property requirements for blade to guarantee sufficient strength reserves, thus improving fatigue resistance under high-stress conditions.

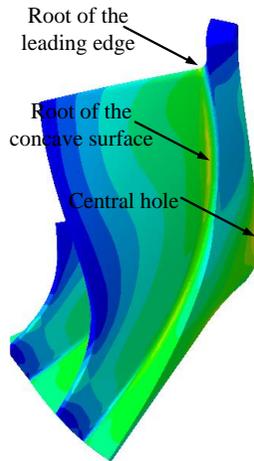
Fig. 7. Equivalent stress contour under operating speed

Analysis of the centrifugal compressor can be performed using a cyclically symmetric model. The FEM model of the blade was established with ANSYS. And the stress analysis was conducted under the operating speed. It was found that the maximum equivalent stress at the blade root on the concave side is sensitive to changes of the fillet radius. The simulation results are provided in Table 3. The equivalent stress is reduced by 9.5 % when the fillet radius is increased from 1.5 mm to 1.7 mm. In areas with high stress, under the action of alternating loads, crack initiation and even crack propagation are more likely to occur. The crack source region corresponds closely to the location of the maximum stress region at the blade root, as shown in Fig. 7.

Finite element analysis demonstrates that the region of maximum stress in the blade situated at the fillet of the concave side, and the equivalent stress is highly sensitive to the fillet radius. Cracks originate from both the concave and convex sides of the blade root. Upon tracing back to the manufacturing process, it was found that the original design specified a fillet radius of 1.7 mm with a free tolerance of  $\pm 0.2$  mm. However, during actual machining, an alloy tapered milling cutter was used, resulting in an actual fillet radius of 1.5 mm with uneven surface quality in the fillet region, accompanied by noticeable tool marks.

Therefore, it is advised to select a larger fillet radius thus ensuring the quality of the machined surface to reduce the risk of crack initiation and fatigue failure, especially in high-stress regions.

1) Increasing the size of the fillet radius of the blade root: Consider increasing the size of the blade root fillets to reduce the sensitivity of high-stress regions and mitigate the risk of crack initiation. This can be achieved through a redesign of the blade structure or manufacturing processes.
