Failure analysis of gas turbine in first stage turbine blades in an urban power plant

Mohamed K. Hassan¹, Waheeb M. Sindi², Ahmed Mohamed³, Ahmed H. Backar⁴

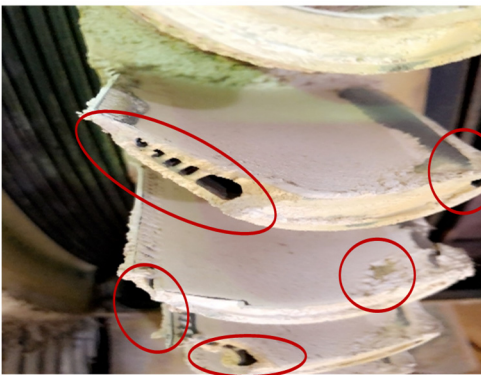
Fig. 8. Turbine blades missing body materials

During the fact-finding process, at 77,521 running hours, some of the turbine blades at the first stage discovered damage, missing elements from the blades body (see Figs. 8 and 9), and a thick layer of sulfuric acid (see Fig. 10) accumulated in the cooling airfoils of the blades. The blades were brand new, having been installed following HGPI at 42,000 running hours. This discovery explains the informality of the vibration, which was plainly visible in the trends during pre-outage data collecting.

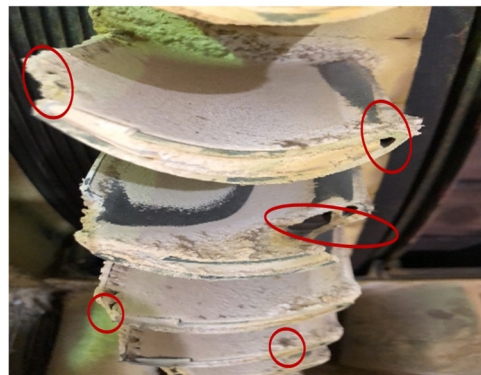
Fig. 9. Other turbine blades missing materials from both sides

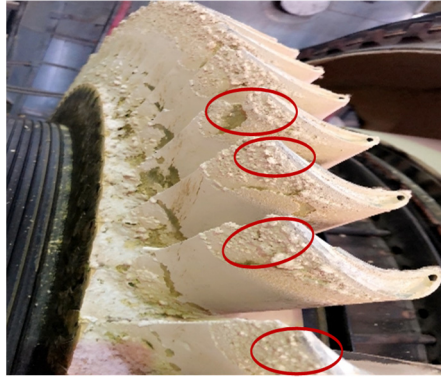
Fig. 10. Sulfuric acid casing corrosion erosion type. Also, accumulated and blocked the cooling air paths

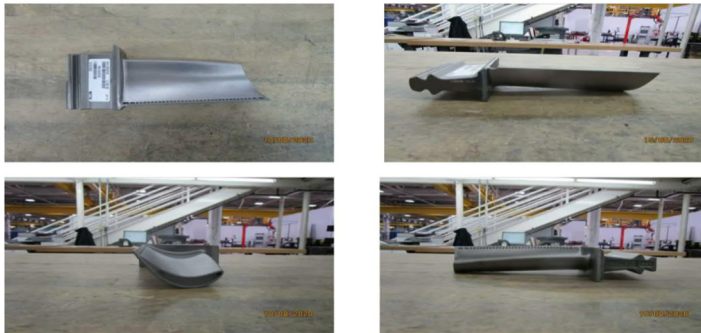
Fig. 11. Group of 1st stage gas turbine blades (89SGT6 200E row 1)

Group of 1st stage gas turbine blades (89SGT6 200E row 1) are employed to refurbishment and examples of these blades are shown in Fig. 11. During the incoming inspection process, sixty-four blades were found to have linear cracking in the blade airfoil that was beyond repair

limits and these blades were deemed unrepairable. Twenty-five blades were successfully processed through repair. All repaired blades were sent to the coating vendor and have been processed through final inspections and are acceptable for release to the customer.

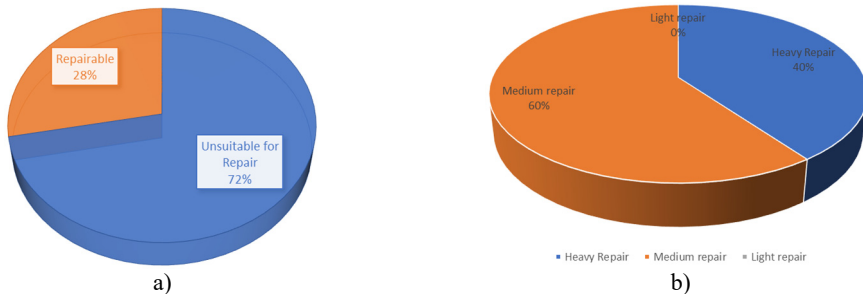
Fig. 12 depicts an overview of the repair process. Twenty-five blades are found to be repairable, accounting for 28 % of the investigated blades, whereas sixty-four blades, accounting for 72 % of the investigated blades, are unsuitable for repair. Ten of the twenty-five repairable blades require serious repair, while fifteen require light repair. There are no blades that require minimal repair.

Fig. 12. Overview of repair process. Percentage of a) repairable and b) Unsuitable for repair
