# Evolution mechanism of high-altitude dangerous rock mass collapse-debris flow chain disaster: a case of study in an open-pit mine

**Abstract.** In order to reveal the mechanism of the chain disaster caused by the collapse of high-altitude dangerous rock bodies in high-altitude open-pit mines and the formation of debris flows, field survey method was used to clarify the morphology, range, and scale of the high-altitude dangerous rock bodies and debris flows. Combined with geological data of open-pit mines and mining technical conditions, the formation mechanism of high-altitude dangerous rock bodies and the causes of debris flow formation were studied. The laws of chain disaster evolution and disaster patterns were revealed. The research results showed that (1) the formation of the collapse-debris flow chain disaster is due to the coupling effect of internal poor engineering geological conditions and external factors such as rainfall, groundwater, freeze-thaw, and blasting vibration. The collapse mode of the dangerous rock body is tensile-crack and tipping, shear-sliding, and tensile-crack and seating. (2) The collapse disaster of high-altitude dangerous rock bodies in open-pit m

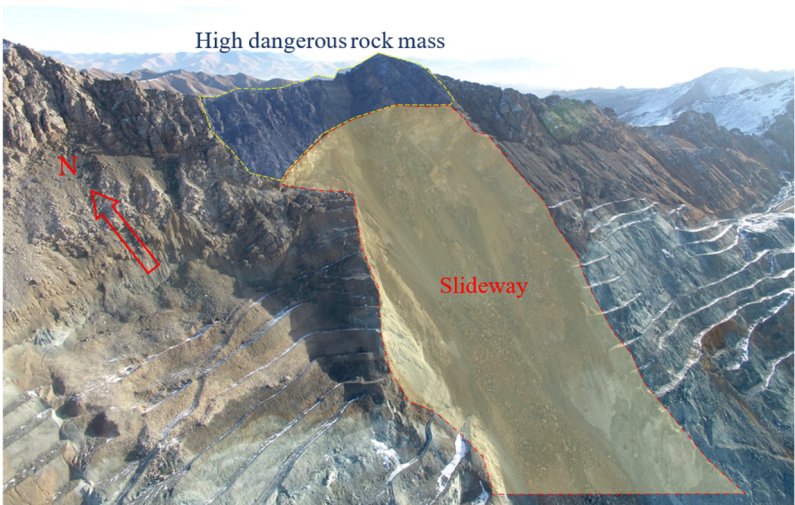
In the early stage of the mining area, a landslide occurred, forming a landslide trough (Fig. 3), the stability of the top of the dangerous rock mass is very important, and the possible collapse forms mainly include: the tilting type driven by water pressure and frost heave force along the direction perpendicular to the crack; the sliding type affected by the cutting of the structural surface along the slope direction; and the seat collapse type controlled by the strength of the underlying low-strength schistose serpentinite.

Fig. 3. Sliding groove formed after the landslide

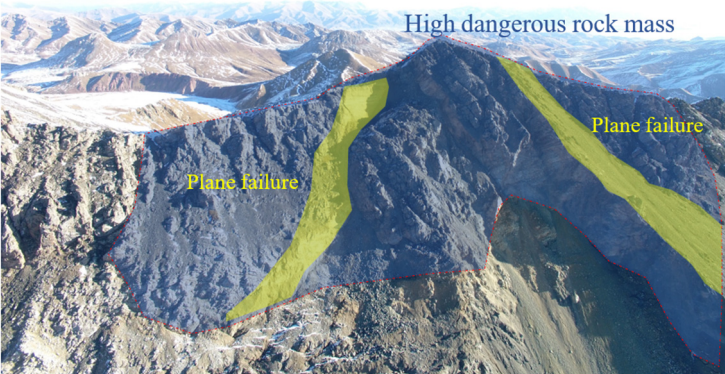
Fig. 4. Before local dangerous rock collapse

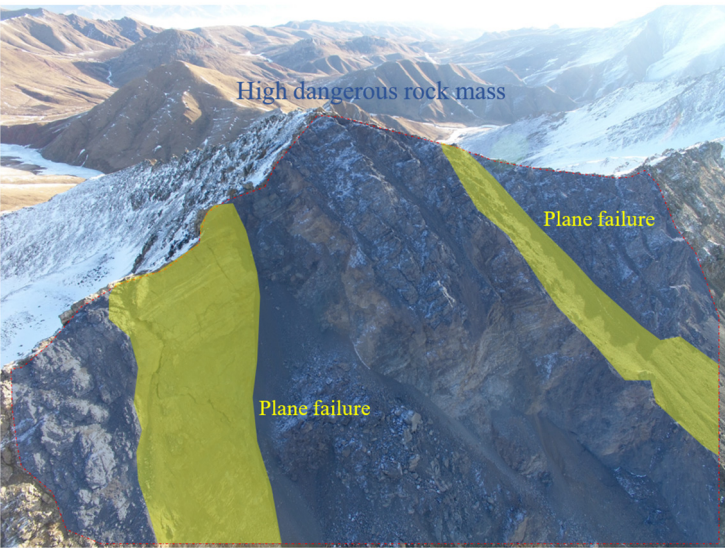
Fig. 5. After local dangerous rock collapse

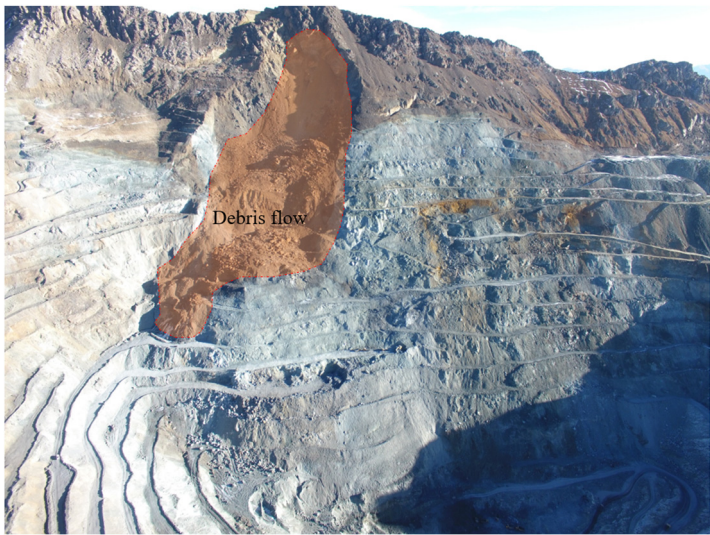
such as rainfall, freeze-thaw cycles, and blasting vibrations, the serpentinite on the northern slope deteriorates and crumbles, forming a local landslide. Due to the high degree of fragmentation of the serpentinite, the rock mass disintegrates during the sliding process, forming smaller rock fragments, thus creating a debris flow disaster. The debris flow formed by the local landslide, under the blocking effect of the open-pit bench, has not yet impacted the bottom of the open-pit mining area (Fig. 6).

The debris flow formed by the local landslide has had a certain impact on the stability of the bottom steps of the open-pit mining area. The debris is concentrated and piled up on the steps, imposing a load on them, and there is a potential trend of landslide on the platform of the lower open-pit mining area slope. Similarly, the local landslide has left the rock mass at the top of the slope in a suspended state, with the rock mass losing its lower support, forming a dangerous rock mass at the top. Under the action of gravity, it is prone to collapse disasters. The first stage of the debris flow disaster triggered the second stage of the debris flow disaster and formed a dangerous rock mass at the top of the slope.

**Fig. 6.** First stage of debris flow disaster in the mining area

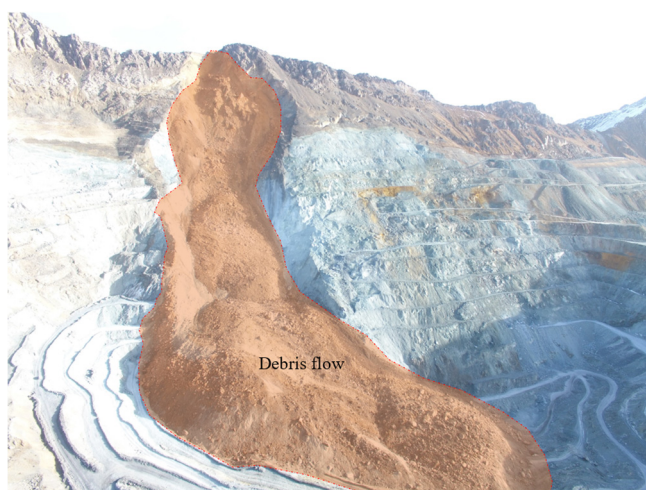
The second phase of the debris flow disaster the second phase of the debris flow disaster is the formation of a through-sliding landslide on the northern slope of the open-pit mining area. The main rock type at the top of the northern slope is serpentinite, which is highly susceptible to softening upon contact with water, is prone to weathering, and has poor rock quality. Field investigations and historical data analysis indicate that after the first phase of the debris flow disaster, the high-altitude dangerous rock mass at the top of the slope, having lost its lower support, experienced a collapse disaster. The high-altitude rock mass impacted the lower slope platform and the debris on it, causing the lower bench rock mass to gradually lose stability. At the same time, under the influence of external factors such as rainfall, freeze-thaw cycles, and blasting vibrations, the serpentinite on the northern slope deteriorated and crumbled, forming a through-sliding landslide that slid from the top of the slope to the bottom. During the sliding process, the rock mass disintegrated, mainly consisting of fragmented rock, thus forming the debris flow disaster in the open-pit mining area (Fig. 7). Using 3D laser scanning combined with 3DMINE software, the volume of the debris flow was measured to be approximately  $200 \times 104 \text{ m}^3$ . The formation of the second phase of the debris flow disaster is the result of the coupling of the collapse of the high-altitude dangerous rock mass with the first phase of the debris flow disaster and the combined action of external factors.

Fig. 7. Second stage of debris flow disaster in the mining area

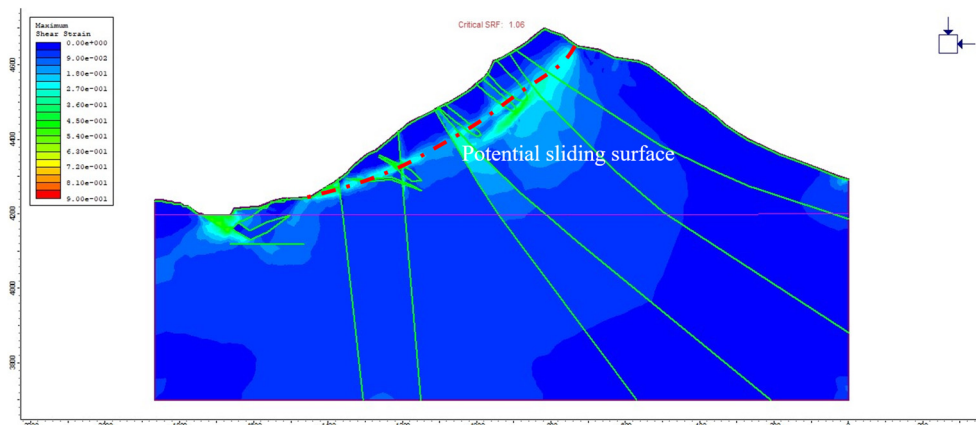
Fig. 9. Slope safety factor and potential sliding surface

The overall safety factor of the slope is 1.06, indicating a marginally stable state, which is prone to dangerous rock mass collapse disasters under the influence of external factors (heavy rainfall, earthquakes, blasting disturbances, etc.). The areas where plastic deformation occurs on the slope are mainly at the top of the slope where the dangerous rock mass is located, and potential sliding surfaces, indicating that the slope has the potential for collapse-debris flow chain disasters. The finite element analysis shows that the maximum deformation displacement of the slope reaches 30 meters, indicating that the slope has already experienced a collapse and landslide disaster. Multiple numerical simulation results confirm that there is a risk

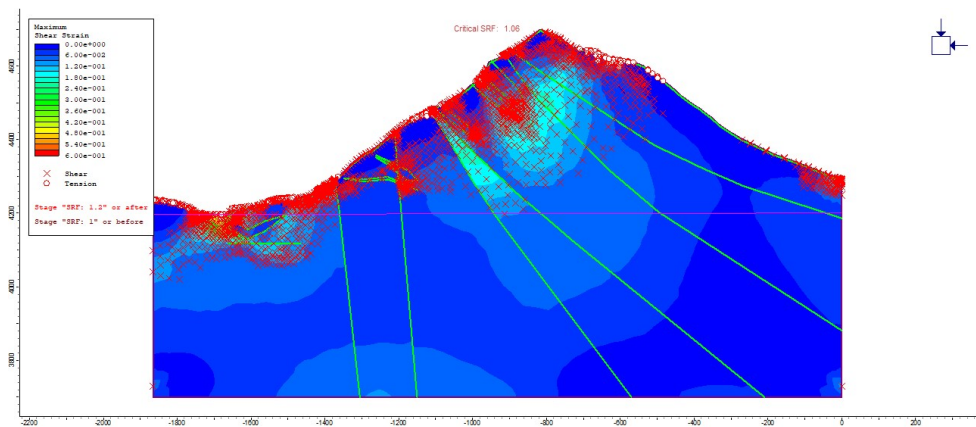
Fig. 10. Distribution of plastic zone on slope

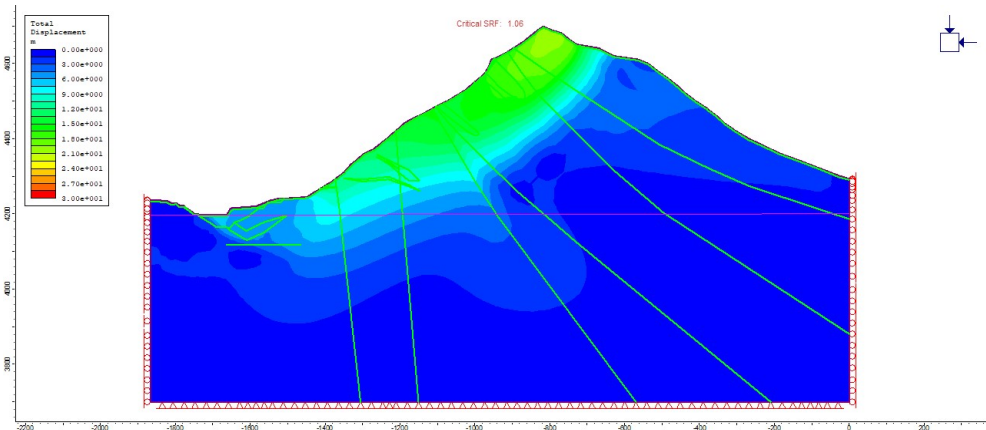
Fig. 11. Slope displacement cloud map
