# Leakage failure analysis of sewage pipe used for buried valve in natural gas station

**Abstract.** Leakage accident occurred during the operation of a buried valve blowdown pipe in a natural gas station. After the macroscopic morphology, mechanical properties, chemical composition, metallography, scanning electron microscopy and energy spectrum analysis of the leaking blowdown pipe, it was found that the corrosion perforation was located in the outer wall of the pipe, and the damage of the corrosion layer caused the corrosion components in the saline soil to contact the steel pipe to produce oxygen corrosion. In addition, Cl<sup>-</sup> ions in the soil played a role in accelerating corrosion, which eventually led to the occurrence of perforation accidents.

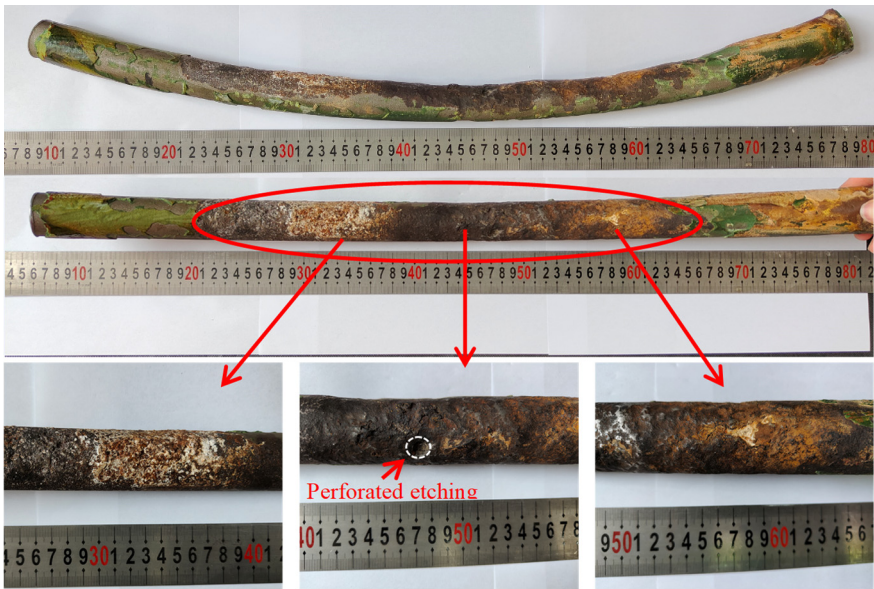
The length of the sampling tube is 680 mm, and the outer surface is covered with green epoxy anticorrosive layer. In some areas, the anti-corrosion coating has been completely removed, while in other areas, there are signs of artificial removal. There was a perforation at the 1 o'clock direction of the bend in the tube body, and a corrosion pit was visible on the outer wall of the perforation position, but no corrosion products were found in the pit, and there were signs of artificial removal. A large area of external corrosion appears within 450 mm from the perforation location, and the tube wall appears black-brown within 100 mm from the pit, and an oil-like substance is attached to the surface. Red and brown corrosion products appeared on other surfaces. White substances were found on the outer wall of the steel pipe at 280-370 mm and 500-640 mm, and yellow and white substances were also attached outside the protective layer at the end of the pipe (as shown in Fig. 1).

Fig. 1. The macroscopic morphology of the sample

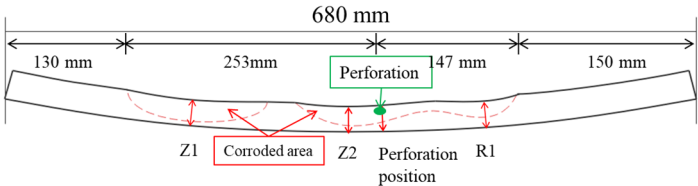
The results of scale detection are presented in Fig. 2. The outer diameter of Z1 measures 31.31 mm, that of Z2 is 31.59 mm, the perforation has an outer diameter of 27.68 mm, and R1 has an outer diameter of 31.78 mm. It is evident that the perforation exhibits the smallest outer diameter, displaying a noticeable thinning phenomenon when compared to the nominal size of 33.4 mm×6.35 mm.

Fig. 2. Schematic diagram of measurement position and sample measurement results

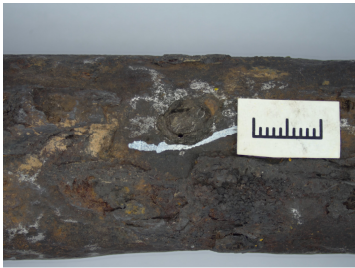
No corrosion scale was observed in the corrosion pit of the perforation. Following the cleaning of the sampling surface, the outer surface exhibited reddish-brown and black corrosion products, as illustrated in Fig. 5 and Fig. 6 illustrates the longitudinal line cutting processing along the perforation of the longitudinal planning cross-section morphology. The inner wall of the tube, which was perforated, did not exhibit corrosion. The corrosion pits were observed to be bowl-shaped, with a diameter of 733  $\mu\text{m}$  at the perforation's base. The remaining wall thickness of approximately 3 mm exhibited localized corrosion pits, with the bottom of the pits measuring approximately 1.7 mm in remaining wall thickness, as illustrated in Fig. 7.

Fig. 5. Macroscopic appearance of perforation

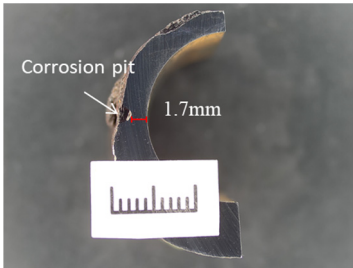
Fig. 7. The morphology of the left end of the specimen in Fig. 6

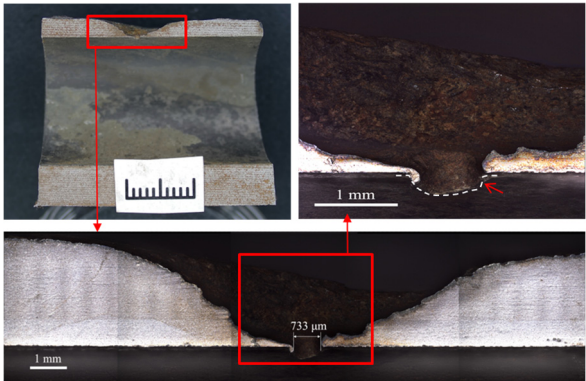
Fig. 6. Morphology of longitudinal planing surfaces at perforations

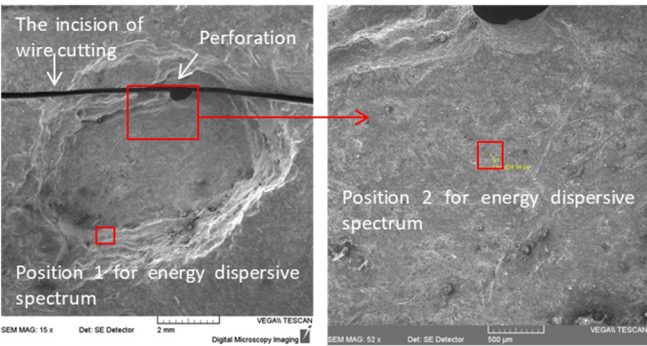
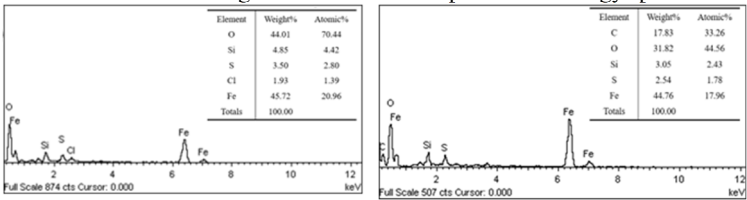
a) The micro-morphology of the inner surface of the perforated corrosion pit and the schematic diagram of the detection position of energy spectrum

b) The results of energy spectrum analysis

Fig. 8. Results of energy spectrum analysis of corrosion products on the inner surface of perforated corrosion pit

and 9. Energy dispersive spectrum analysis of both the bottom and side walls of the corrosion pit reveals that the primary elements constituting the corrosion products at the bottom include Fe, O, C, Si, and S. In contrast, the scale-like corrosion products found on the side walls predominantly consist of Fe, O, S, Cl, and Si.

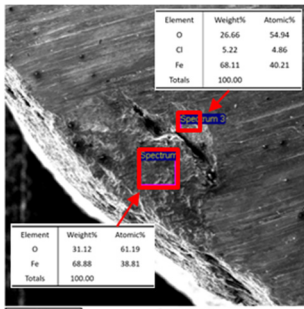
The corrosion pit in Fig. 7 was observed and the products were analyzed. As shown in Fig. 9, the corrosion pit was bowl-shaped and filled with corrosion products. The main elements of the products were Fe and O, and the main elements at the bottom of the pit were Fe, O and Cl.

Fig. 9. The morphology of the corrosion pit corresponding to Fig. 7 and the results of energy dispersive spectrum analysis

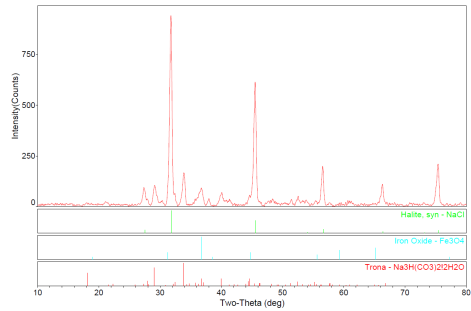
The X-ray diffraction (XRD) analysis results of the materials attached to the tube wall are shown in Fig. 10. The results show that the white substances are mainly NaCl, trona ( $\text{Na}_3\text{H}(\text{CO}_3)_2\text{H}_2\text{O}$ ), and the reddish-brown corrosion product is  $\text{Fe}_3\text{O}_4$ .

Fig. 10. Results of XRD analysis of the materials attached to the outer wall of the tube
