Improvement of the classification of causes for the decommissioning of large-size tires

Abstract. The article presents the results of the analysis of the causes of failure of large-size tyres operated in the conditions of Navoi MMC. On the basis of generalisation of the accumulated data the classification of the main factors leading to tyre failure is proposed. All causes are grouped into three key categories: wear, mechanical damage and thermal damage. Wear includes the processes of natural and accelerated tread abrasion, as well as various forms of uneven wear arising from deviations from the recommended operating conditions. Mechanical damage is considered as a result of short-term or long-term external impacts, including punctures, cuts, cord breaks and frame deformations. In 2024, the plant used more than 19 thousand car tires with a total value of about 1.4 trillion soums. These quarry dump trucks use tires manufactured by Bridgestone, Goodyear, Luan, Michelin, Techking, Advance, Aeolus, Maxam and Noble. For transport enterprises, the task of rational use of tire resources by improving the condition of quarry roads and reducing premature tire failure is relevant. The results

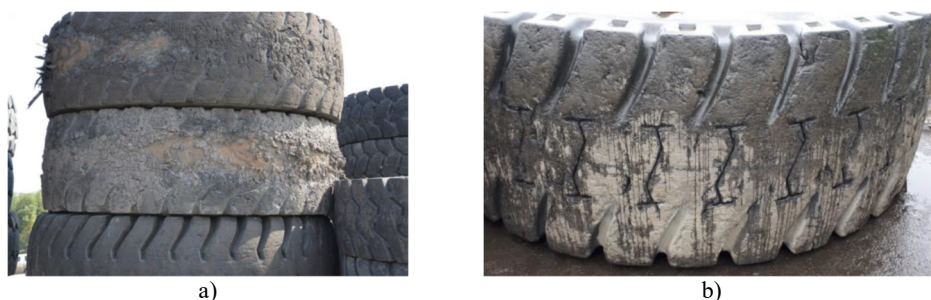
- 1) Normal or natural (even) wear. Tread rubber is frayed, protective and/or working breaker cables are exposed. Operation is permitted up to the second visible layer of breaker.

Suspension elements of the machine are in good condition, technological roads correspond to

norms (Fig. 1).

Fig. 1. Normal (uniform) wear: a) Techking tyres; b) Michelin tyres

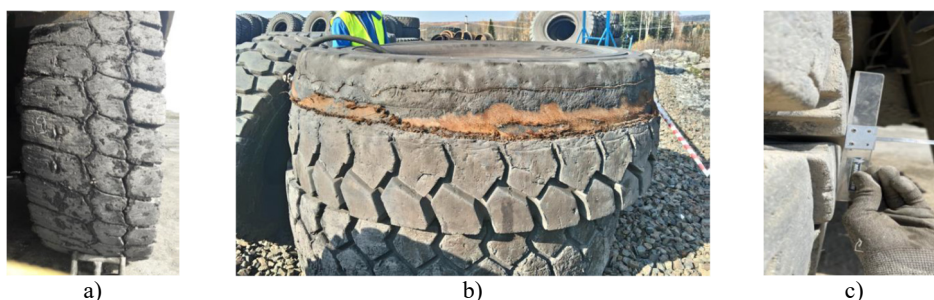
2) Uneven, accelerated wear. Such wear is associated with faulty machinery (Fig. 2(a)), untimely rotation, or a combination of these factors. Sawtooth block wear is associated with high speed in turns (Fig. 2(c)). Can be detected early with regular inspections. Degree of rubber wear on one side of the tread does not allow safe tyre operation (Fig. 2(b)). Caused by additional friction when the wheel rolls. Friction causes an additional temperature rise inside the tyre.

Fig. 2. Uneven wear: a) tyre wear due to machinery failure; b) one-sided wear; c) sawtooth wear

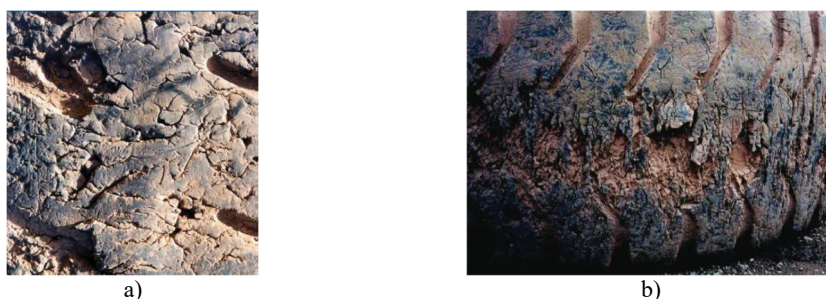
3) Accelerated, aggressive wear. The tread rubber has numerous explosions (Fig. 3) caused not by abrasion but by aggressive action of the road surface. Caused by coarse fraction of road surface underlay, hardness of the underlay material, tread rubber compound not complying with standards, slipping on hard aggressive surface. Remedied by normalising road conditions, correct choice of rubber compound.

Fig. 3. a) Accelerated and b) aggressive tyre wear

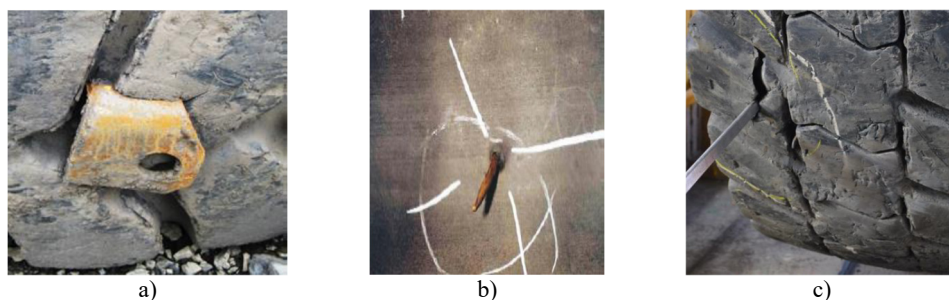
Mechanical damage: Through puncture of the tread. A puncture is accompanied by damage to the tread rubber, protective and working bracing cables, carcass and germ layer. It refers to instant damage caused by hitting sharp rocks or a foreign object (Fig. 4). The possibility of repair is determined depending on the size and nature of the damage.

Fig. 4. a), b) Damage by foreign object and c) sharp rock

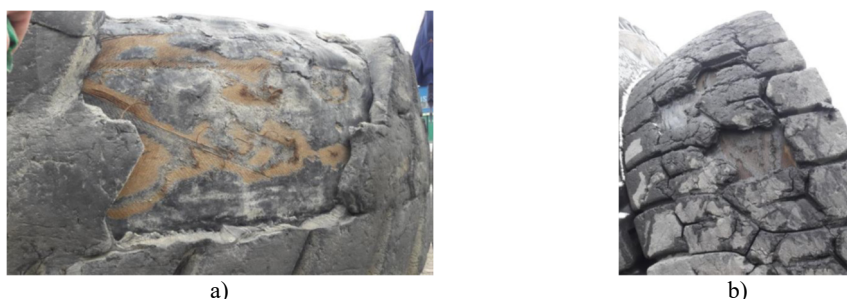
Mechanical damage: non-penetrative. Damage reaches the working bracing layers, accompanied by puncture of the tread rubber and damage to the protective and working bracing cables. The carcass and germ layer remain intact (Fig. 5). The cause is a collision with a sharp foreign object. The damaged tyre is not repairable.

Consequences: the tyre continues to be used for a long time, but corrosion develops inside, the structure is weakened, which can lead to a sudden loss of pressure without breaking the carcass cables.

Fig. 5. Tyre carcass and germ layer remaining intact: a) Techking and b) Michelin

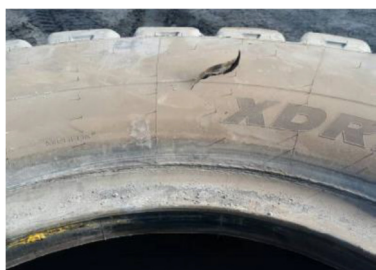
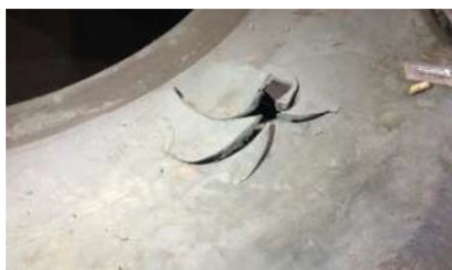
Mechanical damage - swelling with tearing of the sidewall. The defect is characterised by a radial tear in the sidewall rubber or a tear at the edge of the bulge accompanied by localised delamination. In most cases, the radial carcass remains intact and the sidewall area of the tyre is not deformed. The outer surface of the sidewall may show signs of mechanical impact in the form of scuffs and abrasions caused by contact with foreign objects (Fig. 6).

The main cause of damage is the impact load. A slight breach of the integrity of the sealing layer leads to gradual penetration of air into the internal cavity between the carcass and sidewall rubber, which in time causes tearing. Such a defect is irreversible and cannot be repaired.

Fig. 6. Tearing of sidewall rubber by contact with foreign objects

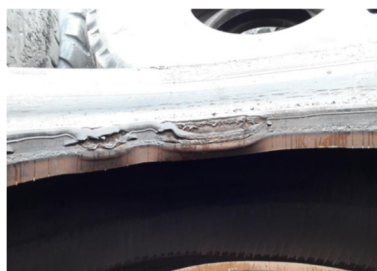
Mechanical damage – bulging of the sidewall (with or without tearing) due to damage to the bead during mounting. The defect is characterised by deformation of the sidewall and visible damage to the rubber on the seating surface of the bead, which can only be detected after disassembly of the tyre. The main cause of damage is non-compliance with the technological process of mounting, which includes insufficient use of lubricants, uneven distribution of load on the rim elements during mounting, as well as assembly work without the use of a specialised bench (Fig. 7).

This type of damage is irreversible and cannot be repaired due to the significant disruption of the rubber structure and the risk of further damage during operation.

Fig. 7. a) Disturbance of rubber structure and b) its damage on the boarding surface

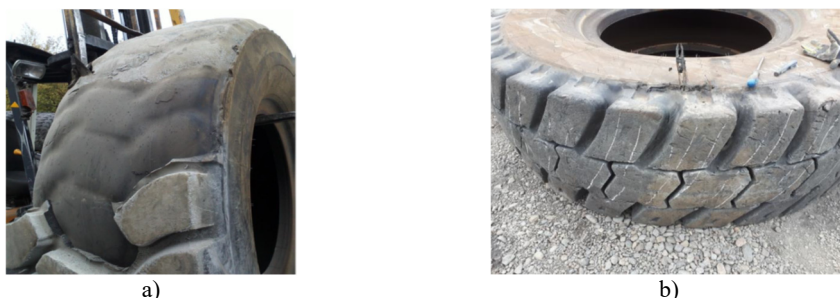
Thermal damage: detachment of the tread rubber due to overheating. Thermal damage manifests itself as a detachment of the tread rubber, but usually no exposed breaker cables are observed. However, in case of significant overheating, localised destruction of the rubber between the bracing layers is possible. As a result of changes in the physical properties of the material, the rubber becomes dark, sticky, with signs of carbonisation, accompanied by the appearance of soot and the characteristic smell of burning rubber.

The main cause of this damage is the exceeding of the permissible operating temperature inside the solid tyre structure, including the inter-breaker space. Factors contributing to overheating:

- Operation of the tyre at parameters exceeding the factory set limits (TKPH) [4].
- The tyre's internal pressure does not match the load conditions.
- Increased rolling friction due to road conditions.
- Exceeding the permissible average operating speed.

This type of damage is not repairable. The lower the wear of the tyre, the higher the probability of overheating due to increased rolling resistance. Most often thermal degradation is observed on the front wheels of dump trucks. The degradation process is irreversible. This problem can only be eliminated by improving the operating conditions, in particular by improving the road surface. As a result of overheating, delamination cavities are formed inside the rubber mass, which increase in size with each revolution of the wheel (Fig. 8(a)). The deformation can propagate both along the rolling axis and transversely, which accelerates tyre failure (Fig. 8(b)).

Fig. 8. Thermal damage to the tyre: a) detachment of the rubber in the tread area due to overheating and b) development of thermal damage in the transverse direction

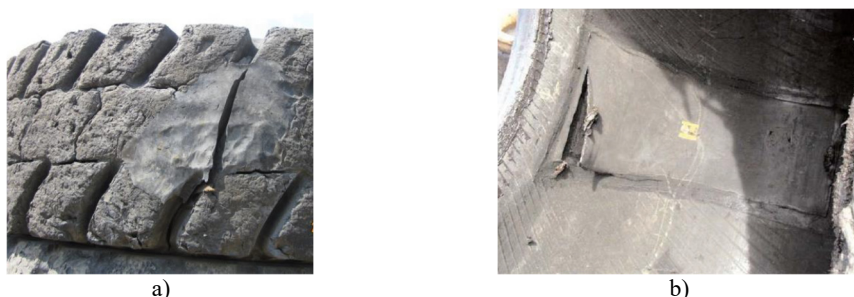
Repair-related damage. The damage is characterised by a sudden loss of pressure in the tyre caused by damage in the area of the previous repair (Fig. 9). The main cause of these damages is non-compliance with technological requirements during repair work.

Factors leading to this type of injury include:

- Use of low-quality repair materials, expired expiry date, storage conditions that do not meet the standards.
- Incorrect selection of the size and type of repair patch depending on the characteristics of the lesion.
- Incorrect positioning of the patch in relation to the damaged area.
- Violations of the technology of preparation of the repaired surface (shape and depth of the funnel, insufficient cleaning and treatment of the surface before applying adhesive and vulcanising compositions).
- Failure to observe the temperature regime in the room during the renovation.

Failure in the repair area results in a complete loss of serviceability of the tyre, as the weakened area becomes a critical zone prone to repeated defects and depressurisation.

Fig. 9. Tyre damage due to non-compliance with technological requirements during repair work: a) tread, b) inner part of sidewall

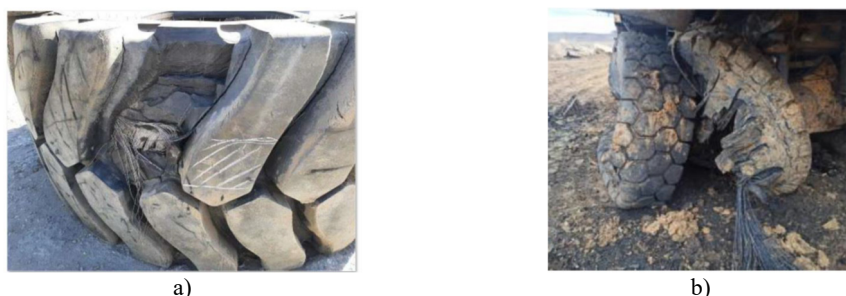
Fatigue damage to the carcass and tyre liner. Fatigue processes develop in the tyre structure during prolonged use, especially under conditions of cyclic overloads and deformations. The most susceptible to fatigue damage are textile or metal carcass and tyre liner elements. The result is the formation of microcracks with subsequent accumulation of damage leading to partial or complete rupture of cords, weakening of the bond between the plies, local loss of strength and, ultimately, tyre failure (Fig. 10(a)).

Fig. 10. a) Fatigue damage of frame elements and b) damage caused by accidents

Damage caused by road traffic accidents (crashes). Accidents can be accompanied by a sharp dynamic impact on the tyre (impacts, lateral shifts, jammed objects), which leads to complex damage: from sidewall and bead tears to destruction of the entire load-bearing structure (Fig. 10(b)). Such damage is often accompanied by irregular carcass deformation, tread separation, depressurisation and, in some cases, instant tyre collapse. After such incidents, further use of the tyre is strictly prohibited, regardless of the apparent extent of the damage.
