Analysis of causes for increased vibrations in Francis hydroelectric generators

Abstract. The present study analyzes the causes of increased vibration in Francis-type hydroelectric generators, focusing on the rotor-stator assembly and the rotor support structure (rotor spider), and considering installation and operational performance. Through comprehensive analysis of vibration histories, visual and topographic inspections, roundness measurements, alignment and magnetic-center surveys, and finite element modeling (FEM) under nominal speed and runaway speed conditions (81.8 and 175 rpm), the principal causes of elevated vibration were identified. Key findings include: fatigue fracture of the bases supporting the polar rim support block; loss of rotor-stator magnetic centering (polar rim descent up to 20 mm); and loss of rotor roundness (maximum deviation 1.7 mm). FEM revealed stress concentrations in the original design that exceed the yield strength of A-36 steel and fatigue safety factors below 1 in the critical region. These conditions produce structural imbalance and intermittent vertical forces that increase vibration – particularly during start/stop transients and in pass-thr

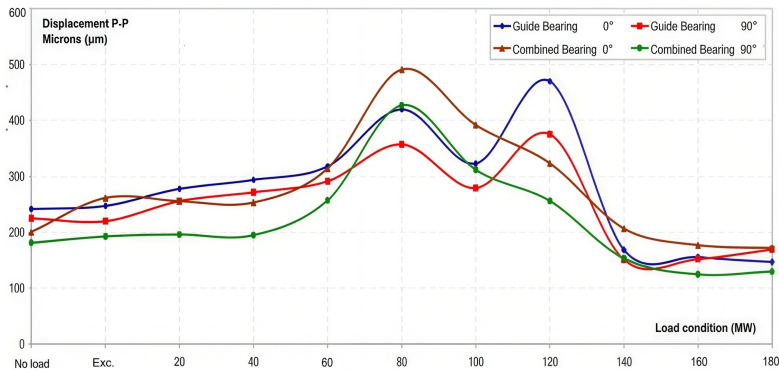
Fig. 7. Overall vibration of Francis-type unit under study [12]

Fig. 7 demonstrates an increase in the reported vibration after assembly. This increase is already noticeable at no load, with a 117 % rise, which is considered acceptable. However, in the low generation zone (20-40 MW), while the increase remains within acceptable operating limits, it is approaching the long-term damage threshold. The unit has a defined operational range for rapid passage through a natural frequency known as the rough zone (between 60-140 MW); in this range, the increase is significantly greater, ranging from 183 % to 286 %, indicating at a risk of a long-term damage. In the nominal operating zone (140-180 MW), the increase in vibration varies between 100 % and 120 %, positioning itself at the upper limit of what is considered normal.

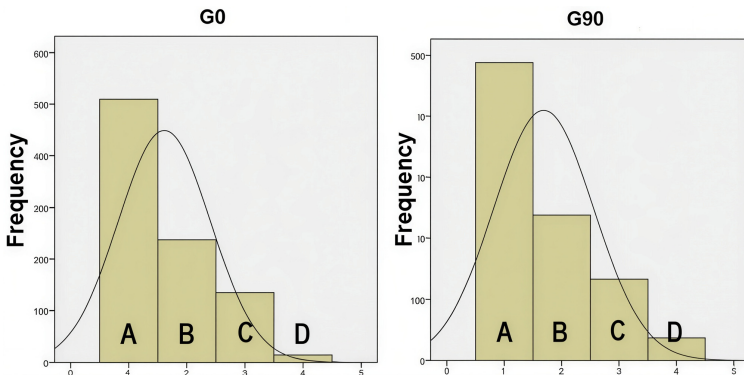
Fig. 9. Historical vibration of generation units. Divided by operating range according to ISO 7919-5 standards [12]

The results obtained are presented in a frequency chart (see Fig. 9). It can be observed that, while the highest value is associated with the operation range A (normal operation, see Table 1), there is a significant proportion of values within the range B (acceptable operation). Notably, values also appeared in ranges C and D, which represented the operational zones at risk for long-term and short-term damage, respectively.

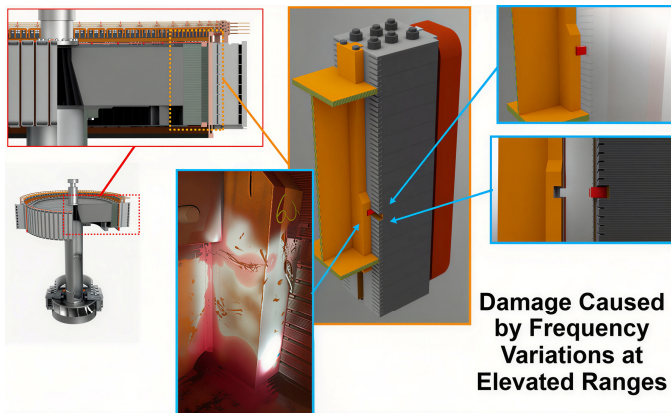
Fig. 12. Damage area, rotating parts, with detailed view of rotor, arm, and polar rim. [12].
Photograph was taken at the unit under study by P. Hernandez on December 15, 2022

Fig. 12 presents the precise location of the failure, starting from the macro level (rotating parts of the unit) and progressing to a detailed view of the rotor, followed by a 3D model of the spider arm (in ochre), the polar rim (in gray), and a pole (in red). In this last section, an image is included to show one of the fractured arms. Here, the failure is magnified through a penetrant testing (PT) method, where the white area reveals the fracture in a light red tone.

These findings are significant, as the allowable tolerance for the descent of the polar rim should not exceed the specific thresholds established by the technical standards for design and operation set by the manufacturer, which in this case is ± 2 mm [12].

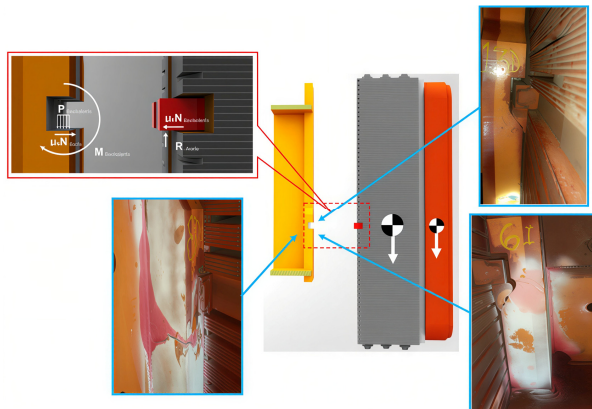
Fig. 13. Damage area, detailed view of arm and polar rim of rotating parts [12].
Photograph was taken at the unit under study by P. Hernandez on December 15, 2022

Fig. 13 displays a cross-section of the arm (ochre), the polar rim (gray), and a pole (red). This section includes three images of the fractured arms, as well as a detailed view of the arm support and its contact point (Polar Rim Support Block).

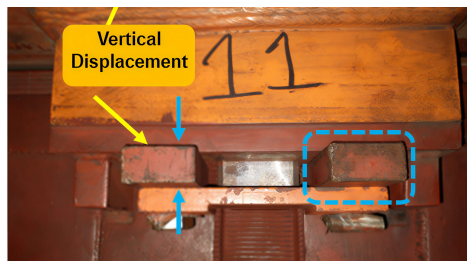
Fig. 16. Descent of vertical polar rim support block connecting rotor spider to the polar rim [12]. Photograph was taken at the unit under study by P. Hernandez on December 15, 2022

Figs. 16-17 show a loss of height of the polar rim relative to its supporting structure. Upon further investigation, the rotor magnetic center was first measured in relation to the stator, revealing a significant misalignment between the rotor and stator magnetic center (Fig. 18), evidenced by a descent of up to 20 mm (see Table 4), which exceeds the -2 mm tolerance permitted by the manufacturer [12].

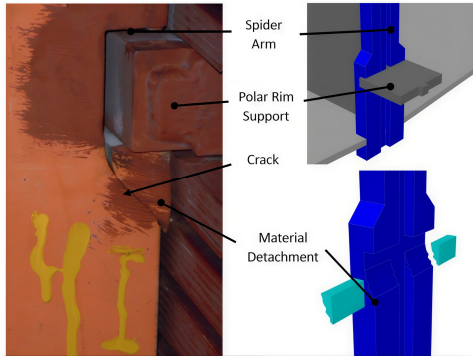
Fig. 17. Cracks and material detachment in horizontal polar rim support block [12].
 The photograph shown in the figure by P. Hernandez on December 15, 2022

As a consequence of the first condition, rotor spider supports are broken (see Fig. 17). This breakage is directly related to the loss of alignment of the magnetic centers, as the additional forces generated by the misalignment increase the stresses on the supporting structure, ultimately leading to its eventual fracture.

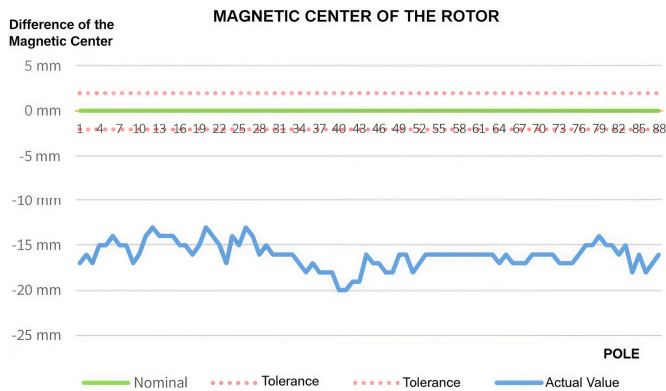
Fig. 18. Results of measurement of rotor magnetic center [12]

This misalignment is a critical factor in the generation of vibrations within the unit, as the rotor and stator magnetic centers shall be perfectly aligned during operation. Any misalignment leads to the emergence of intense vertical forces, as these centers attempt to readjust for alignment. These forces exert significant stress on the polar rim, which is transmitted to the rotor supporting structure, known as the rotor spider.

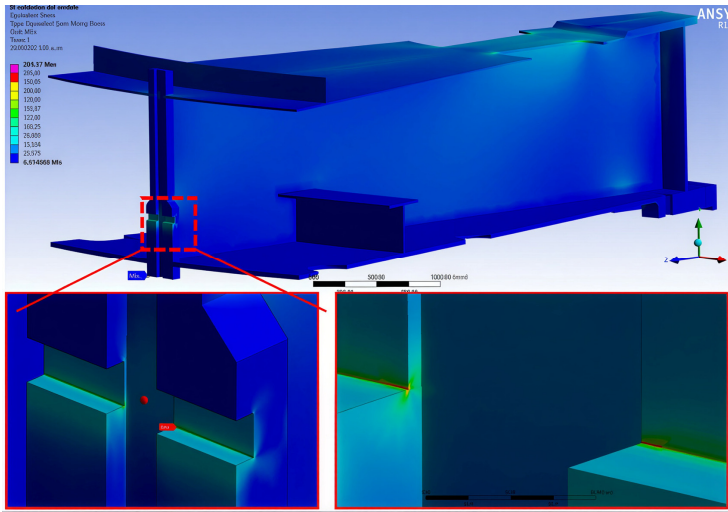
Fig. 25. Distribution of Von Mises stresses for nominal speed [12]

maximum value is concentrated in the area highlighted in the red boxes.

In the lower left and right views of the figure, the exact location of this concentration of critical stresses is shown in a greater detail. On the other hand, the rest of the structure exhibits uniform behavior with average stresses of $Se = 50$ MPa, values significantly below the yield strength, indicating that the majority of the structure operates within the established safety margins.

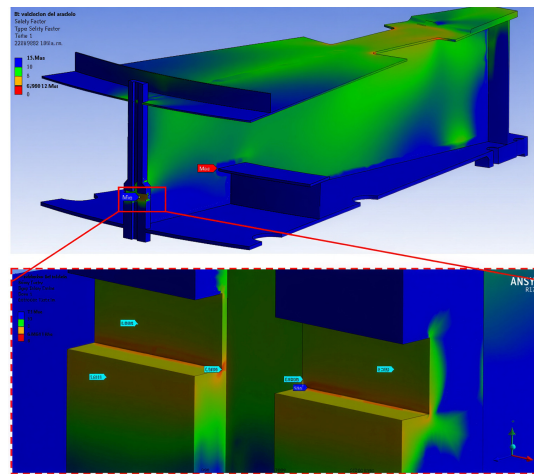
Fig. 28. Safety factors in structure under static load [12]

It is observed that, overall, the structure exhibits an acceptable safety factor under static loading conditions. However, critical concentrations are highlighted in the lower boxes of Fig. 28, where regions with the minimum safety factor are identified, corresponding to the marker “min”, which records a value of $N = 0.889$. This value indicates an insufficient margin against the yield strength, which could compromise the structure integrity in those areas.

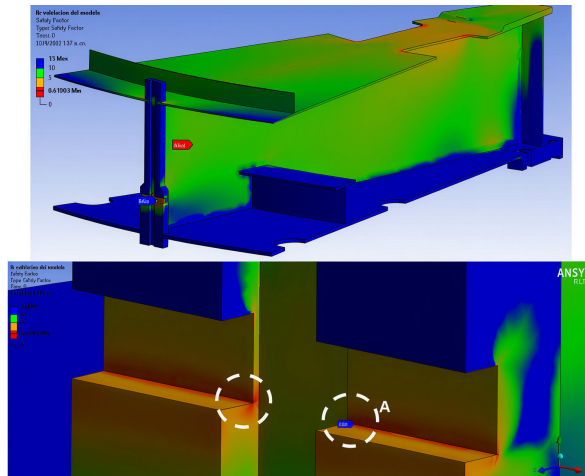
Fig. 29. Safety factors for current condition [12]

From this study, the distribution of the Fatigue Safety Factor was obtained, and the results are presented in Fig. 29. This analysis provides key information about the structure ability to withstand repetitive stresses without failures due to fatigue.

The identification of these deficiencies highlights a fundamental issue in the initial design of the rotor spider, indicating that significant modifications are needed to improve its strength and reliability. Therefore, it is imperative to implement design solutions that not only address the existing failures but also incorporate engineering principles that ensure adequate performance under operating conditions. This includes reviewing the analysis methods used in the design, implementing rigorous control in manufacturing, and establishing proactive maintenance strategies to mitigate the risk of future failures.
