# Analysis of causes for increased vibrations in Francis hydroelectric generators

**Abstract.** The present study analyzes the causes of increased vibration in Francis-type hydroelectric generators, focusing on the rotor-stator assembly and the rotor support structure (rotor spider), and considering installation and operational performance. Through comprehensive analysis of vibration histories, visual and topographic inspections, roundness measurements, alignment and magnetic-center surveys, and finite element modeling (FEM) under nominal speed and runaway speed conditions (81.8 and 175 rpm), the principal causes of elevated vibration were identified. Key findings include: fatigue fracture of the bases supporting the polar rim support block; loss of rotor-stator magnetic centering (polar rim descent up to 20 mm); and loss of rotor roundness (maximum deviation 1.7 mm). FEM revealed stress concentrations in the original design that exceed the yield strength of A-36 steel and fatigue safety factors below 1 in the critical region. These conditions produce structural imbalance and intermittent vertical forces that increase vibration – particularly during start/stop transients and in pa

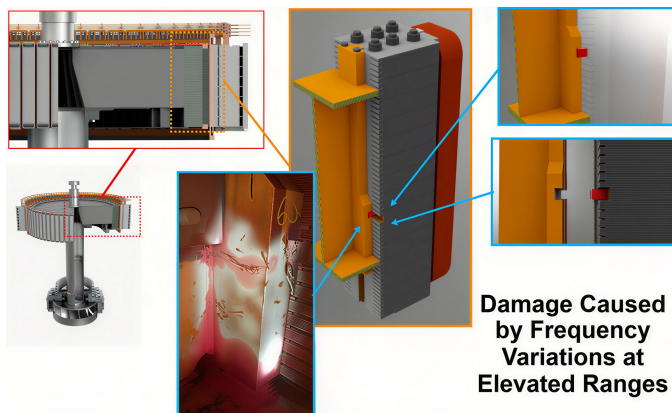
**Fig. 12.** Damage area, rotating parts, with detailed view of rotor, arm, and polar rim. [12].  
Photograph was taken at the unit under study by P. Hernandez on December 15, 2022

Fig. 12 presents the precise location of the failure, starting from the macro level (rotating parts of the unit) and progressing to a detailed view of the rotor, followed by a 3D model of the spider arm (in ochre), the polar rim (in gray), and a pole (in red). In this last section, an image is included to show one of the fractured arms. Here, the failure is magnified through a penetrant testing (PT) method, where the white area reveals the fracture in a light red tone.

These findings are significant, as the allowable tolerance for the descent of the polar rim should not exceed the specific thresholds established by the technical standards for design and operation set by the manufacturer, which in this case is  $\pm 2$  mm [12].

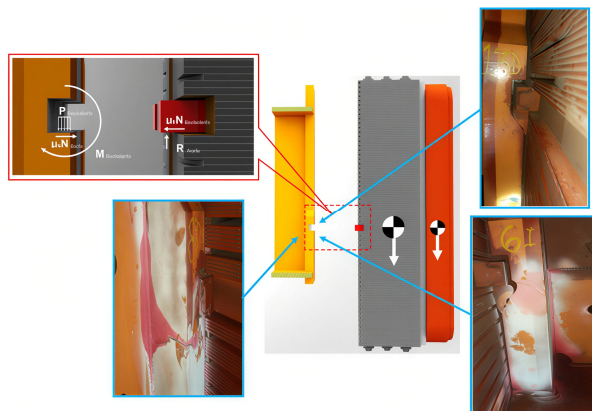
**Fig. 13.** Damage area, detailed view of arm and polar rim of rotating parts [12].  
Photograph was taken at the unit under study by P. Hernandez on December 15, 2022

Fig. 13 displays a cross-section of the arm (ochre), the polar rim (gray), and a pole (red). This section includes three images of the fractured arms, as well as a detailed view of the arm support and its contact point (Polar Rim Support Block).

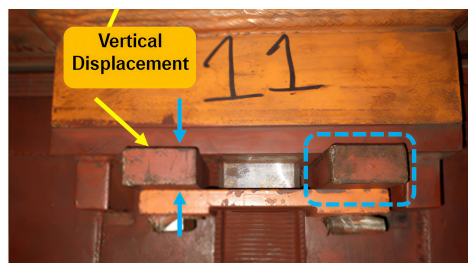
Figs. 16-17 show a loss of height of the polar rim relative to its supporting structure. Upon further investigation, the rotor magnetic center was first measured in relation to the stator, revealing a significant misalignment between the rotor and stator magnetic center (Fig. 18), evidenced by a descent of up to 20 mm (see Table 4), which exceeds the  $-2$  mm tolerance permitted by the manufacturer [12].

**Fig. 16.** Descent of vertical polar rim support block connecting rotor spider to the polar rim [12]. Photograph was taken at the unit under study by P. Hernandez on December 15, 2022

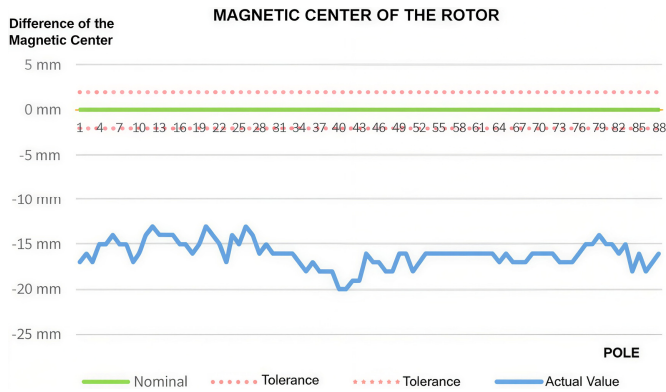
**Fig. 18.** Results of measurement of rotor magnetic center [12]

This misalignment is a critical factor in the generation of vibrations within the unit, as the rotor and stator magnetic centers shall be perfectly aligned during operation. Any misalignment leads to the emergence of intense vertical forces, as these centers attempt to readjust for alignment. These forces exert significant stress on the polar rim, which is transmitted to the rotor supporting structure, known as the rotor spider.

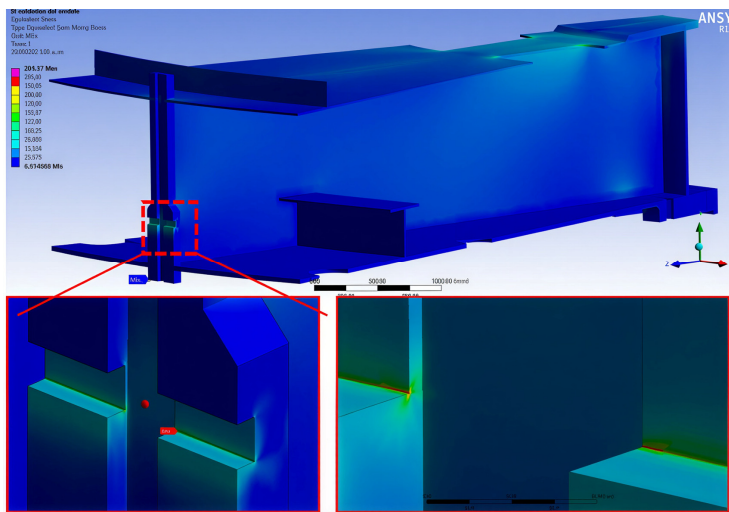
Fig. 25. Distribution of Von Mises stresses for nominal speed [12]

maximum value is concentrated in the area highlighted in the red boxes.

In the lower left and right views of the figure, the exact location of this concentration of critical stresses is shown in a greater detail. On the other hand, the rest of the structure exhibits uniform behavior with average stresses of  $Se = 50$  MPa, values significantly below the yield strength, indicating that the majority of the structure operates within the established safety margins.

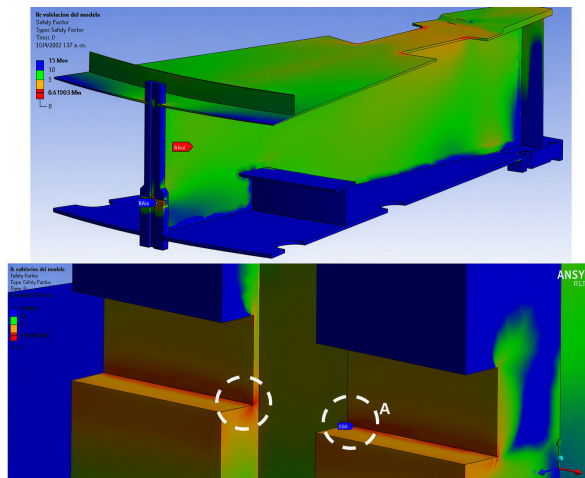
Fig. 29. Safety factors for current condition [12]

From this study, the distribution of the Fatigue Safety Factor was obtained, and the results are presented in Fig. 29. This analysis provides key information about the structure ability to withstand repetitive stresses without failures due to fatigue.

The identification of these deficiencies highlights a fundamental issue in the initial design of the rotor spider, indicating that significant modifications are needed to improve its strength and reliability. Therefore, it is imperative to implement design solutions that not only address the existing failures but also incorporate engineering principles that ensure adequate performance under operating conditions. This includes reviewing the analysis methods used in the design, implementing rigorous control in manufacturing, and establishing proactive maintenance strategies to mitigate the risk of future failures.

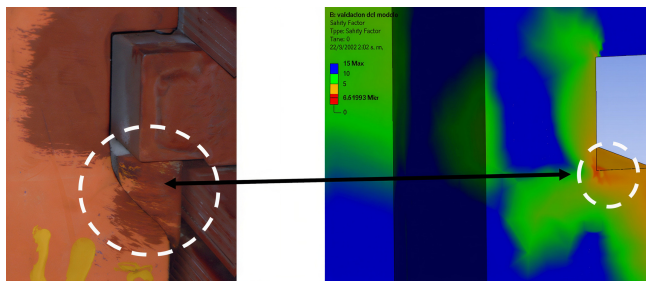
Fig. 30. Current fracture condition at nominal speed [12]. Photograph was taken at the unit under study by P. Hernandez on December 15, 2022
