# 2312. Extensive vibrations of the belt conveyor drive electromotor of a bucket wheel excavator as a result of intensified wear-and-tear of its mount support

Vesna Damnjanović<sup>1</sup>, Predrag Jovančić<sup>2</sup>, Snežana Aleksandrović<sup>3</sup>

University of Belgrade – Faculty of Mining and Geology, Belgrade, Serbia <sup>2</sup>Corresponding author **E-mail:** <sup>1</sup>*vesna.damnjanovic@rgf.bg.ac.rs*, <sup>2</sup>*predrag.jovancic@rgf.bg.ac.rs*, <sup>3</sup>*snezana.aleksandrovic@rgf.bg.ac.rs*

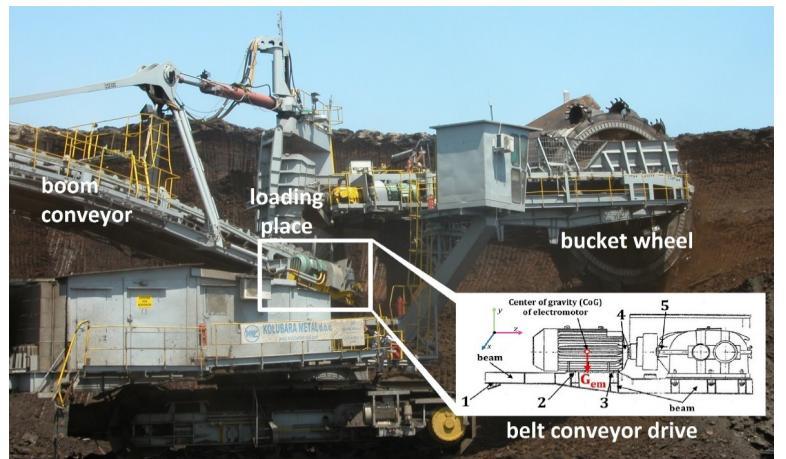
Fig. 1. Bucket wheel excavator. The insert shows a layout of the belt conveyor drive and the characteristic points where vibrations were monitored

To prove a negative impact, primarily that of a worn rear support of the electromotor mount (increased clearance), which has an adverse effect on the overall performance of the drive (point 1 in the insert in Fig. 1), preventative vibration measurements are needed as soon as the excavator is put into operation after overhaul/installation (i.e. long before a structural clearance occurs), and then also after a clearance ensues. In the present case, measurement was undertaken after11850 hours of operation since overhaul/installation of the conveyor drive. To ensure validity of the results, nearly the same operating conditions of the excavator were specified and achieved in both measurement cycles. More precisely, in both cases:

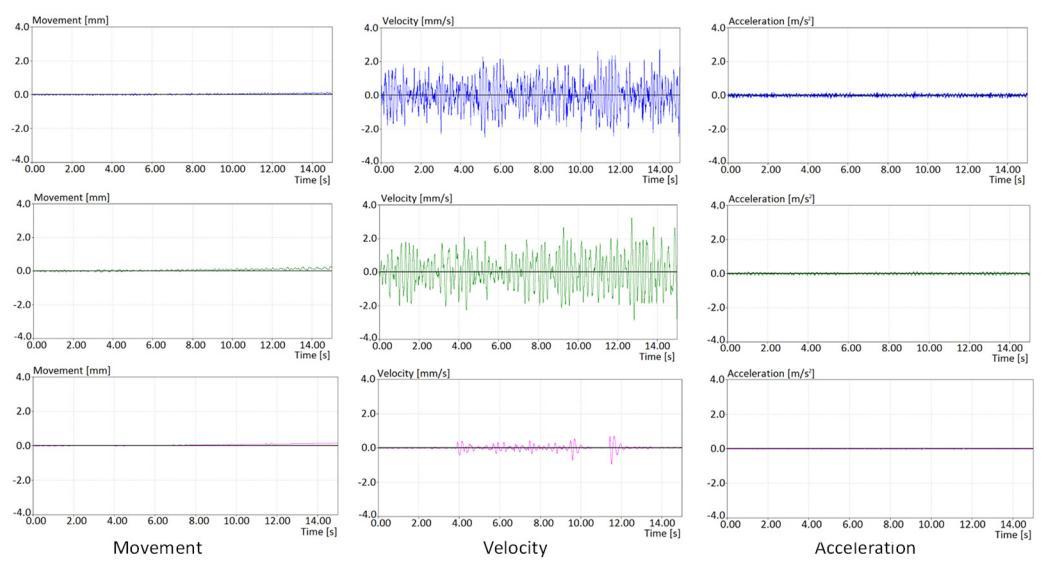
Fig. 2. Movement, velocity and acceleration, respectively, based on measurements conducted at the rear support of the drive mount on the bucket wheel excavator boom, at the beginning of operation after overhaul

beginning of operation of the conveyor drive after overhaul/installation. The color blue denotes vibrations in the transverse direction, green in the vertical direction, and red in the axial direction. Diagrams of movement, velocity and acceleration of oscillations were also produced, as shown. The results in Fig. 2 are typical of a reconstructed drive put into operation after overhaul, such that movement in all three directions is minimal, from 0.1 mm to 0.2 mm, or as much as allowed by the installation clearance of the connection between the drive mount and the steel structure of the boom. With this type of connection, the speed of movement is also very low, especially in the axial direction, which is indicative of both overall and local stiffness. Corresponding to such low velocities are minimal accelerations, from  $0.1 \text{ m/s}^2$  to  $0.2 \text{ m/s}^2$ .

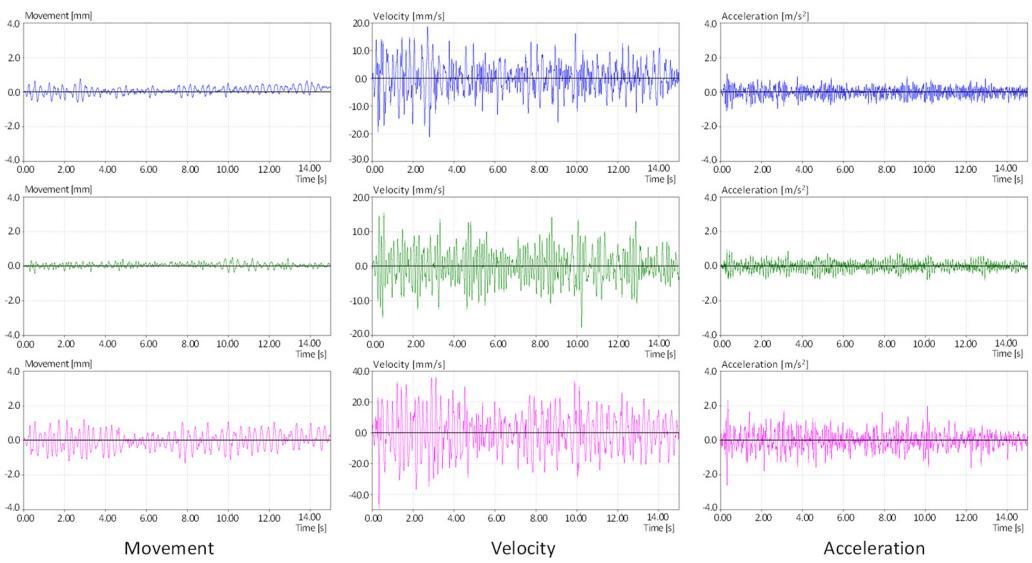
Fig. 3. Movement, velocity and acceleration, respectively, based on vibration measurement at the rear support of the drive mount on the bucket wheel excavator boom after 11850 hours of operation since overhaul/repair

It is apparent by comparing Figs. 2 and 3 that the largest differences in the vibrations were registered in the axial direction (*z* axis/red). In other words, the drive mount support (connection via axles) had a greater clearance in the assembly after 11850 hours of operation, which intensified vibrations, particularly in the axial direction. The overall movement of the drive was caused, inter alia, by the movement of mass on the conveyor parallel to the drive center line (i.e. in the axial direction). This caused the support assembly to give way. The clearance was about 1.2 mm, which was the space within which movement occurred within the assembly. Table 1 shows the relations (quotients) of the recorded movement, velocity and acceleration, immediately after overhaul and after 11850 hours of operation.

The data clearly indicated that the support gave way in the axial direction. Slackening of the entire system was a result of a sudden increase in clearance and support failure/breakage. The reasons for this suggested the following:

-Measurement point 1 in Fig. 1 was quite distant from the center of gravity of the electromotor and caused the elasticity of the support to increase and the stiffness levels to differ;

-Point 1 was common to two different dynamic systems: drive with mount and belt conveyor boom. These two systems had different dynamic relationships with the support. Point 1 was the point of interaction of two different dynamic systems – the drive and the boom.

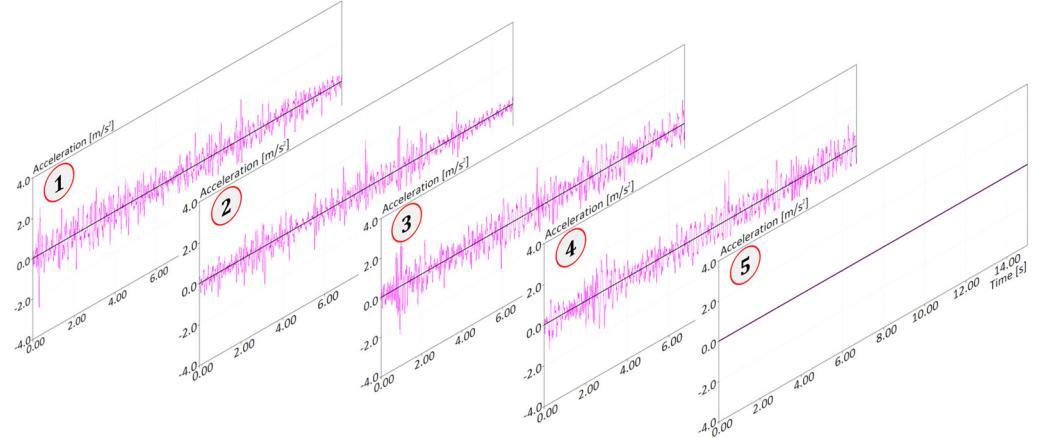
Fig. 4. Measured acceleration vibrations in the time domain, in the axial direction, at characteristic points of the drive after 11850 hours of operation

The first four measurement points delivered more pronounced signals in the axial direction that the last (fifth) point. At the fifth point, which is the bearings at the gearbox inlet, the signal in the axial direction was not strong and indicated that the stiffness of the gearbox was much higher than that of the other components. Also, the presence of a flexible coupling between the electromotor and the gearbox prevented transmission of axial movement.

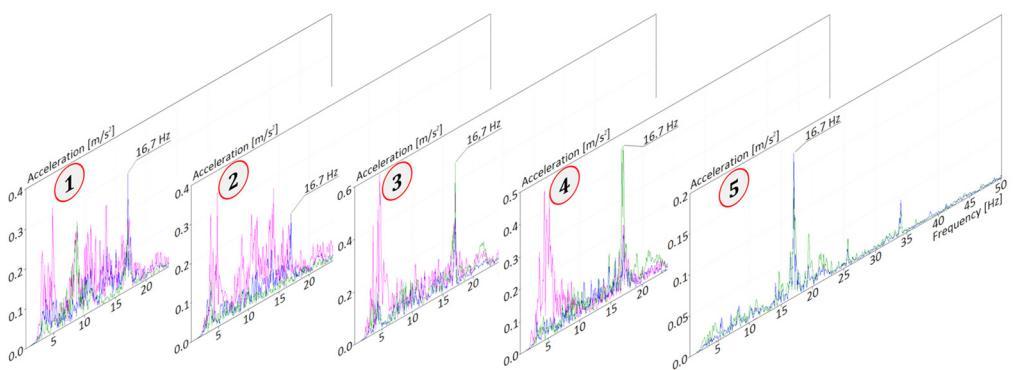
Fig. 5. Vibration acceleration in the frequency domain at characteristic points on the conveyor drive after 11850 hours of operation

Vibration measurements conducted on the belt conveyor drive of the bucket wheel excavator after 11850 hours of operation revealed the following dominant frequencies:

1) Frequencies 3.1 Hz, 3.6 Hz, 4.1 Hz and 4.8 Hz were registered at the first four characteristic points, but not the fifth (gearbox). The amplitude was from 0.3 m/s<sup>2</sup>to 0.6 m/s<sup>2</sup> (all the frequencies were pronounced in the axial direction). These low frequencies were associated with the drive mount, or the rear support on the boom (due to poor condition of the rear connection). This behavior was generally the result of the way the drive mount was suspended on the boom, but also of loading of large pieces of coal. Low frequencies that coincided with natural frequencies of the mount were a result of bending and twisting of the drive support. The amplitudes increased because of the increased clearance in the support on the boom. More precisely, the measured dominant frequencies overlapped with the initial natural forms of oscillation. Low frequencies had an extremely negative effect on the supporting steel structure.

2) The frequency of 16.7 Hz originated from excitation (electromotor RPM was 1000 min<sup>-1</sup>) and this signal was recorded at all measurement points. The amplitude was from 0.2 m/s<sup>2</sup> to  $0.45 \text{ m/s}^2$  (all excitation frequencies were pronounced in all three directions, except at the fifth measurement point – gearbox inlet – where the dominant directions were vertical and transverse). The values were still not alarming from an operational safety perspective but indicated future problems. There will always be an excitation frequency, but it might have an upward trend depending on the condition of the system and decreasing stiffness.
