Impact testing of hydro generators end-winding in different temperature state

Abstract. The fault detection of rotating electrical machines has become very attractive field of research from vibrational aspect, because these machines are susceptible to failure due to thermal, electrical, mechanical or environmental stresses. Therefore, the vibrational analysis of generators as rotating machines will be beneficial for the generator design in the initial stage and also for online monitoring and faults diagnostics during generator operation. This paper presents a novel methodology for hammer impact testing („bump-test“) of stators end-winding vibrations with an accent on the influence of the physical parameters such as temperature. Introductory, a brief survey of recent research in the area is presented. Furthermore, a detailed description of the used instrumentation and conducted testing methodology according to established standards is systematically exposed. The measurement methodology is implemented on two generators, a cold one in its‘ repairing phase and second identical, generator in a warm condition in order to detect the damaged elements and to investigate the influence of th

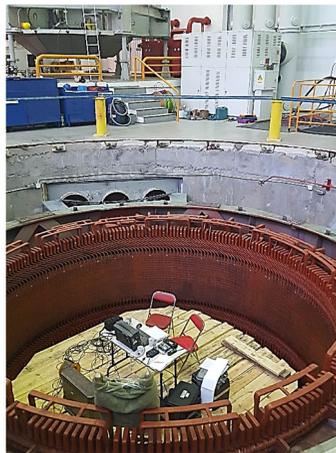
Fig. 1. View of the generator stator in a repairing phase

In one of the two synchronous hydro-electrical generators in a hydro powerplant in the country, an insulation problem with the series loop caps of the stator occurred. Immediately after this problem was noticed, the repairing phase of generator started (Fig. 1).

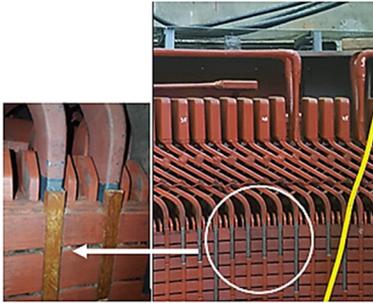
Fig. 2. Slot wedges between the bars

Since a lot of the problems in generators occur in the stator electrical connections, for insulating each bar from another and preventing insulation failure, an insulating material is used. Each bar is covered with a wedge slot (Fig. 2) which provides insulation, tightness and higher rigidity by preventing movement of the parallel phase leads in radial direction.

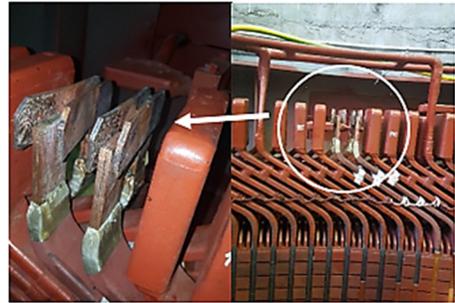
Fig. 3. Failure of caps and hoop strengths in the generator during the repairing phase

The vibrations of the bars generally may occur due to the main external exciting force which is the electromagnetic frequency (100 Hz). Very often as in this case can come to insulation damage because of enlarged vibration of the parallel phase leads and series loop caps in the resonant region of 100 Hz (Fig. 3).

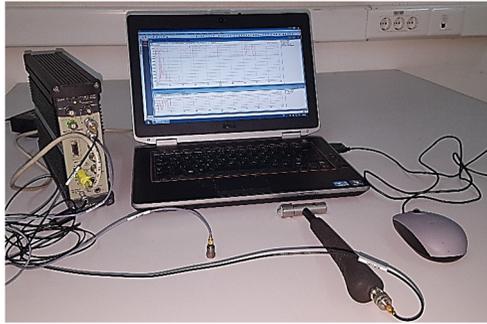
Fig. 4. Instrumentation setup consisting of impact hammer, accelerometer, data acquisition unit and lap-top

The instrumentation setup in a laboratory conditions is shown in Fig. 4.

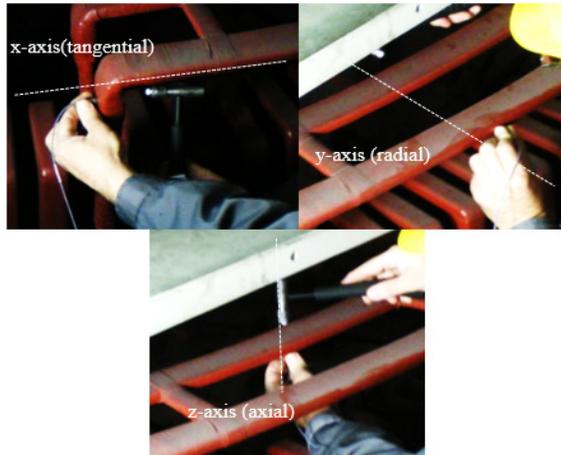
Fig. 5. Directions of measurement of parallel phase leads from [18]

Furthermore, the points where the impact with the hammer are implemented and the accelerometer will be placed were defined. The measurement points need to provide information about the natural frequencies in three directions: tangential (x -axis), radial (y -axis) and axial (z -axis) as shown in the Fig. 5 [18].

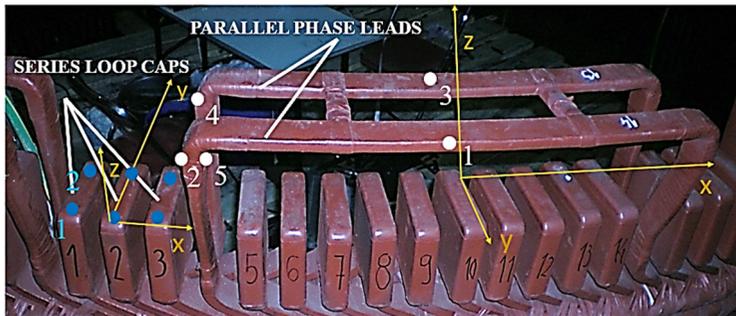
Fig. 6. Measurement points of parallel phase lead from [18]

In Fig. 6 [18] are shown the measurement points on the parallel phase leads (white) and loop caps (blue) where the impact with the hammer was made and where the accelerometer was positioned.

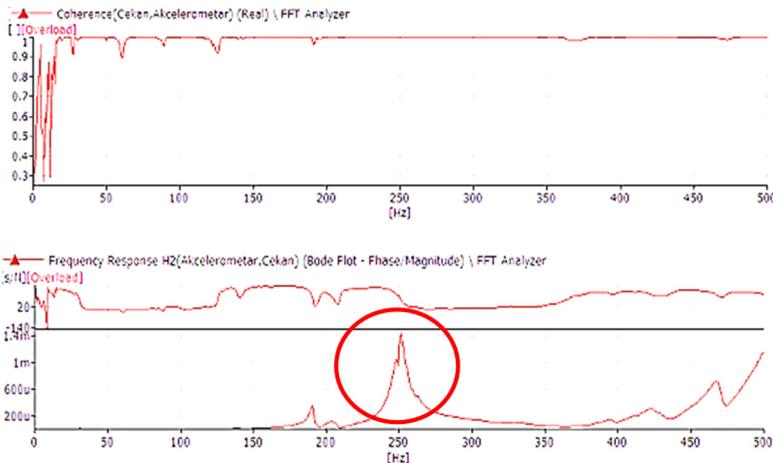
Fig. 7. Coherence, phase spectra and the frequency response function (FRF) with the natural frequency value for G1-MP11-y

frequency of the element and it is excited by the hammer impact. The natural frequency can be read out from the frequency response function (FRF) obtained from the measurement in a form of a dominant peak as it is shown in Fig. 7 and Fig. 8. It is evident that the natural frequency value is represented by the most prominent peak in the graph followed by phase shift of approximately 90° and high coherence. For example, the natural frequency of the phase leads belonging to the cold generator in y-direction which is marked with the red circle is 251,25 Hz (Fig. 7), while the natural frequency of the phase leads belonging to the warm generator is 216,25 Hz (Fig. 8) which is significantly lower. This lead to a possible conclusion that the difference in temperature implies on a difference in the natural frequency.

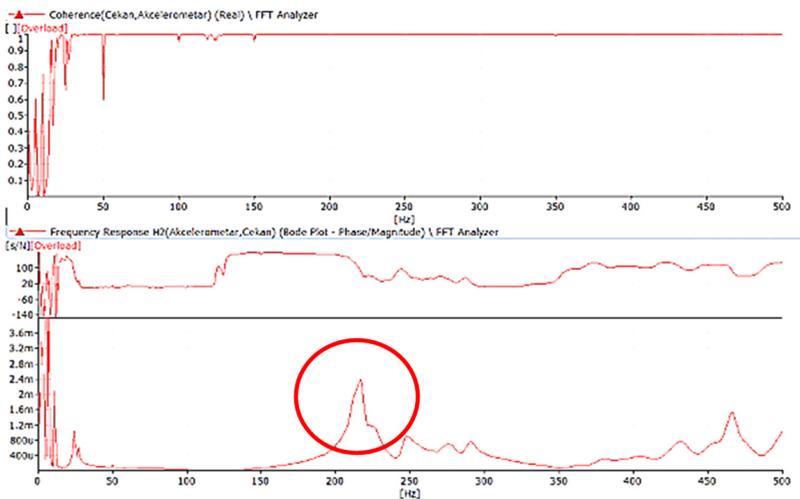
Fig. 8. Coherence, phase spectra and the frequency response function (FRF) with the natural frequency value for G2-MP11-y

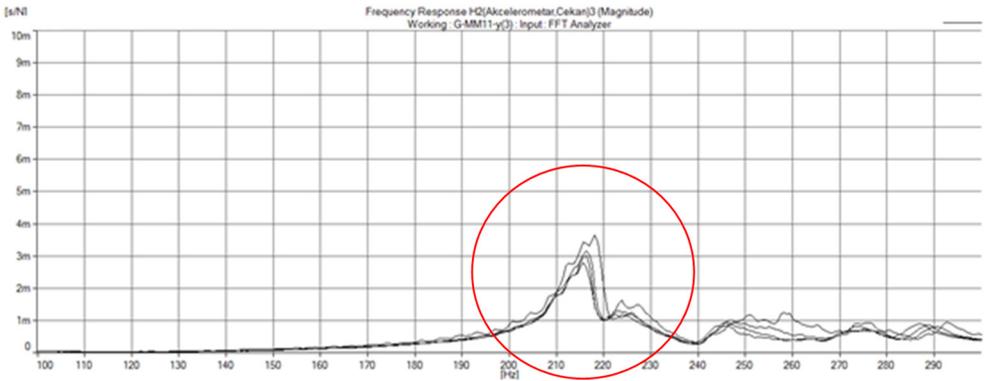
Fig. 9. Frequency response functions in y -direction for the four different temperatures

Figs. 9, 11 and 13 show the frequency response functions in the three directions (y , z and x) for the four different temperatures. On graphs in Figs. 10, 12 and 14, the dependence of the natural frequency with the temperature in the same three directions is given.

Given the values and the frequency response functions, can be perceived that the natural frequencies in all three directions of measurement increases with the reduction of temperature. This effect may occur due to the increase of the rigidity as a physical phenomenon of the material (steel) out of which the parallel phase leads are made with the decrease in their temperature. This proportionally affects to increasing of the natural frequency when the mass is unchanged.

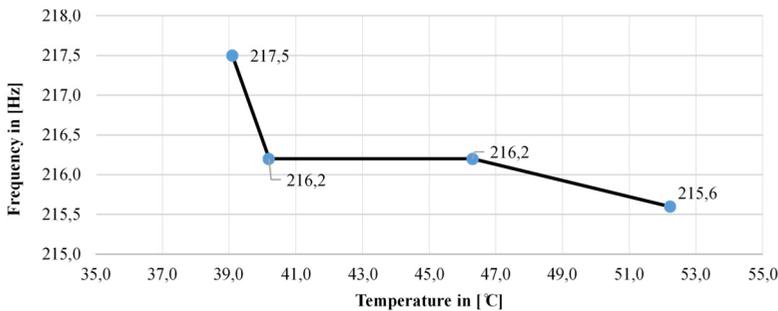
Fig. 10. Changes in the natural frequency depending on the temperature changes in y -direction

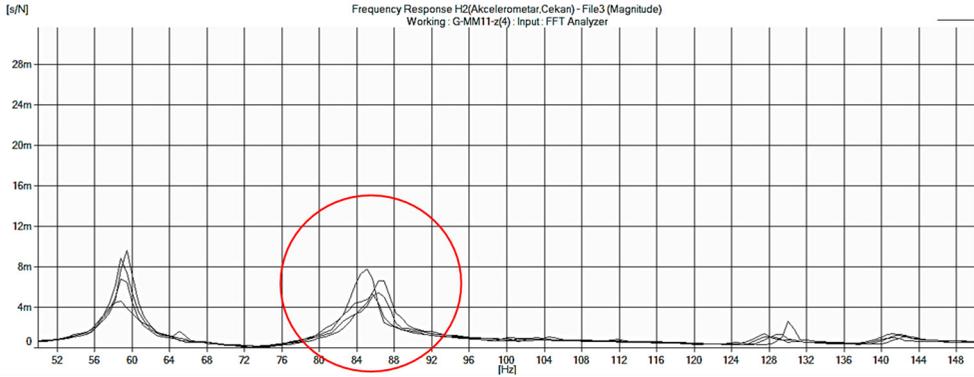
Fig. 11. Frequency response functions in z-direction for the four different temperatures

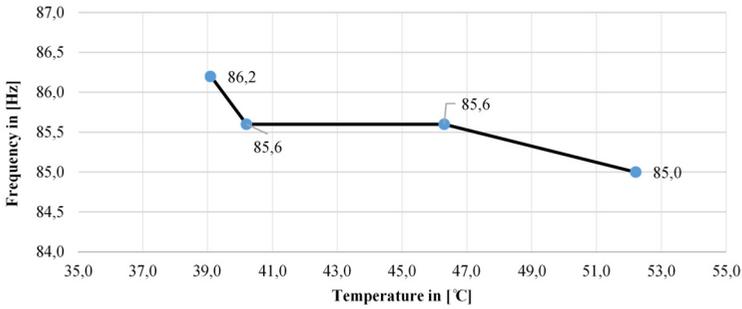
Fig. 12. Changes in the natural frequency depending on the temperature changes in z-direction

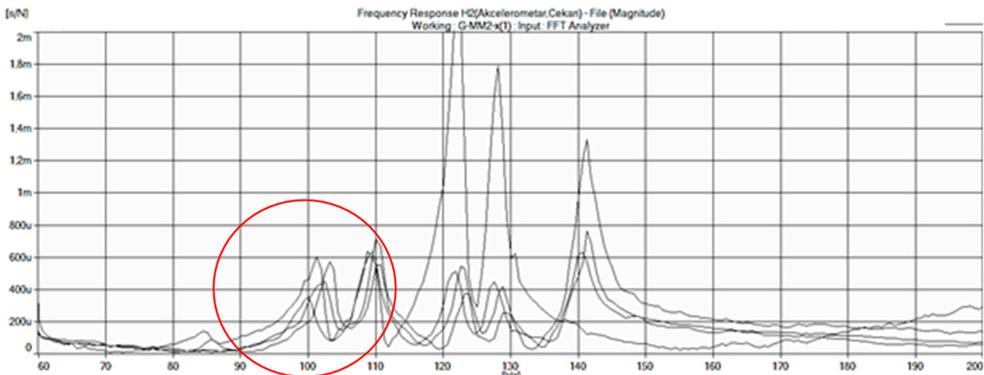
Fig. 13. Frequency response functions in z-direction for the four different temperatures

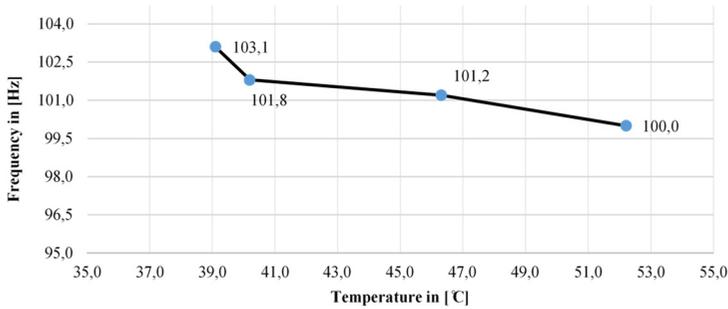
Fig. 14. Changes in the natural frequency depending on the temperature changes in x-direction
