Vibration characteristics and seismic performance of historical buildings with brick-wood structures

Abstract. To explore the vibration characteristics and seismic performance of historical buildings in Tianjin, we conducted on-site vibration testing under ambient vibration on three historical buildings with brick-wood structures in Tianjin. Specifically, we delved into the vibration characteristics and seismic performance of historic buildings with brick-wood structures by establishing the vibration analysis model, performing the theoretical calculations, and conducting seismic performance analysis. The results reveal that 1) the vibration frequencies of historical buildings with brick-wood structures are low, mainly concentrated in 2.0-8.0 Hz, which conforms to the vibration range of general buildings; 2) based on vibration analysis, it is concluded that the structural integrity of these buildings is good and there are no obvious structural defects; 3) the layout and storey height of historical buildings have great impacts on the vibration characteristics and seismic performance. 4) the comprehensive seismic capacity index of three buildings ranges from 0.91 to 1.75. The results

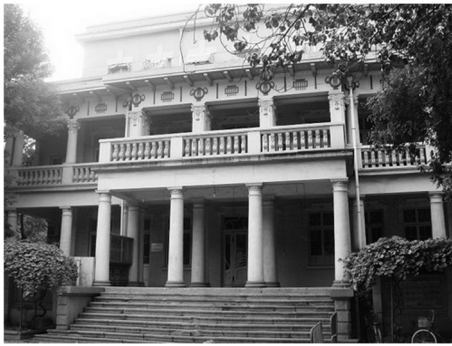
Fig. 1. Building A

a) Architectural appearance of building A

Located in the Heping District of Tianjin, Building A was built in 1920. It is a historical building with a classical European style. It has a building area of about 2,430 m². It is a three-storey building with brick-wood structures and a semi-basement. Its planar structure is basically symmetrical, 25.9 m in the north-south direction (*X* direction) and 26.2 m in the east-west direction (*Y* direction); while its vertical structure is unevenly distributed, in which the basement

is 2.74 m high, the first floor is 4.74 m high, and the second and third floors are 5.18 m high. Due to the long history of natural disasters such as earthquakes, and man-made sabotage such as wars, Building A has issues such as the decrease in safety and the gradual deterioration of architectural functions. The architectural appearance and ground floor plan of Building A are shown in Fig. 1.

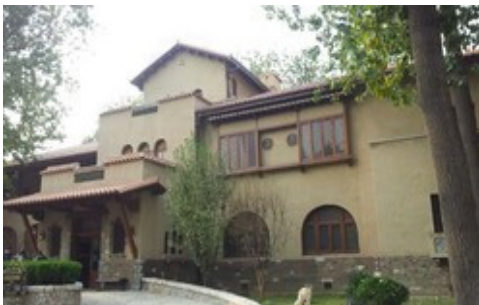
Fig. 2. Building B

a) Architectural appearance of building B

Building B is located in Heping District, Tianjin City. Built in 1921, it was designated as a historical building with special protection level by Tianjin Municipal People's Government, with the renovation project completed in 2007. The main body is a Spanish-style two-storey (some parts of the building are three-storey) building with brick-wood structures. The first floor is 4.50 m high, the second floor is 3.93 m high, and the third floor is 4.03 m high. The building is long in the north-south direction (X direction), about 36.5 m, and short in the east-west direction (Y direction), about 20.0 m. The planar structure is rectangular, while the horizontal and longitudinal layout is regular. The architectural appearance and ground floor plan are shown in Fig. 2.

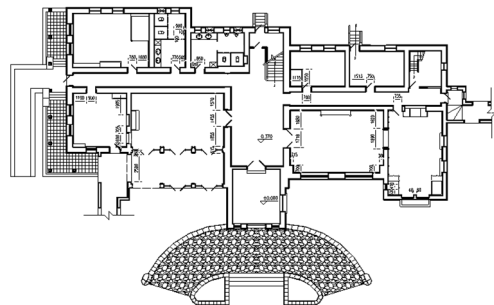
b) Ground floor plan

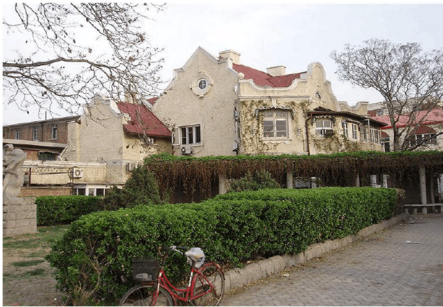
Fig. 3. Building C

a) Architectural appearance of building C

Building C is located at No. 121 Machang Road, south of downtown Tianjin City. It is a three-storey building with brick-wood structures and a basement. It is 16.46 m long in the east-west direction (X direction) and 14.91 m long in the north-south direction (Y direction). The planar and vertical structures are symmetrical. The first floor is 3.6 m high, and the other floors are 3.3 m high. Fig. 3 shows the architectural appearance and ground floor plan of Building C.

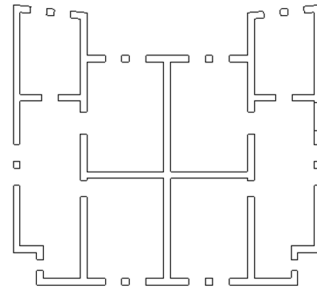
b) Ground floor plan

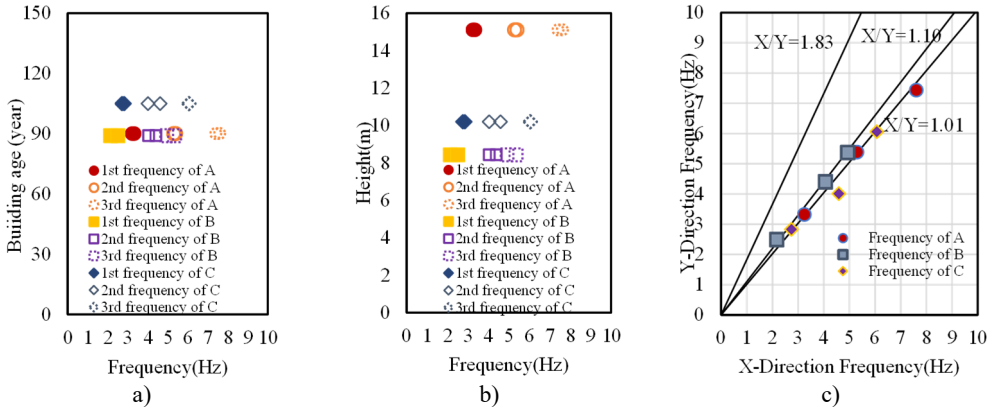
Fig. 4. Relationship between vibration frequency and the age and layout of the building: a) correlation between vibration frequency and the age of building; b) correlation between frequency and height; c) correlation between frequency and plane size

The vibration frequency of historical buildings is subject to the age of the building, material deterioration, natural disasters, and structural layout. Fig. 4 shows the relationship between the vibration frequencies of three historical buildings and the age of the building, building height, and plane size. Building C was built about 15 years earlier than Buildings A and B, but the correlation between the first-to-third-order vibration frequencies and the age of the building is not obvious. As shown in Fig. 4(b), the vibration frequency tends to increase with the rise in building height. So, we assume that the vibration frequency of historic buildings with brick-wood structures is correlated with the building height. When the long and short axes of historic buildings suffer from the same seismic action, the direction with weak stiffness is prone to more deformation and damage. So, it is of great importance to explore the building stiffness in different directions and analyze the different directions of the resonance period [26]. Fig. 4(c) shows that the horizontal

and vertical axes reveal the vibration frequencies in the X and Y directions, respectively. The oblique line denotes the ratio of the length in the X direction to the length in the Y direction. The plane size of Buildings A and C are similar, and the length of Building B in the X direction is about 1.83 times that in the Y direction. However, the vibration frequencies of three buildings in the X and Y directions are distributed along the diagonal. Therefore, we presume that the vibration period of the building in the short-axis direction is nearly equal to that in the long-axis direction, so their stiffness is considered the same. As a result, we conclude that the vibration characteristics of the building are closely related to the building shape and the configuration of the main structure.

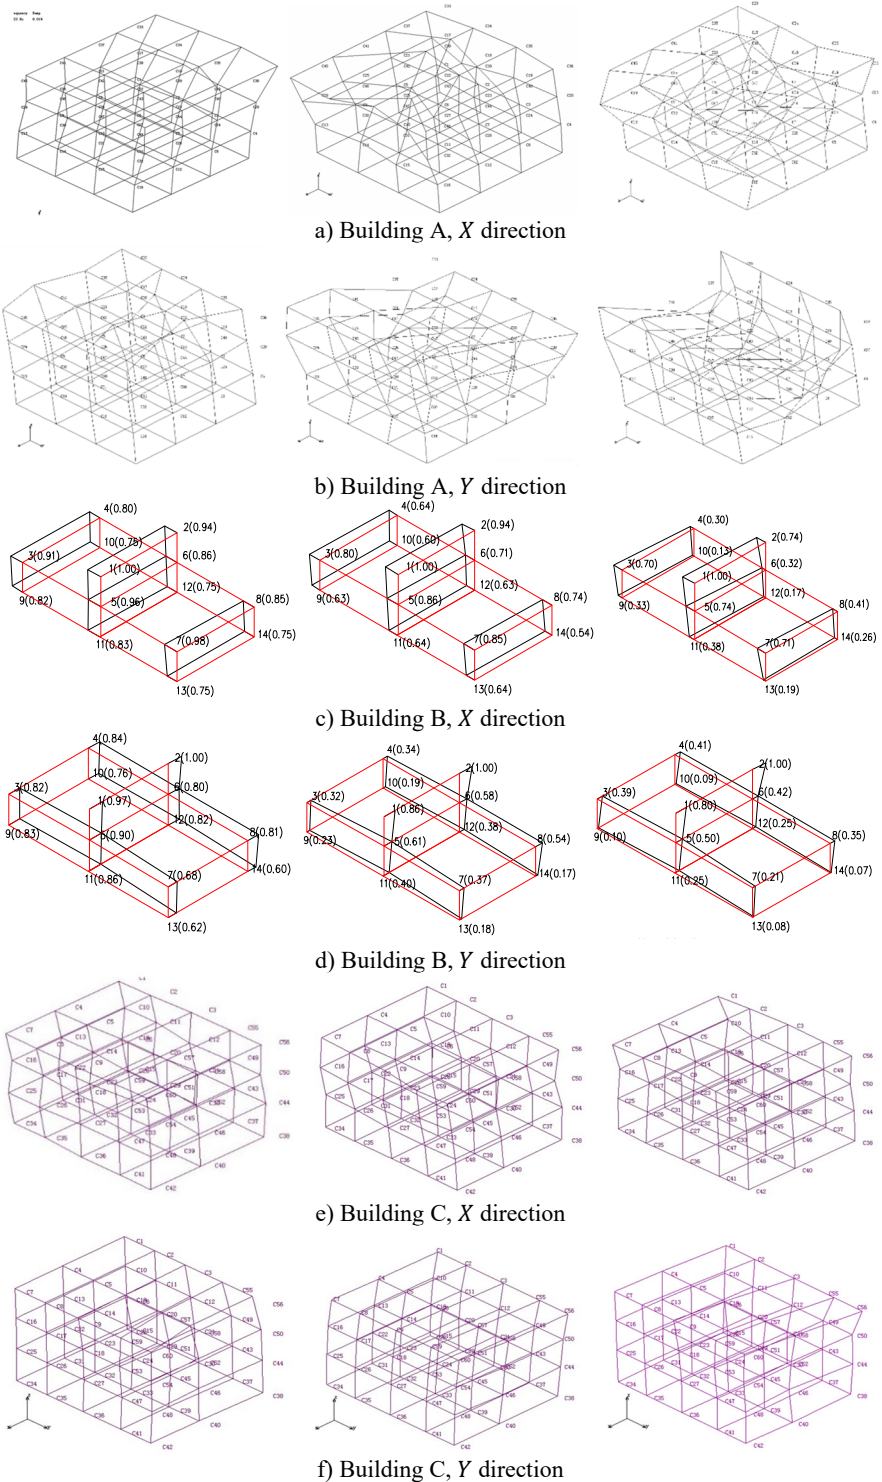
Fig. 5. First-to-third-order mode shape diagram of historical buildings

The vibration-based safety assessment is an overall assessment based on the dynamic response of the structure. There is a correspondence between the physical parameters, such as the mass and damping of the brick-wood historical buildings, and the modal parameters of the structure. The modal parameters can reflect the dynamic performance of the reaction structure. Fig. 5 shows the first-to-third-order mode shape diagrams of three historical buildings obtained from the test under ambient vibration.

According to the analysis of the first-to-third order mode shapes, the characteristics of vibration mode shapes in the X and Y directions conform to the structural vibration characteristics within the low-frequency range, with stable vibration amplitude and good structural integrity. The first-to-third-order mode shapes mainly show translational motion. In the high-frequency stage, there may be a local vibration amplitude mutation due to the weak local connection. Additionally, the delayed torsional vibration occurs in the higher-order vibration, indicating that the plane layout of the lateral force-resisting members is reasonable, and the center of mass and the center of rigidity overlap. The vibration amplitude of the measuring points in the middle part of the long-axis direction of Building B is slightly larger than that of the measuring points on both sides, indicating that the lateral stiffness of the wall in the middle of the structure is slightly lower. The vibration amplitude of the relevant measuring points in the long-axis direction on both sides of the structure is equal, indicating that the deformation of the floor slab in the long-axis direction of the structure is weak, the internal stiffness of the floor slab is strong, and the integrity of the wall and floor slab in the long-axis direction is good. Therefore, based on the mode shape of historical buildings, we can intuitively understand the vibration characteristics of the structure and provide a scientific basis for the preservation and protection of historical buildings by long-term monitoring of potential safety hazards caused by environmental changes and material deterioration.
