# Experimental thermal fatigue crack on brake disc of heavy vehicle

**Abstract.** Brake system reliability is critical for the safety and performance of heavy vehicles, including semi-trailers, passenger buses, and industrial transport units. This study investigates the thermal fatigue failure mechanisms in brake discs (BDs), which are subjected to extreme operational conditions. The primary motivation is to enhance brake disc durability and reduce the risk of catastrophic failures by understanding the interplay between material properties, thermal stress, and fatigue resistance. A comprehensive experimental approach was employed, including visual inspections, chemical composition analysis, metallurgical structure examination, hardness testing, and tensile strength evaluation. The study compares brake discs that have undergone extensive service with those in an undamaged state to identify critical degradation patterns. The results indicate that temperature fluctuations and cyclic thermal stresses induce crack formation and propagation, with rough graphite inclusions significantly reducing fatigue strength. Furthermore, deviations in silicon and carbon content were found to impact

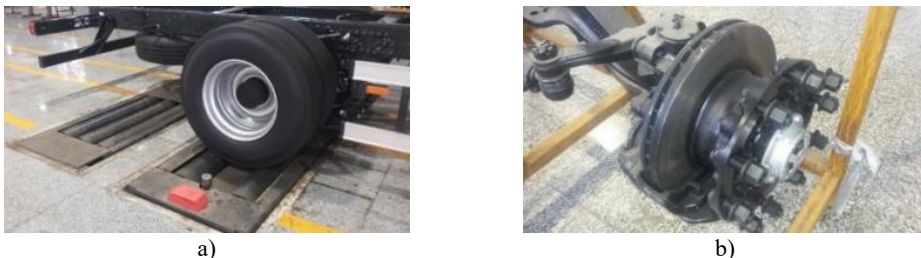
**Fig. 1.** Real model of the BD: a) brake test, b) assembled brake

In these experiments, the focus is on the main parts of the brake system (see Fig. 1), which include the structure of the BD on heavy vehicles. In two types, they are worked and damaged separately (see Fig. 2).

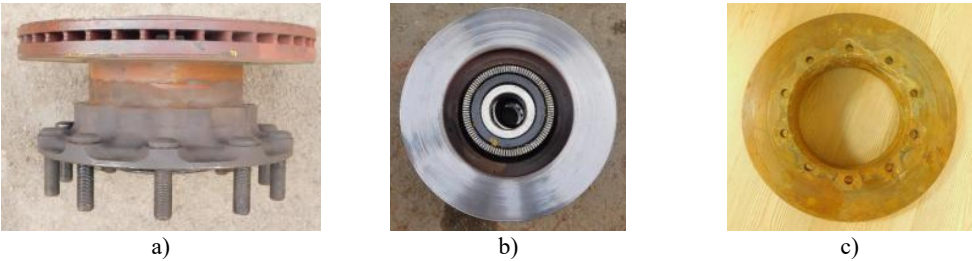
**Fig. 2.** BD’s structure: a) disc area, 1-Hub, Forward, Backward, b) damaged backward disc, c) worked BD

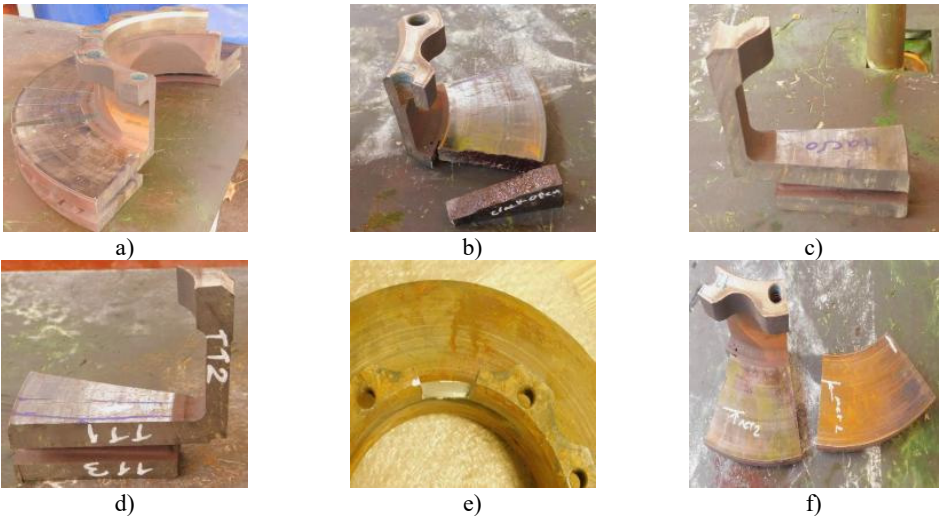
**Fig. 3.** BD: a) damaged BD, quantometry position, cutting cross-section, b) cracked area, Opened crack surface, c) macrography and hardness tests sample, d) tensile test, 1 – test Zones, e) worked BD, sample test, f) metallography, test zones

surface and study the failure mechanism. Next, sampling was done to perform chemical analysis, microscopic structure, hardness, and tensile tests. Fig. 3 shows the sampling positions, and Table 1 displays the list of tests performed.

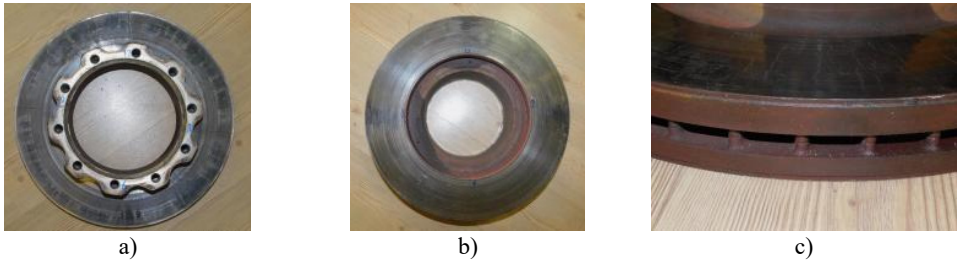
**Fig. 4.** Worked disc sample: a) forward area, b) backward area, c) before cutting BD

Before visual inspection, different zones on both sides of two discs were assumed to be clockwise numbered. The forward disc (FD) and rearward disc (RD) are on the flange side and its front, respectively (see Fig. 4).

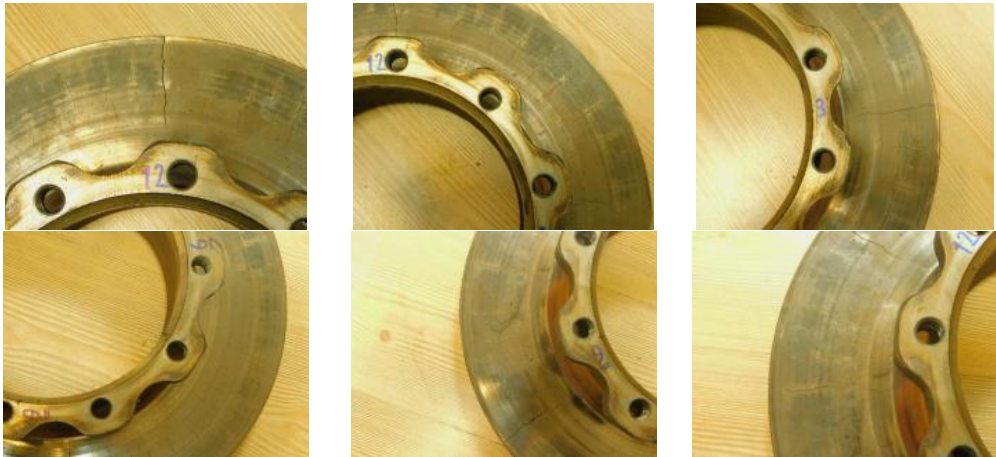
**Fig. 5.** Visual inspection of FD since 12 AM - 2 PM

During the visual inspection, numerous radial cracks were observed on the disk surface on the wheel side. The cracks are discontinuously located in the radial direction, with a misaligned morphology. After cutting, it was seen that most of these cracks did not grow much in the direction of thickness and did not reach the edge of the lateral surface in the radial direction. However, observing three deep radial cracks at three different locations, each extending through the entire thickness and spreading to the side surface. On the surface of the back disc, the cracks are more delicate and exhibit significantly less joining and growth. In Figs. 5 to 8, the growth model of radial cracks can be seen on the surfaces of the wheel-side disk and the back disk, respectively.

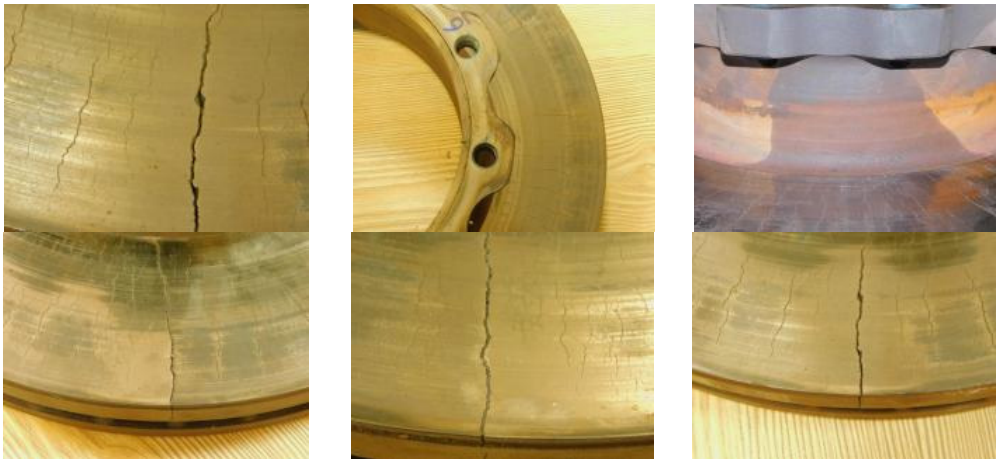
**Fig. 6.** Crack types on FD

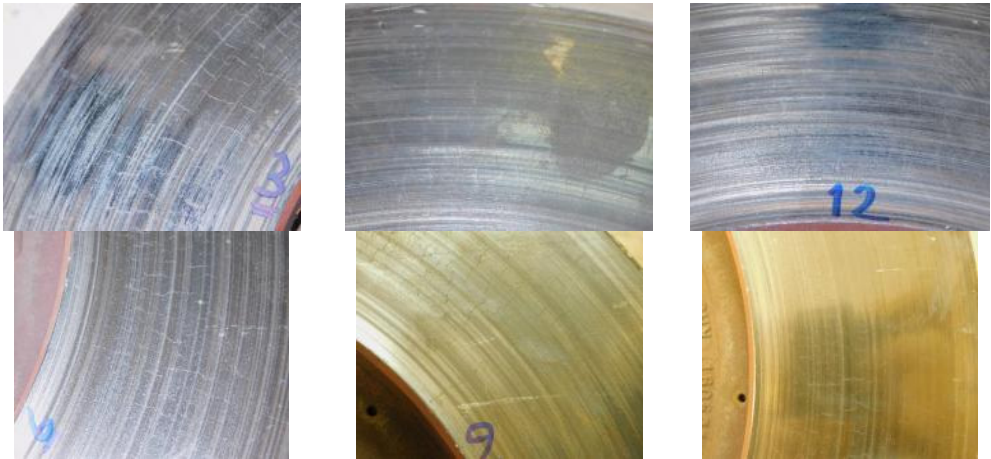
**Fig. 7.** Visual inspection of RD since 12 AM-2 PM

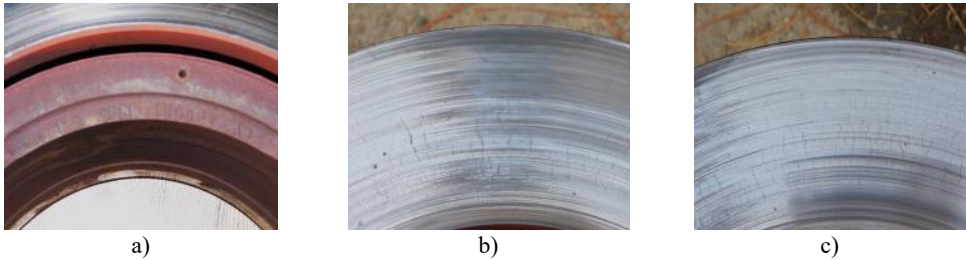
**Fig. 8.** Radial cracks on RD: a) manufacture legend, b) radial crack growth, c) crack growth on thickness

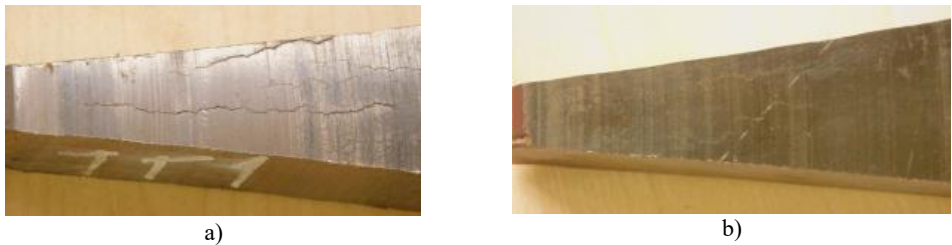
Upon visual inspection, traces of peripheral wear lines can be seen on the surface of both discs. However, the wear band model is different on both sides. On the disc's back side, the distribution of wear bands is more uniform, while on the disc's wheel side, the wear lines are not visible in a wide middle band, revealing wear bands similar to those on the back side (Fig. 9).

**Fig. 9.** Distribution corrosion band: a) FD, b) RD

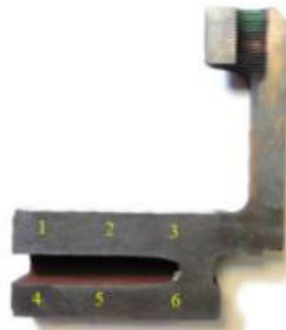
Based on the ASTM E10-2018 test reference standard, the Brinell hardness test was done by using a bullet with a diameter of 2.5 mm and 187.5 kg/f of force at the points shown below in the cross section made from the disc. The test results are presented in Table 6.

**Fig. 10.** Numbered position of damaged disc for hardness test

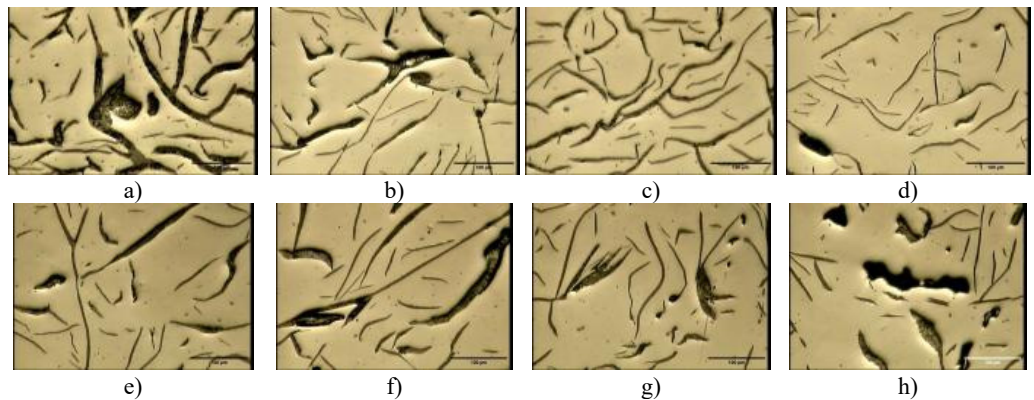
This study is based on the ASTM A247-19 standard. Based on studies with a light microscope, type VII sheet graphite with A and C distributions were made in the structure of both the back disk and the disk on the wheel side. The microscopic structure of the micro-cavity also showed shrinkage in the back disk and a scattered distribution of the MnS phase in both disks. Fig. 12 shows the distribution of graphite.

Fig. 12. Distribution graphite layers, a), b) FD – type C, c), d) FD – type A, e), f), g), h) BD – type C, shrinkage cavity

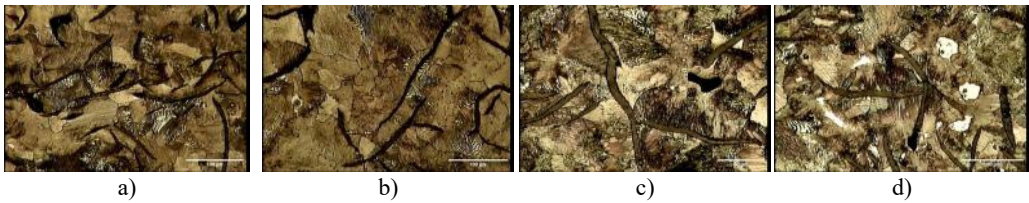
The cast iron base’s structure is completely pearlite in the middle after chemical etching, and the bulk carbide phase can be seen in the cell network. Pearlite layers are typically observed with small layer intervals, and no structural tempering effects can be detected in the central areas. Fig. 14 shows images of the background structure in the central regions of the disk.

**Fig. 14.** Perlite transparency, a), b) FD, c), d) BD

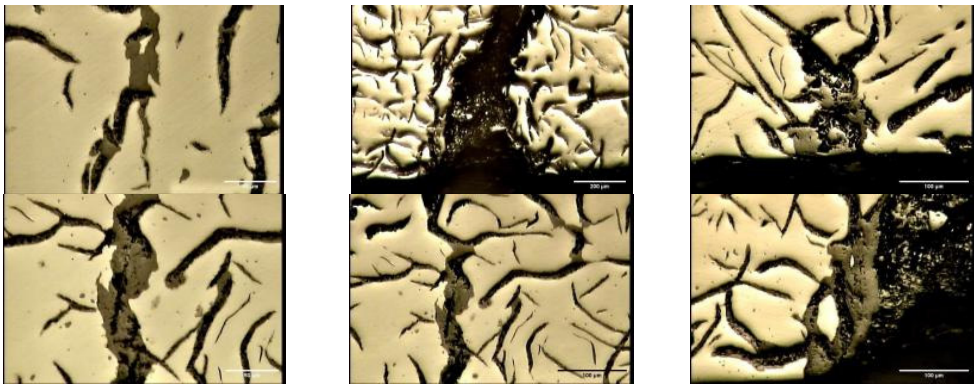
Internal oxidation is present around the graphite phase, and cracks are growing on the outside of both discs, specifically on the wheel side and the back side. This is due to the phenomenon of surface oxidation occurring in the absence of graphite. Some of these defects are shown in Fig. 15 and Fig. 16. Although the disc on the wheel side has deeper cracks, both discs have similar surface and internal oxidation.

**Fig. 15.** Crack growth, and surface oxidation on surface of FD

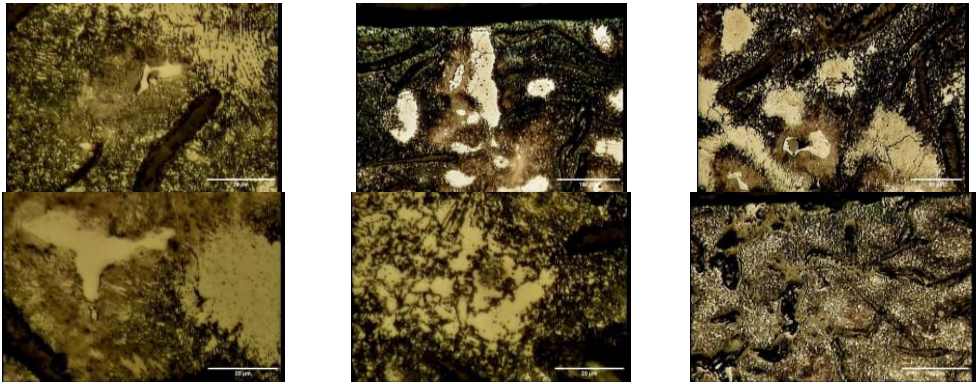
After etching, traces of cast iron were observed on the disk surface. On the outside of the wheel side disc, the ground structure is made up of tempered pearlite, some ferrite phase, and large white

carbide particles. Pearlite tempering has caused cementite particles to be crushed and spherical. The ferrite phase is not observed on the outer surface of the back disc, but the effects of tempering the pearlite background are still evident. In this area, masses of white carbide can be observed in the microscopic structure. Figs. 17 and 18 provide microscopic images of the background.

Fig. 17. Tempering pearlite, whiten ferrite phase, and Carbide particles results on FD

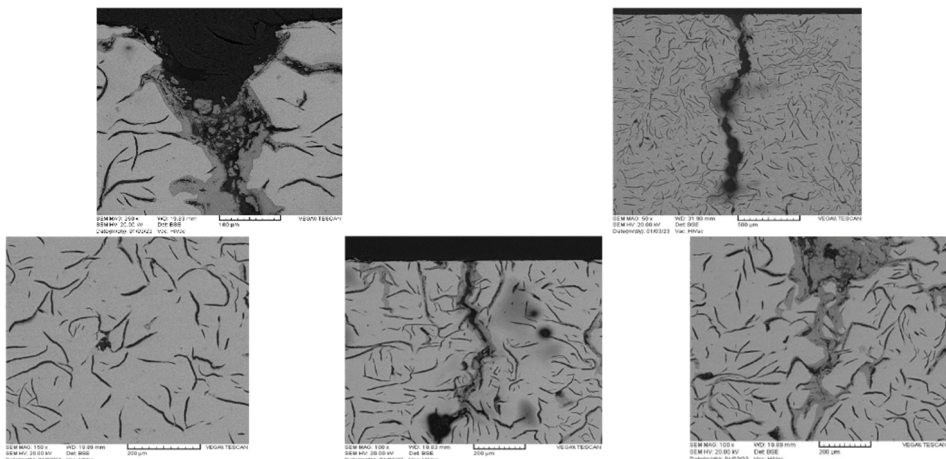
This section focuses on the study of microscope structure. In the examination by electron microscope, traces of intense oxidation were seen in the crack opening and then in the path of crack propagation in the thickness. Oxides and relatively significant amounts of sulfur represent the effects of oxidation (Fig. 19).

Fig. 19. Internal oxidation on surface and edge of crack in FD

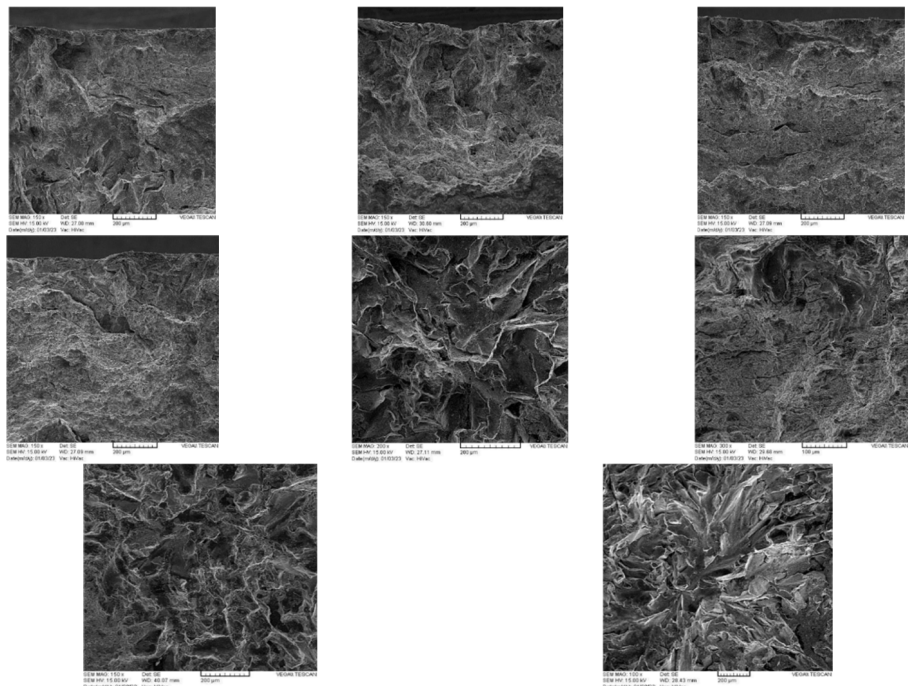
The fracture surface of one of the wheel side disc cracks was examined by an electron microscope. In Fig. 20, the results of studies in the vicinity of the edge of the external surface indicate the propagation of microscopic cracks from this surface. The effects of surface oxidation can be seen in the vicinity of the surface. Propagated cracks have grown from the surface in the thickness direction. However, a large number of oblique cracks can also be seen. These cracks probably developed in the oxidized boundary of sheet graphite. However, many secondary cracks parallel to the surface can be seen below the fracture edge. These cracks indicate the propagation of fatigue failure on the fracture surface. The morphology of the fracture surface confirms the existence of rough graphite in the surface and central areas. In the central areas, the effects of forced fracture can be seen with signs of soft fracture areas in the background.

**Fig. 20.** Layered graphite and soft fracture on surface center of RD
