Deformation mechanisms of open-pit high-steep slopes controlled by a fault: An integrated remote sensing, field investigation and numerical simulation study

Abstract. The engineering disasters caused by fault structural zones represent a persistent challenge in geotechnical engineering. This study employs an integrated approach, combining multi-temporal remote sensing, field investigation, and numerical simulation, to investigate the deformation mechanisms and stability of an open-pit slope controlled by the F15 fault. The results demonstrate that the collapse of the northern slope results from the combined effect of the internal F15 fault structure and external unloading due to underground mining. Remote sensing imagery reveals a four-stage failure process: initial rock deformation, local landslides, local surface subsidence, and final surface subsidence. Significantly, the F15 structural zone alters the deformation trend of the upper slope, channeling displacement towards the eastern valley, with a maximum simulated displacement of 5.4 cm. The safety factor of the slope, calculated using the strength reduction method, is 1.45, and the potential sliding surface is identified as t

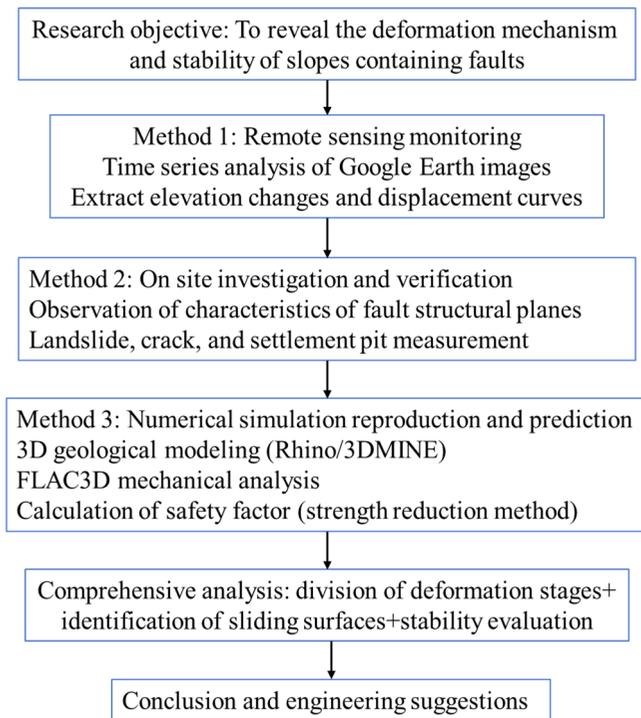
Fig. 1. Research methodology framework

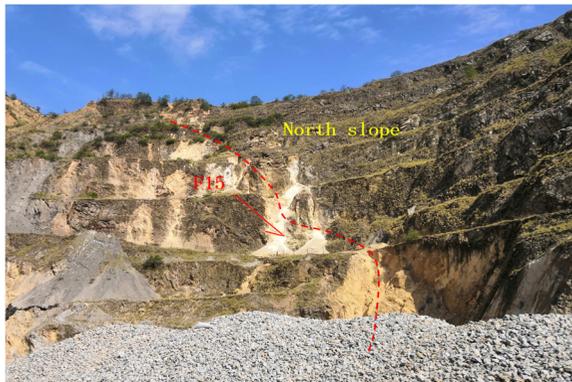
Fig. 2. F15 Exposed on the northern slope of the open pit.
Photo by Wang Feifei, Sichuan, China, July 5, 2023

The F15 is located in the northern part of the mining area, crossing the entire mining area from northwest to southeast, forming the northern boundary of the mining area's graben like structure. A "black fractured zone" is developed on the south side of the fault, and the mining area is rich in industrial ore bodies. It is 15-20 km long, 0.7-6.3 m wide, with a controlled extension depth of 240 m and a total fault displacement of 408m. It tends to be southwest or northeast with an inclination angle of $56-89^\circ$, and has a northwest trending fault. Before mineralization, it was a translational reverse fault, and after mineralization, it was a translational normal fault. The exposed location on the surface is shown in Fig. 2.

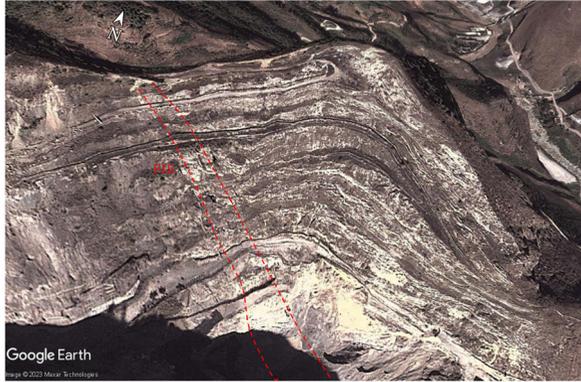
Fig. 3. Satellite image from December 2012

According to satellite remote sensing images of deformation and failure of the northern slope of the open-pit mining site, local slope collapse has been occurring at the bottom of the northern pit since 2012. The main reason is that under the unloading effect of open-pit mining, the fault structure zone undergoes deformation and displacement, resulting in a weakened support effect at the bottom of the upper slope of the fault, leading to the deformation and failure of the slope. The remote sensing images from 2015 and 2012 are basically consistent, indicating that during this period, the mining disturbance caused by mining was relatively small, and there were no conditions for further development of slope collapse disasters.

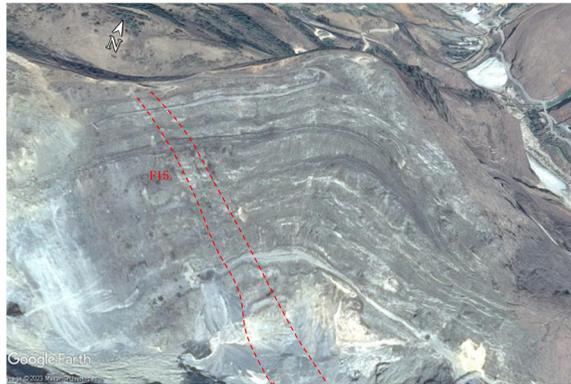
Fig. 4. Satellite image from December 2015

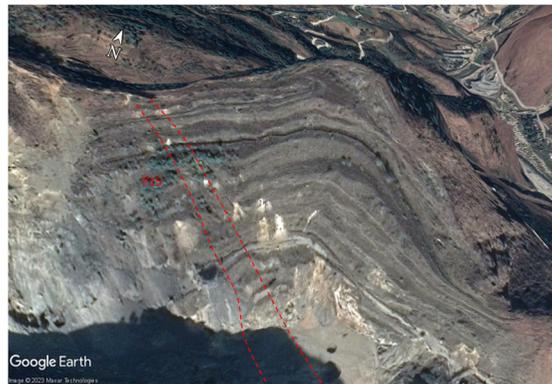
Fig. 5. Satellite image from December 2017

In the remote sensing image of 2017, it can be clearly seen that there is a phenomenon of local step slope rock fragmentation and collapse in the upper part of the northern slope (white spot in the figure). The area where the original collapse occurred at the bottom has not further expanded. During this period, the impact of underground mining on the open-pit mining slope gradually developed towards the surface, and from 2012 to 2015, it had not yet developed to affect the surface slope. Around 2017, signs of underground mining affecting the slope began to appear.

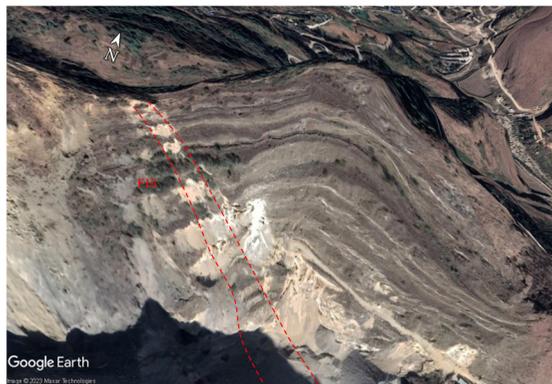
Fig. 6. Satellite image from December 2020

From the satellite images in 2020, it can be seen that multiple collapses have occurred on the northern slope of the open-pit mining area. The local step slope fragmentation zone in the upper part of the slope has been connected to the bottom collapse zone, forming a collapse zone centered on F15. The continuous expansion of the goaf formed by underground ore body mining has affected the stability of the northern slope. The lower part of the slope has experienced unloading, resulting in a sliding and collapsing phenomenon of the broken body, that is, the occurrence of landslides and holes. Due to the development of the F15 in the northern slope area, under the unloading effect of the lower ore body mining, the slope will experience displacement deformation along the fault, further exacerbating the damage to the northern slope and causing landslides. Over time, the northern slope may develop into a large-scale landslide disaster.

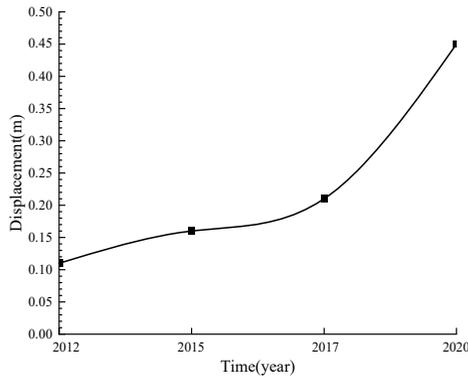
Fig. 7. Typical displacement variation curve at the fault

To obtain the deformation and development process of the slope with fault structures, professional Google Earth software was used to obtain the process of the northern slope of the open-pit mining site gradually forming a landslide disaster from stability for a total of 10 years from 2012 to 2022. The typical remote sensing image is shown in Fig. 3-Fig. 6. Typical areas with significant changes were selected from the fault. On the Earth map, elevations were extracted for each year. And compared and analyzed the values over the years, and plotted the displacement change curve, as shown in Fig. 7.

According to Fig. 7, the rock mass at the fault gradually developed and failed during the period of 2012-2017. After 2017, rapid displacement changes occurred, indicating significant displacement of the rock mass at the fault. The fault is rapidly breaking down. Significant damage has occurred on the northern slope.

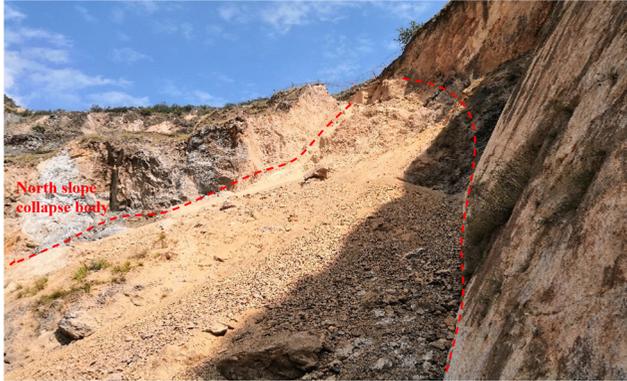
Fig. 8. Dangerous rock mass group on the hillside.
Photo by Wang Feifei, Sichuan, China, July 5, 2023

To obtain the deformation and failure characteristics of the northern slope of the open-pit mining area, a field investigation and analysis method was used to obtain the typical failure characteristics of the northern slope of the open-pit mining area. As shown in Fig. 8, a landslide

collapse phenomenon occurred in the northern slope of the fault structure zone. The rocks in the fault structure zone are highly fragmented and weathered, which accelerates the deformation and damage of the exposed fault structure zone after rainwater erosion. Recent studies on the micro-scale deterioration of sandstone have shown that water-rock interactions, including mineral dissolution and micro-crack propagation driven by cyclic wetting-drying, can lead to significant strength reduction [19-20]. This micro-mechanism provides a plausible explanation for the macroscopic weakening of the F15 fault zone materials observed in the field. Due to the collapse and collapse of the goaf formed by underground mining, surface subsidence pits were formed at the bottom of the open-pit mining area, as shown in Fig. 3. The fault structure zone exposed on the slope has formed multiple cracks with a width of about 1m under the erosion of rainwater. The platform of the northern slope at the location of the fault tension joint experienced a 2.1 m subsidence and displacement, mainly due to the collapse of the underground goaf, which caused the large rock mass between the fault and the goaf to tilt and sink, resulting in platform subsidence and displacement, and the appearance of tensile cracks.

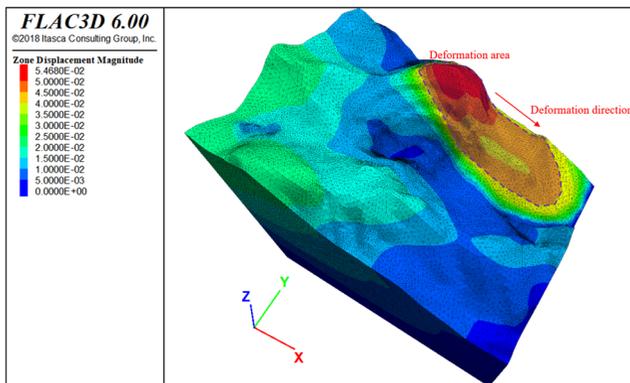
Fig. 9. Cloud map of slope deformation and displacement

According to the deformation displacement cloud map of the open-pit mining slope in Fig. 9, the focus of this study is on the relatively large deformation displacement at the top of the northern slope, which gradually decreases in the bottom direction, with a maximum displacement of 5.4 cm. The deformation displacement occurring below the F15 zone is relatively small. The main reason is the void formed after underground ore body mining, which provides spatial conditions for the rock mass below the fault structure zone to deform deeper, so the possibility of deformation and failure towards the east is relatively small. The deformation displacement of the rock mass above the potential sliding surface develops along the F15 structural zone towards the eastern valley, indicating that the F15 structural zone has changed the deformation and failure trend of the upper slope of the northern slope. With the mining of underground ore bodies, the impact on the upper open-pit mining area gradually increases. Finally, the underground mining of the ore body caused deformation of the northern slope. Landslides may occur on the northern slope, and the potential sliding arc surface is a fault fracture zone.

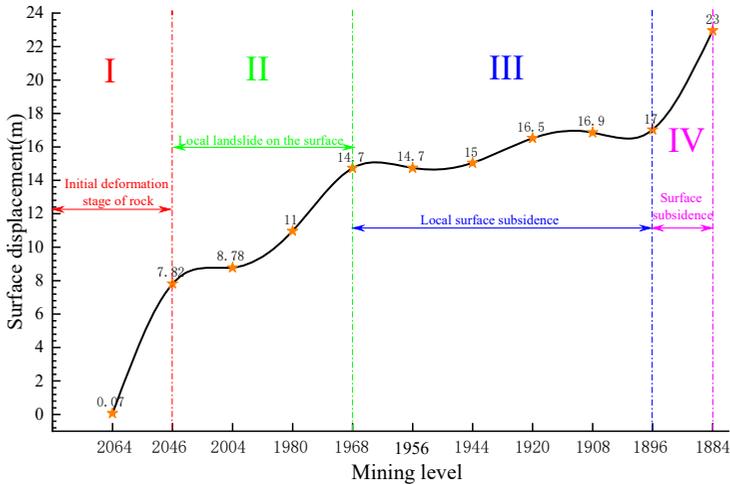
Fig. 10. Relationship between mining level and surface displacement

In this study, to investigate the impact of mining orebodies near faults on northern slopes, multiple horizontal mining levels were simulated. We extracted vertical surface displacement after the simulation and obtained maximum vertical displacement contour maps and data. The results are shown in Fig. 10.

Fig. 10 indicates that after mining the 2004 level, the slope displacement reached 8.78 m, showing the mountain is in the landslide stage, consistent with the actual site. This confirms the numerical simulation results are reliable.

From Fig. 10, as mining levels deepen, displacement increases. During surface displacement development, three inflection points appear at the 2046, 1968, and 1896 levels, dividing the process into four stages. Currently, the mountain is in the second stage with local landslides. Severe landslides or collapses are expected when mining the 1968 level. Maximum displacement is 22.96 m in the final stage, and minimum displacement is 0.07 m in the initial stage.

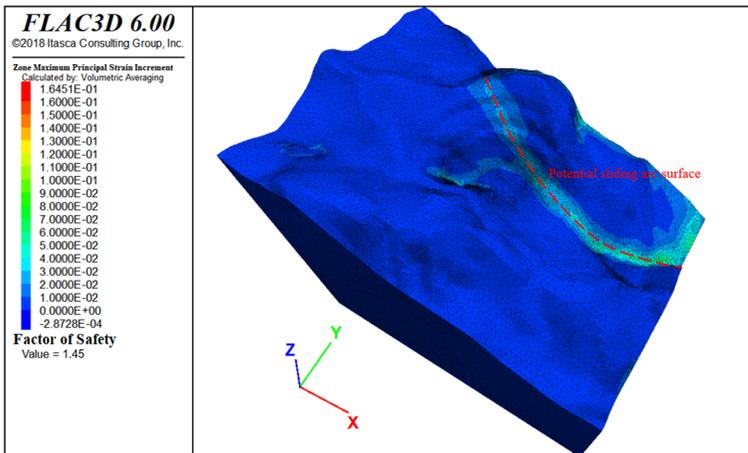
Fig. 11. Slope shear strain and safety factor

According to the Technical Code for Slope Engineering of Non-Coal Open Pit Mines GB51016-2014 [26], the allowable safety factor of the slope under normal conditions is 1.25-1.20. The safety factor is used to evaluate the stability of the northern slope of the open-pit mine after underground mining. The shear strain and safety factor are shown in Fig. 11.

According to the shear strain increment cloud map in Fig. 11, it can be seen that the deformation and failure of the upper rock mass of the northern slope mainly develop towards the east. The area with the largest increase in shear strain is the F15 zone, where the slope mainly exhibits a flat shear failure mode. This finding underscores that the presence of a dominant geological structure dictates the failure mechanism. Similar to the observations by Ma et al. [27] in underground structures, where structural components and interfaces controlled seismic failure patterns, the F15 fault in this study acts as the primary structural control governing the slope's failure mode. According to the on-site investigation results, it is known that a landslide disaster occurred along the F15 structure zone on the northern slope, which is consistent with the numerical simulation results, indicating the reliability of the numerical simulation results.

The safety factor of the open-pit mining slope calculated by the finite element strength reduction method is 1.45, and the potential sliding surface is the F15 structure zone, indicating that there has not been significant deformation and damage along the fault structure zone in the northern slope. The on-site investigation results show that there is a local collapse disaster in the fault structure zone inside the mining site, which is consistent with the numerical simulation results. The safety factor of the slope meets the requirements of the specifications, but the redundancy of the safety factor is small. With the continuous weathering, collapse, and disturbance and damage of the fault structure zone by underground mining, serious large-scale landslide disasters may occur in the later stage of the fault structure zone. Targeted measures can be taken by monitoring the deformation displacement and slope stress of open-pit mining slopes to prevent landslide disasters from posing safety hazards to mining production.
