# Deformation mechanisms of open-pit high-steep slopes controlled by a fault: An integrated remote sensing, field investigation and numerical simulation study

**Abstract.** The engineering disasters caused by fault structural zones represent a persistent challenge in geotechnical engineering. This study employs an integrated approach, combining multi-temporal remote sensing, field investigation, and numerical simulation, to investigate the deformation mechanisms and stability of an open-pit slope controlled by the F15 fault. The results demonstrate that the collapse of the northern slope results from the combined effect of the internal F15 fault structure and external unloading due to underground mining. Remote sensing imagery reveals a four-stage failure process: initial rock deformation, local landslides, local surface subsidence, and final surface subsidence. Significantly, the F15 structural zone alters the deformation trend of the upper slope, channeling displacement towards the eastern valley, with a maximum simulated displacement of 5.4 cm. The safety factor of the slope, calculated using the strength reduction method, is 1.45, and the potential sliding surface is identifie

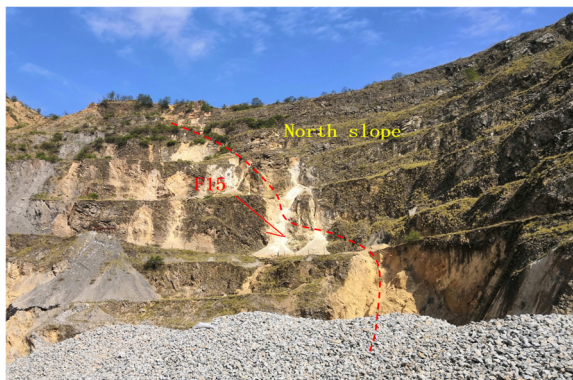
The F15 is located in the northern part of the mining area, crossing the entire mining area from northwest to southeast, forming the northern boundary of the mining area's graben like structure. A "black fractured zone" is developed on the south side of the fault, and the mining area is rich in industrial ore bodies. It is 15-20 km long, 0.7-6.3 m wide, with a controlled extension depth of 240 m and a total fault displacement of 408m. It tends to be southwest or northeast with an inclination angle of  $56-89^\circ$ , and has a northwest trending fault. Before mineralization, it was a translational reverse fault, and after mineralization, it was a translational normal fault. The exposed location on the surface is shown in Fig. 2.

**Fig. 2.** F15 Exposed on the northern slope of the open pit.  
Photo by Wang Feifei, Sichuan, China, July 5, 2023

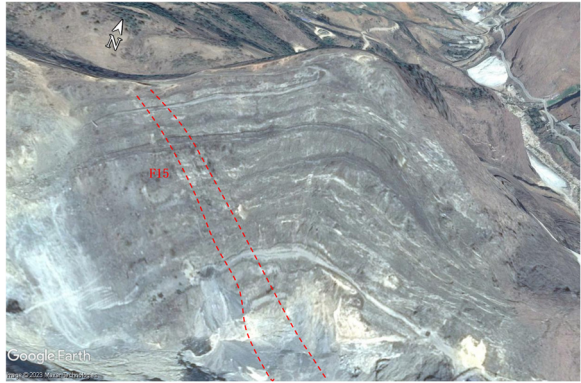
**Fig. 4.** Satellite image from December 2015

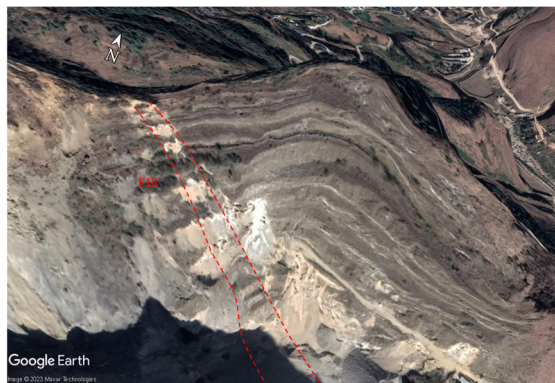
From the satellite images in 2020, it can be seen that multiple collapses have occurred on the northern slope of the open-pit mining area. The local step slope fragmentation zone in the upper part of the slope has been connected to the bottom collapse zone, forming a collapse zone centered on F15. The continuous expansion of the goaf formed by underground ore body mining has affected the stability of the northern slope. The lower part of the slope has experienced unloading, resulting in a sliding and collapsing phenomenon of the broken body, that is, the occurrence of landslides and holes. Due to the development of the F15 in the northern slope area, under the unloading effect of the lower ore body mining, the slope will experience displacement deformation along the fault, further exacerbating the damage to the northern slope and causing landslides. Over time, the northern slope may develop into a large-scale landslide disaster.

Fig. 6. Satellite image from December 2020

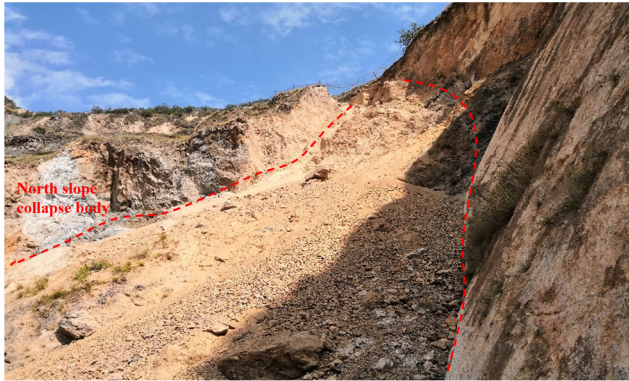
To obtain the deformation and failure characteristics of the northern slope of the open-pit mining area, a field investigation and analysis method was used to obtain the typical failure characteristics of the northern slope of the open-pit mining area. As shown in Fig. 8, a landslide

collapse phenomenon occurred in the northern slope of the fault structure zone. The rocks in the fault structure zone are highly fragmented and weathered, which accelerates the deformation and damage of the exposed fault structure zone after rainwater erosion. Recent studies on the micro-scale deterioration of sandstone have shown that water-rock interactions, including mineral dissolution and micro-crack propagation driven by cyclic wetting-drying, can lead to significant strength reduction [19-20]. This micro-mechanism provides a plausible explanation for the macroscopic weakening of the F15 fault zone materials observed in the field. Due to the collapse and collapse of the goaf formed by underground mining, surface subsidence pits were formed at the bottom of the open-pit mining area, as shown in Fig. 3. The fault structure zone exposed on the slope has formed multiple cracks with a width of about 1m under the erosion of rainwater. The platform of the northern slope at the location of the fault tension joint experienced a 2.1 m subsidence and displacement, mainly due to the collapse of the underground goaf, which caused the large rock mass between the fault and the goaf to tilt and sink, resulting in platform subsidence and displacement, and the appearance of tensile cracks.

**Fig. 8.** Dangerous rock mass group on the hillside.  
Photo by Wang Feifei, Sichuan, China, July 5, 2023

Under the continuous disturbance of underground mining and heavy rainfall seepage, the overlying large rock mass gradually collapsed and collapsed, eventually leading to surface subsidence. There is an F15 trending towards the northeast on the western and northern slopes, with a distance of about 100 meters from the ore body. As the ore body is gradually mined, the formed goaf gradually expands, and the overlying rock strata collapse, affecting the stability of the fault and causing the large rock mass between the goaf and the fault to gradually tilt towards the goaf, resulting in tipping type damage. At present, according to on-site investigation, there have been significant tension joints at the fault location.

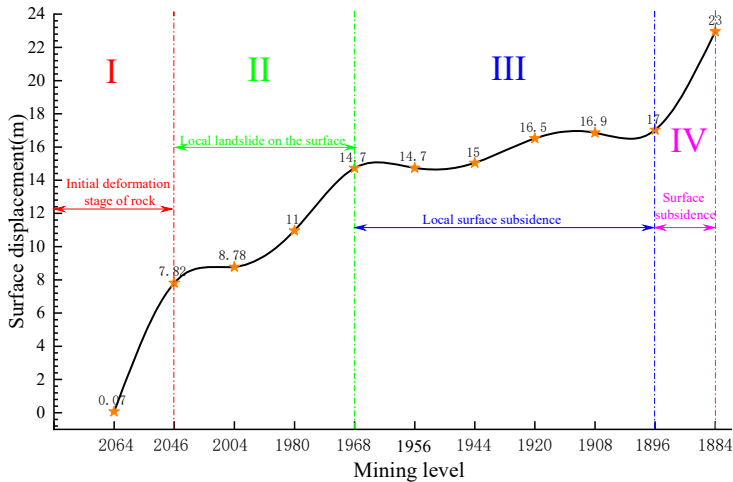
Fig. 10. Relationship between mining level and surface displacement

Fig. 10 indicates that after mining the 2004 level, the slope displacement reached 8.78 m, showing the mountain is in the landslide stage, consistent with the actual site. This confirms the numerical simulation results are reliable.

From Fig. 10, as mining levels deepen, displacement increases. During surface displacement development, three inflection points appear at the 2046, 1968, and 1896 levels, dividing the process into four stages. Currently, the mountain is in the second stage with local landslides. Severe landslides or collapses are expected when mining the 1968 level. Maximum displacement is 22.96 m in the final stage, and minimum displacement is 0.07 m in the initial stage.

In this study, to investigate the impact of mining orebodies near faults on northern slopes, multiple horizontal mining levels were simulated. We extracted vertical surface displacement after the simulation and obtained maximum vertical displacement contour maps and data. The results are shown in Fig. 10.

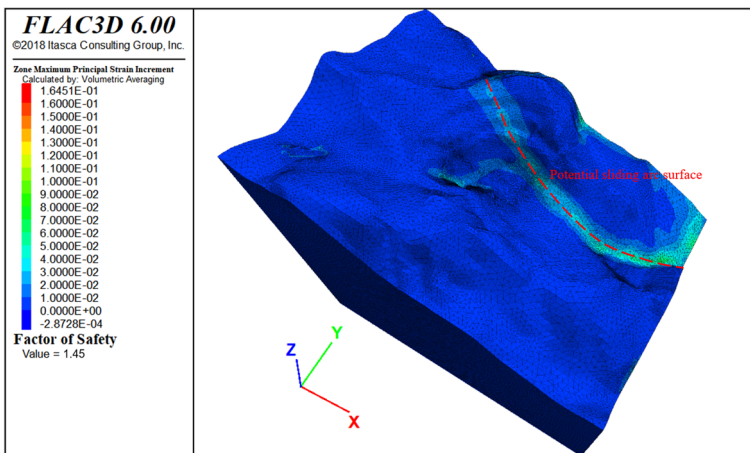
According to the shear strain increment cloud map in Fig. 11, it can be seen that the deformation and failure of the upper rock mass of the northern slope mainly develop towards the east. The area with the largest increase in shear strain is the F15 zone, where the slope mainly exhibits a flat shear failure mode. This finding underscores that the presence of a dominant geological structure dictates the failure mechanism. Similar to the observations by Ma et al. [27] in underground structures, where structural components and interfaces controlled seismic failure patterns, the F15 fault in this study acts as the primary structural control governing the slope's failure mode. According to the on-site investigation results, it is known that a landslide disaster occurred along the F15 structure zone on the northern slope, which is consistent with the numerical simulation results, indicating the reliability of the numerical simulation results.

The safety factor of the open-pit mining slope calculated by the finite element strength reduction method is 1.45, and the potential sliding surface is the F15 structure zone, indicating that there has not been significant deformation and damage along the fault structure zone in the northern slope. The on-site investigation results show that there is a local collapse disaster in the fault structure zone inside the mining site, which is consistent with the numerical simulation results. The safety factor of the slope meets the requirements of the specifications, but the redundancy of the safety factor is small. With the continuous weathering, collapse, and disturbance and damage of the fault structure zone by underground mining, serious large-scale landslide disasters may occur in the later stage of the fault structure zone. Targeted measures can be taken by monitoring the deformation displacement and slope stress of open-pit mining slopes to prevent landslide disasters from posing safety hazards to mining production.

Fig. 11. Slope shear strain and safety factor

According to the Technical Code for Slope Engineering of Non-Coal Open Pit Mines GB51016-2014 [26], the allowable safety factor of the slope under normal conditions is 1.25-1.20. The safety factor is used to evaluate the stability of the northern slope of the open-pit mine after underground mining. The shear strain and safety factor are shown in Fig. 11.
