# Evolution mechanism of high-altitude dangerous rock mass collapse-debris flow chain disaster: a case of study in an open-pit mine

**Abstract.** In order to reveal the mechanism of the chain disaster caused by the collapse of high-altitude dangerous rock bodies in high-altitude open-pit mines and the formation of debris flows, field survey method was used to clarify the morphology, range, and scale of the high-altitude dangerous rock bodies and debris flows. Combined with geological data of open-pit mines and mining technical conditions, the formation mechanism of high-altitude dangerous rock bodies and the causes of debris flow formation were studied. The laws of chain disaster evolution and disaster patterns were revealed. The research results showed that (1) the formation of the collapse-debris flow chain disaster is due to the coupling effect of internal poor engineering geological conditions and external factors such as rainfall, groundwater, freeze-thaw, and blasting vibration. The collapse mode of the dangerous rock body is tensile-crack and tipping, shear-sliding, and tensile-crack and seating. (2) The collapse disaster of high-altitude dangerous rock bodies in open-pit m

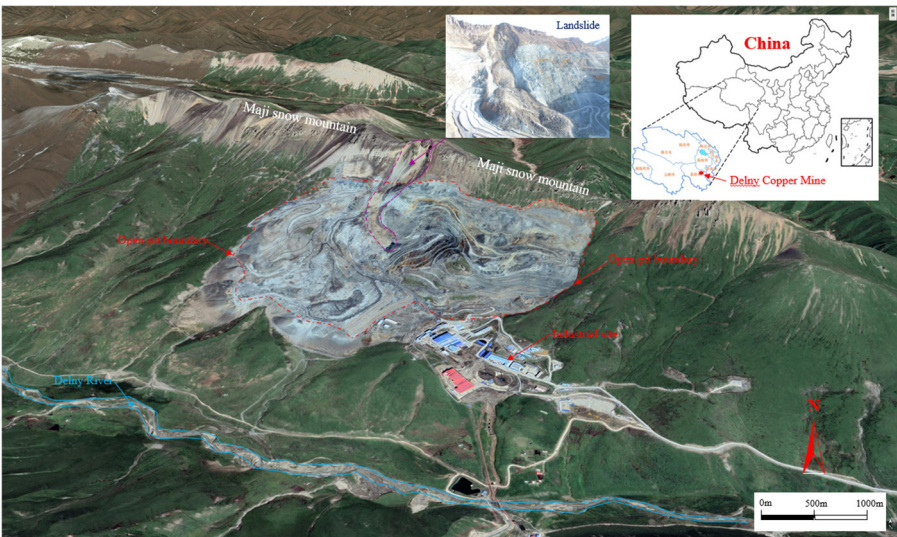
At present, the mining area is in the mid-low mountain landscape unit at high altitude. Due to open-pit mining, the original terrain has been completely altered, forming mining pits. The bottom elevation of the mining pit is 4220 m. The ore body is distributed in a northwest direction. The lower part of the mining pit is 170-240 m above the valley, and the upper boundary of the mining pit is 300-320 m above the watershed. The topography and geomorphology of the mining area are shown in Fig. 1.

Fig. 1. Landform and topography of the mining area [24]

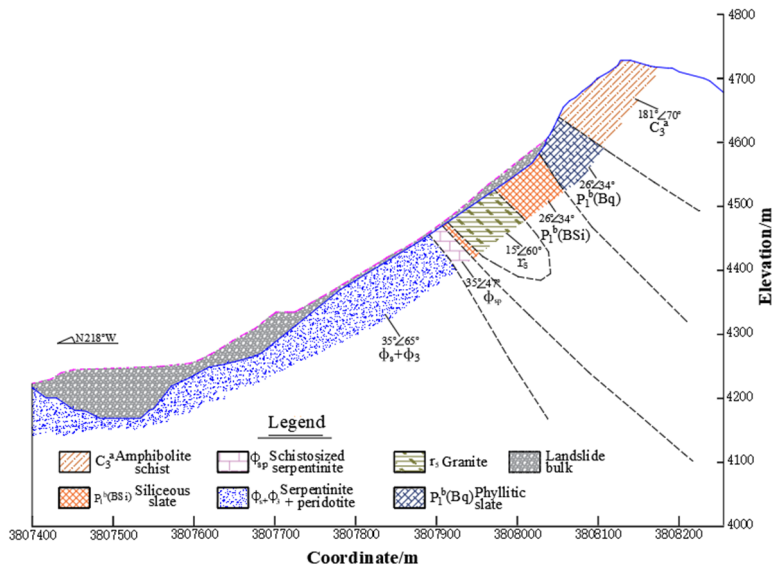
Soft disintegrated residual slope deposit rock group: Mainly composed of residual slope debris soil with a disintegrated structure, widely distributed around the current mining field, on the top of the slope, in the mountain gullies, and at the foot of the slope, see Fig. 2 for the geological profile of the open-pit mine collapse-debris flow disaster.

Fig. 2. Geological profile of open-pit mining collapse [24]

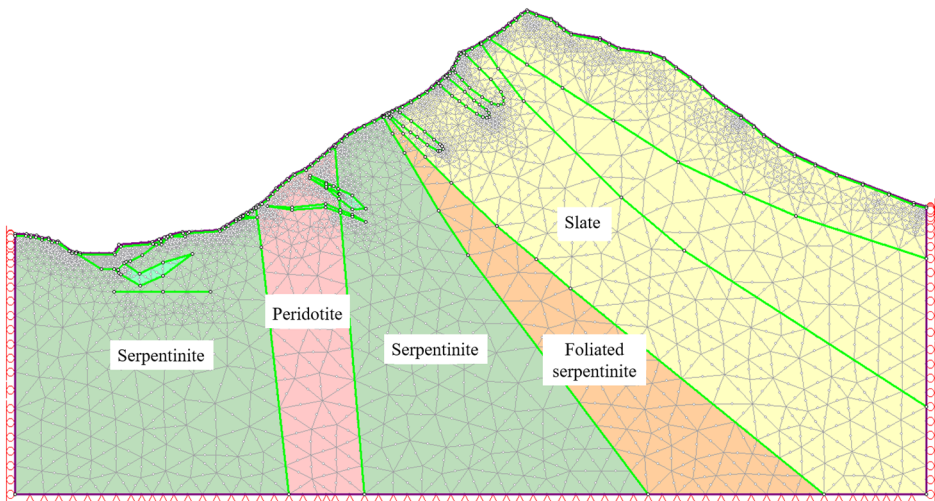
Using the Canadian geotechnical engineering analysis software Phase2 8.0, an analysis of the stability of the high-altitude dangerous rock mass on the slope of the open-pit mining area was conducted. Based on the engineering geological characteristics of the open-pit mining slope, a geological profile that can represent the typical geological and topographical conditions of the high-altitude collapse body was selected as the finite element analysis model. The model includes slate, schistose serpentinite, serpentinite, and peridotite, as shown in Fig. 8. A plane strain analysis was performed on the slope model to obtain results such as the overall displacement of the mining slope, plastic zone, and safety factor, and to study the sliding mode of the dangerous rock mass [29].

**Fig. 8.** Finite element analysis model of dangerous rock mass
