Analysis of causes for increased vibrations in Francis hydroelectric generators

Abstract. The present study analyzes the causes of increased vibration in Francis-type hydroelectric generators, focusing on the rotor-stator assembly and the rotor support structure (rotor spider), and considering installation and operational performance. Through comprehensive analysis of vibration histories, visual and topographic inspections, roundness measurements, alignment and magnetic-center surveys, and finite element modeling (FEM) under nominal speed and runaway speed conditions (81.8 and 175 rpm), the principal causes of elevated vibration were identified. Key findings include: fatigue fracture of the bases supporting the polar rim support block; loss of rotor-stator magnetic centering (polar rim descent up to 20 mm); and loss of rotor roundness (maximum deviation 1.7 mm). FEM revealed stress concentrations in the original design that exceed the yield strength of A-36 steel and fatigue safety factors below 1 in the critical region. These conditions produce structural imbalance and intermittent vertical forces that increase vibration – particularly during start/stop transients and in pass-thr

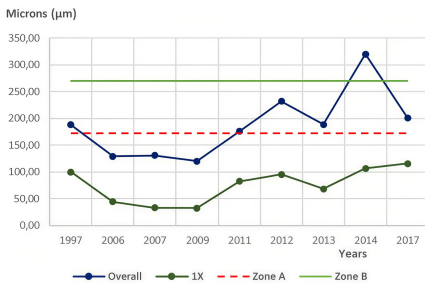
a) Historical overall and 1X vibration

Fig. 8. Vibration and frequency monitoring of the unit under study

Moreover, the results of historical overall vibration and 1X measurements under speed with no load conditions are presented (see Fig. 8(a)). There, a vibration spectrum of the natural frequencies in the same condition is included (see Fig. 8(b)), highlighting the 1X value

initially operated with acceptable vibration values (see Fig. 8(a)).

This phenomenon is exacerbated by unexpected rotor mass distribution caused by the failure, along with the forces exerted by the stator trying to self-level the rotor. Unit vibration monitoring confirms this increase (see Fig. 8(a)).

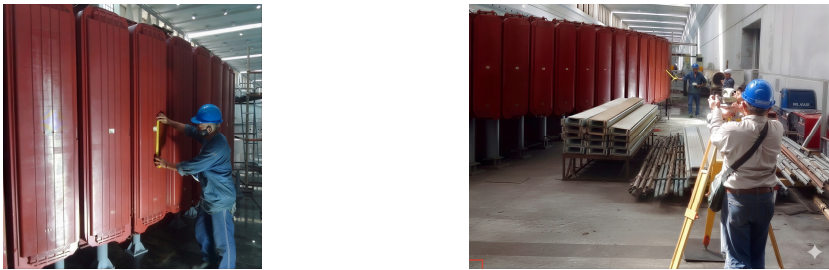
Fig. 15. Measurement of magnetic center of rotor [12]. Photographs were taken at the unit under study by P. Hernandez on December 13, 2022.

Subsequently, using a leveling survey station, topographic survey of the magnetic center of the rotor in relation to its base (lower flanged face) was conducted. The measurements were taken in the assembly bay, after the rotor was positioned and leveled on a pedestal adjusted with high-precision topographic techniques (total station, optical level, and laser) (see Fig. 15).

The obtained measurement should be 650 mm as per the reference data provided by the manufacturer [12].

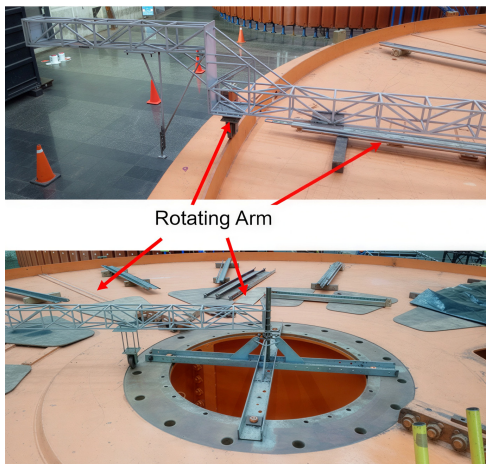
a) End with micrometer vernier and detailed view of centering and rotation of device

During the rotor roundness verification, it was observed that the maximum measured value is 8.93 mm, and the minimum value is 7.23 mm, resulting in a maximum deviation of 1.7 mm (see Fig. 19(b)). This value significantly exceeds the tolerance of ± 0.10 mm (100 μ m) permitted by the manufacturer [12], indicating a substantial deviation from the acceptable parameters.

Additionally, a generalized rotor deformation (loss of roundness) was detected, which may compromise its operational performance by inducing a magnetic unbalance. This lack of roundness causes variations in the gap between the rotor and the stator (generator air gap) during rotation, causing undesirable vibrations that affect the stability, efficiency and safety of the unit.

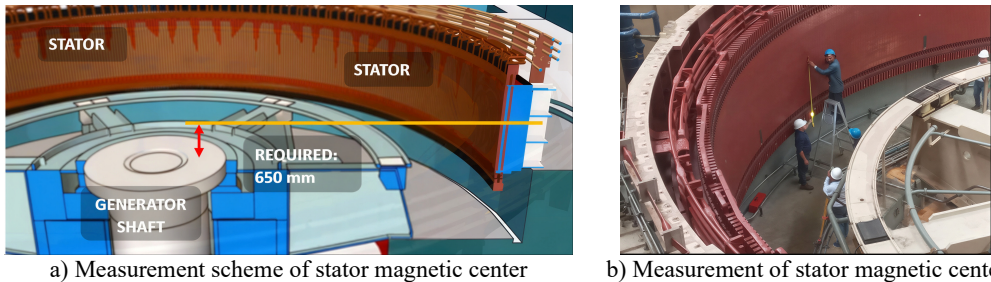
Fig. 20. Measurement of stator magnetic center. Photograph was taken at the unit under study by P. Hernandez on December 12, 2022

A topographic survey was conducted to determine the position of the stator magnetic center in relation to the upper flange of the generator shaft. The measurements were taken in the turbine pit of the prototype unit, using high-precision equipment to ensure the reliability of the data obtained (see Fig. 20(b)).

The obtained measurement should be 650 mm, in accordance with the reference provided by the manufacturer [12].

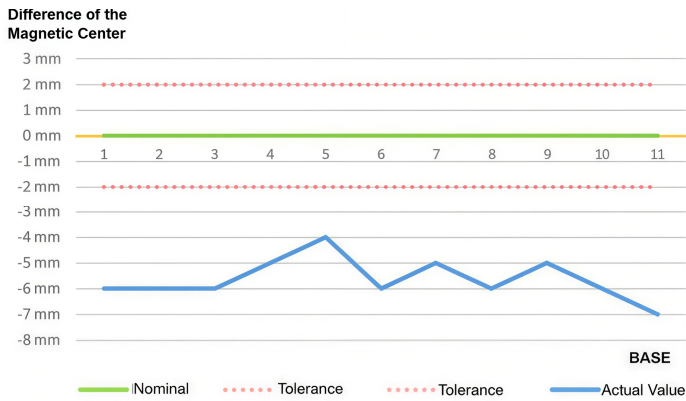
Fig. 21. Measurement results of stator magnetic center [12]

Complementary to the above measurements, the measured parameters of the stator magnetic center was compared with the theoretical data. A significant alignment shift of the stator magnetic center was detected (see Fig. 21). From the stator perspective, a misalignment of -7 mm was reported (see Fig. 21 and Table 5), which exceeds the -2 mm tolerance permitted by the manufacturer.

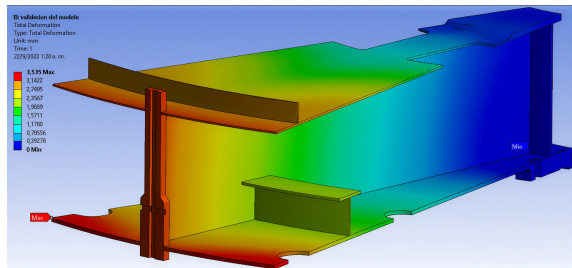
Fig. 26. Total deformation (x, y, z) of element under study [12]

In Fig. 26, the distribution of total deformation (x, y, z components) is observed across the entire structure. The analysis yielded a maximum displacement value of $d = 3.535$ mm.

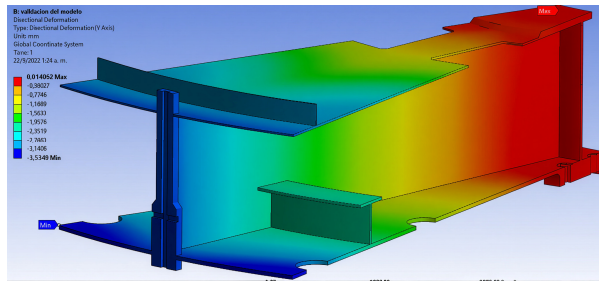
Fig. 27. Y-Axis deformation of element under study [12]

In Fig. 27, the deformation corresponding only to the Y -axis is detailed, where the maximum reached displacement is -3.535 mm, coinciding with the total value. This behavior indicates that the largest deformations have that direction, but remain within the acceptable parameters for the analyzed structure.
