# Analysis of causes for increased vibrations in Francis hydroelectric generators

**Abstract.** The present study analyzes the causes of increased vibration in Francis-type hydroelectric generators, focusing on the rotor-stator assembly and the rotor support structure (rotor spider), and considering installation and operational performance. Through comprehensive analysis of vibration histories, visual and topographic inspections, roundness measurements, alignment and magnetic-center surveys, and finite element modeling (FEM) under nominal speed and runaway speed conditions (81.8 and 175 rpm), the principal causes of elevated vibration were identified. Key findings include: fatigue fracture of the bases supporting the polar rim support block; loss of rotor-stator magnetic centering (polar rim descent up to 20 mm); and loss of rotor roundness (maximum deviation 1.7 mm). FEM revealed stress concentrations in the original design that exceed the yield strength of A-36 steel and fatigue safety factors below 1 in the critical region. These conditions produce structural imbalance and intermittent vertical forces that increase vibration – particularly during start/stop transients and in pa

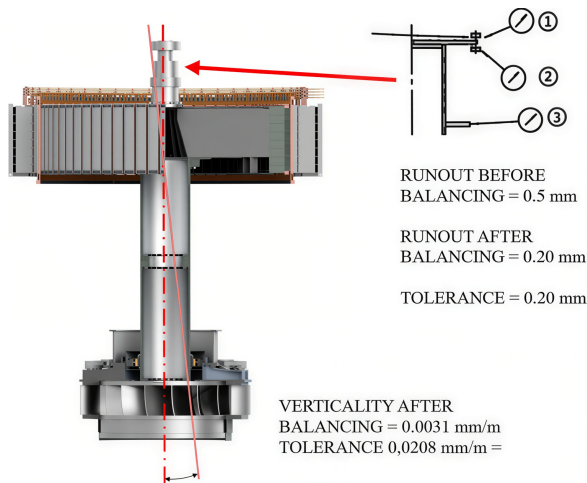
**Fig. 3.** Eccentricity of unit under study [12]

Moreover, a eccentricity of 20  $\mu\text{m}$  was recorded for the assembly after the final alignment, according to the manual rotation tests or “runout” (see Fig. 3) as per the manufacturer’s assembly protocols [12]. This eccentricity was a negligible value and felt within the limits established by the manufacturer [12], demonstrating that the alignment during the original assembly was conducted appropriately. By keeping all the parameters within the permitted ranges, it was ensured that the unit performance would not be adversely affected allowing it to operate efficiently and safely over time.

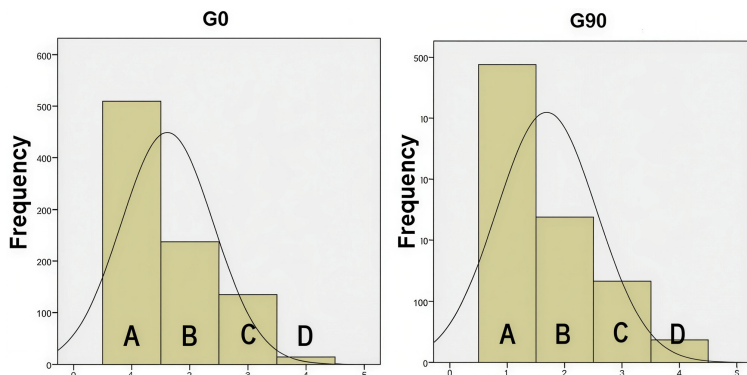
**Fig. 9.** Historical vibration of generation units. Divided by operating range according to ISO 7919-5 standards [12]

The results obtained are presented in a frequency chart (see Fig. 9). It can be observed that, while the highest value is associated with the operation range A (normal operation, see Table 1), there is a significant proportion of values within the range B (acceptable operation). Notably, values also appeared in ranges C and D, which represented the operational zones at risk for long-term and short-term damage, respectively.

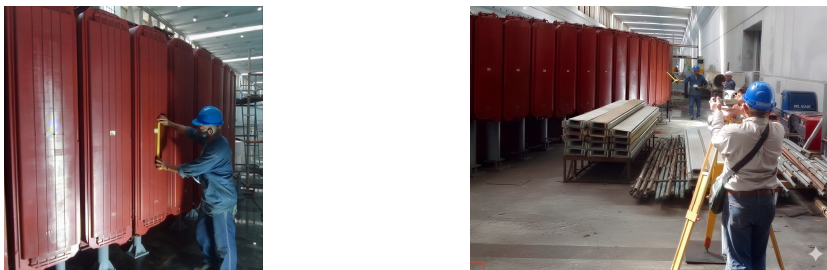
**Fig. 15.** Measurement of magnetic center of rotor [12]. Photographs were taken at the unit under study by P. Hernandez on December 13, 2022.

Subsequently, using a leveling survey station, topographic survey of the magnetic center of the rotor in relation to its base (lower flanged face) was conducted. The measurements were taken in the assembly bay, after the rotor was positioned and leveled on a pedestal adjusted with high-precision topographic techniques (total station, optical level, and laser) (see Fig. 15).

The obtained measurement should be 650 mm as per the reference data provided by the manufacturer [12].

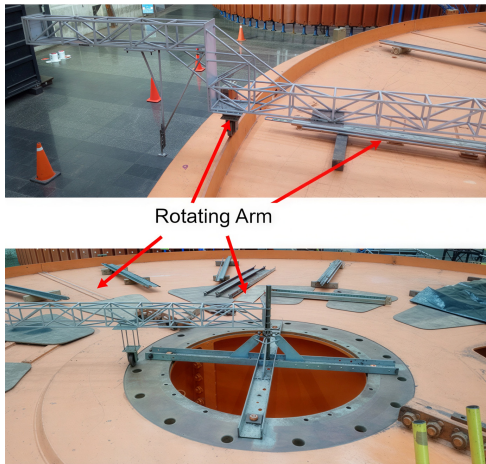
a) End with micrometer vernier and detailed view of centering and rotation of device

During the rotor roundness verification, it was observed that the maximum measured value is 8.93 mm, and the minimum value is 7.23 mm, resulting in a maximum deviation of 1.7 mm (see Fig. 19(b)). This value significantly exceeds the tolerance of  $\pm 0.10$  mm (100  $\mu$ m) permitted by the manufacturer [12], indicating a substantial deviation from the acceptable parameters.

Additionally, a generalized rotor deformation (loss of roundness) was detected, which may compromise its operational performance by inducing a magnetic unbalance. This lack of roundness causes variations in the gap between the rotor and the stator (generator air gap) during rotation, causing undesirable vibrations that affect the stability, efficiency and safety of the unit.

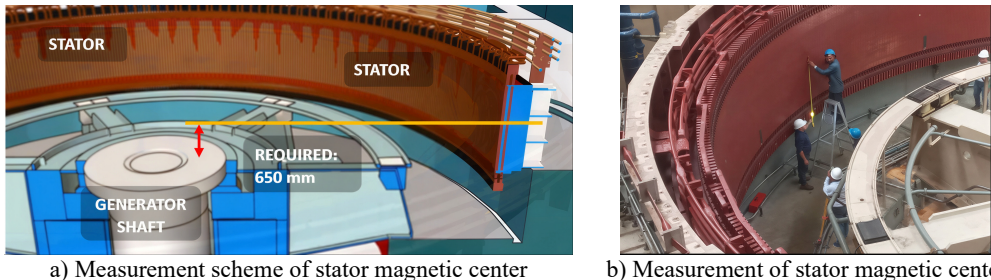
**Fig. 20.** Measurement of stator magnetic center. Photograph was taken at the unit under study by P. Hernandez on December 12, 2022

A topographic survey was conducted to determine the position of the stator magnetic center in relation to the upper flange of the generator shaft. The measurements were taken in the turbine pit of the prototype unit, using high-precision equipment to ensure the reliability of the data obtained (see Fig. 20(b)).

The obtained measurement should be 650 mm, in accordance with the reference provided by the manufacturer [12].

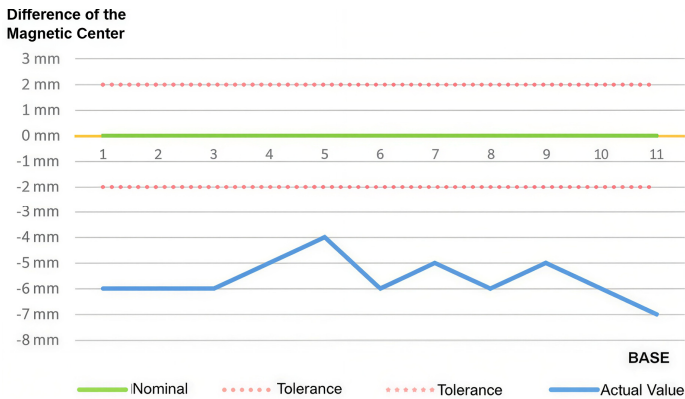
Fig. 21. Measurement results of stator magnetic center [12]

Complementary to the above measurements, the measured parameters of the stator magnetic center was compared with the theoretical data. A significant alignment shift of the stator magnetic center was detected (see Fig. 21). From the stator perspective, a misalignment of  $-7$  mm was reported (see Fig. 21 and Table 5), which exceeds the  $-2$  mm tolerance permitted by the manufacturer.

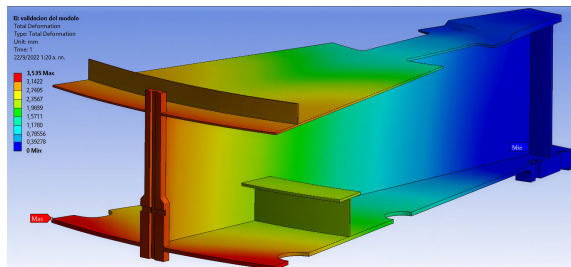
Fig. 26. Total deformation ( $x, y, z$ ) of element under study [12]

In Fig. 26, the distribution of total deformation ( $x, y, z$  components) is observed across the entire structure. The analysis yielded a maximum displacement value of  $d = 3.535$  mm.

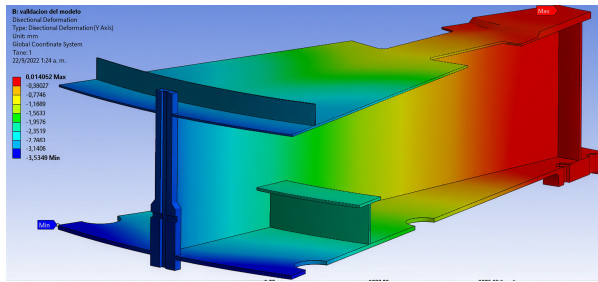
Fig. 27. Y-Axis deformation of element under study [12]

In Fig. 27, the deformation corresponding only to the  $Y$ -axis is detailed, where the maximum reached displacement is  $-3.535$  mm, coinciding with the total value. This behavior indicates that the largest deformations have that direction, but remain within the acceptable parameters for the analyzed structure.

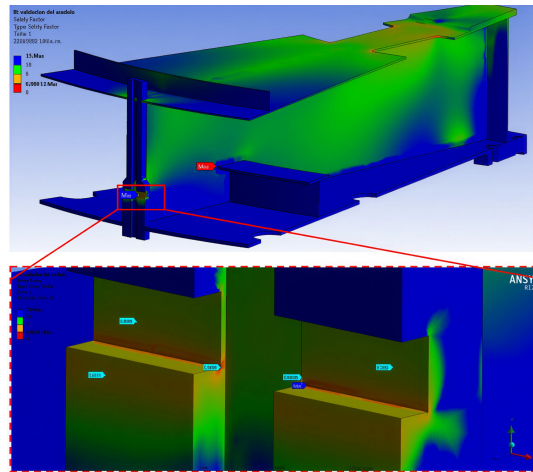
Fig. 28. Safety factors in structure under static load [12]

Using the yield strength of A-36 steel ( $S_y = 250$  MPa) and the various stress concentrations obtained during the analysis, the authors calculated the distribution of safety factors (FS) for static conditions in the structural elements. This distribution is shown in Fig. 28, where regions with higher and lower safety margins are identified, allowing for the assessment of the structure capacity to withstand the applied loads in each area.

It is observed that, overall, the structure exhibits an acceptable safety factor under static loading conditions. However, critical concentrations are highlighted in the lower boxes of Fig. 28, where regions with the minimum safety factor are identified, corresponding to the marker “min”, which records a value of  $N = 0.889$ . This value indicates an insufficient margin against the yield strength, which could compromise the structure integrity in those areas.
