Experimental study on failure characteristics of jointed rock mass under staged unloading conditions

Abstract. Strength and deformability characteristics of rock with pre-existing fissure are governed by cracking behavior. To further research the effects of pre-existing fissures on the mechanical properties and crack coalescence process under staged unloading conditions, a series of uniaxial compression tests were carried out. In this study, cement, fine sand, and water were used to fabricate a kind of brittle rock-like material rectangular model specimen. The mechanical properties of rock-like material specimen used in this research were all in good agreement with the brittle rock materials. The pre-existing fissure was created by mica sheets and the unloading zone was created by pre-filling Poly(lactic acid) (PLA) resin material during the molding processes the model specimen. And the staged unloading test was conducted based on poly(lactic acid)'s hot-melt characteristics. In order to investigate the crack initiation, propagation and coalescence process, inclination angle of pre-existing fissure was set to change from 0° to 90°. The mechanism of crack propagation and coalescenc

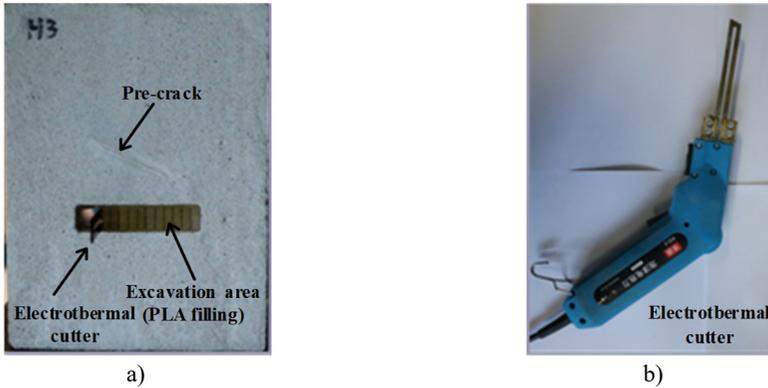
Fig. 3. Step excavation unloading operation diagram and the tool

normal deformation to ensure that the normal stress of the pre-existing fissure specimen reaches a steady state. Staged unloading was proceeded using hot-melt method. Use of the electric cutting knife made polylactic acid resin unloading zone melt gradually. A detailed description of the unloading operation and electric cutting tool is given in Fig. 3. The unloading test is divided into 14 unloading steps, each of which is 5 mm in length. Moreover, to ensure the stress state of specimen reaches equilibrium, a new step of staged unloading will not be performed until the normal deformation was stabilized. Besides, if an unstable crack growth phenomenon was found during staged unloading, the unloading process would stop immediately.
