Permeability evolution of prefabricated grouted curtain specimens with artificial defects under cyclic loading/unloading

Abstract. Two types of rock specimens simulating grout curtains were prepared: one featuring solely an axial through-hole and the other featuring combined axial and transverse holes (termed combined-hole specimens). Coupled permeability-damage tests under cyclic loading-unloading were conducted to analyze the effects of peak stress level, confining pressure, seepage pressure difference, and defect geometry (curtain filling configuration) on permeability evolution and damage accumulation. The results indicate that: (1) Peak stress level is the primary factor governing damage development rate; (2) Higher confining pressure mitigates damage in the surrounding rock and decelerates permeability increase; (3) Larger seepage pressure difference (≥ 0.5 MPa) significantly enhances the stability and accuracy of permeability measurements; (4) For combined-hole configurations, increasing the transverse hole area (and thus the grout volume) provides more lateral seepage paths, effectively reducing axial permeability by up to two orders of magnitude. This study provides an ex

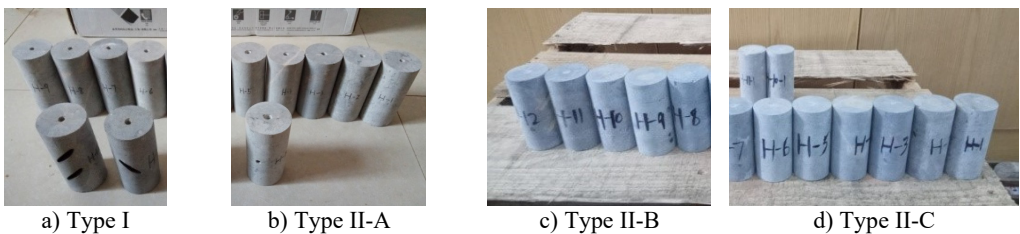
Fig. 1. Schematic diagrams and photographs of grouted curtain specimens.

Two types of artificial through-holes were prefabricated to simulate different karst defect geometries before grouting: (1) a single axial through-hole, and (2) combined axial and transverse through-holes. All holes were drilled using a precision computer numerical control (CNC) drilling machine equipped with a diamond-tipped bit ($\text{\O}6$ mm). The drilling process was conducted at a low feed rate (5 mm/min) with continuous water cooling to minimize the generation of microcracks around the hole periphery, thereby ensuring the defect geometry was the dominant

Type II (Complex Cross-Hole Network): This type incorporates combined axial and transverse through-holes and is subdivided based on the morphology and cross-sectional area of the transverse hole: II-A: A circular transverse hole ($\varnothing 6$ mm), corresponding to a grout mass filling ratio of 0.9 %. II-B: A single elliptical transverse hole (6 mm \times 30 mm), with a grout mass filling ratio of 2.18 %. II-C: Double elliptical transverse holes, resulting in a grout mass filling ratio of 3.96 %.

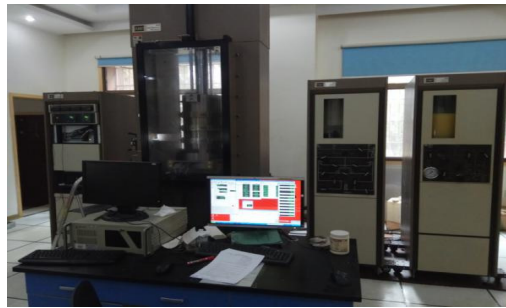
Fig. 2. MTS 815 Electro-hydraulic Servo-controlled Rock Triaxial Testing System.
Photo by Haijie Wen, Zhuzhou, China, July 16, 2025

The experimental tests employed an electro-hydraulic servo-controlled rock triaxial testing system (MTS Model 815), manufactured by MTS Systems Corporation, USA, as shown in Fig. 2. This system is capable of conducting static and dynamic mechanical tests on geo-materials such as rock and concrete. Key functionalities include uniaxial and triaxial compression tests, pore water pressure application, permeability tests, and temperature simulation. It features three control modes: displacement, load (force), and strain. Control mode switching is possible during testing (e.g., from triaxial compression to permeability testing), enabling the simulation of multi-field coupling conditions, such as stress-seepage coupling, stress-temperature coupling, and permeability-damage coupling.

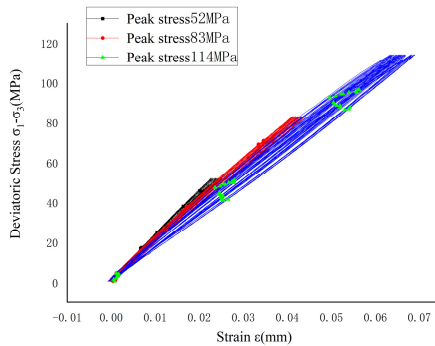
As shown in Fig. 3, the deviatoric stress-strain curve for test case 1 under graded cyclic axial loading-unloading clearly demonstrates that the deformation of the specimen subjected to the same stress load disturbance gradually increases with the number of loading-unloading cycles within the same load level. As shown in the Fig. 3, at peak stresses of 52 MPa, 83 MPa, and 114 MPa, the maximum peak strains corresponding to the deviatoric stress-strain curves are parallel to the ε -axis (strain axis). This phenomenon indicates that the damage variable defined by the maximum strain method is reasonable and feasible, and that this method can effectively represent the damage development in rock specimens during the cyclic loading-unloading process.

Fig. 3. Deviatoric stress-strain curves for test case 1 under graded cyclic axial loading-unloading

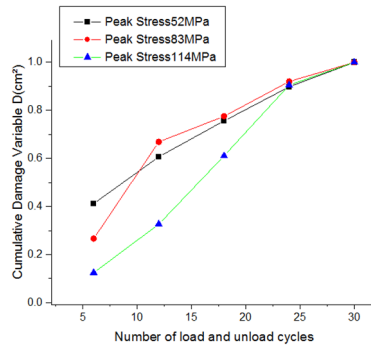
Fig. 4 shows the cumulative damage variable versus number of cycles curves for rock specimens containing a grout curtain under cyclic loading-unloading at different peak stresses. In

the figure, at peak stresses of 52 MPa, 83 MPa, and 114 MPa, the rate of increase damage variable for the rock mass containing a grout curtain are differed. At a peak stress of 52 MPa, the cumulative damage variable increases approximately linearly with increasing number of cycles. As the peak stress level increases, the increase of the cumulative damage variable with increasing number of cycles follows a polynomial evolution law. If the relationship between the cumulative damage variable and number of cycles is represented by a linear slope for all three peak stress levels in the figure, the slope increases. That is, as the peak stress increases, the rate of damage accumulation accelerates. Thus, the peak stress is the primary factor governing the damage development rate in rock specimens containing a grout curtain.

Fig. 4. Cumulative damage variable versus number of cycles curve for specimens with a grout curtain under cyclic loading-unloading

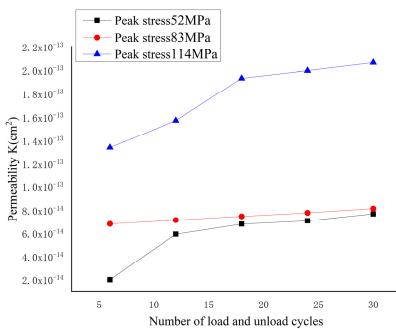
Fig. 5 shows the permeability evolution of rock specimens containing a grout curtain under cyclic loading-unloading at different peak stress levels. When the peak stress is low and cyclic loading-unloading disturbance is applied at the same stress level, the permeability increases relatively slowly and approximately linearly with increasing number of cycles. However, when the peak stress transitions from a lower stress level to the next higher stress level, the first loading-unloading cycle causes a significant increase in permeability. Subsequent cyclic loading-unloading at that same stress level has little effect on the permeability evolution. Overall, under a constant seepage pressure differential, permeability first increases, then decreases, and then increases again with increasing peak stress.

Fig. 5. Permeability evolution of specimens with a grout curtain under cyclic loading-unloading

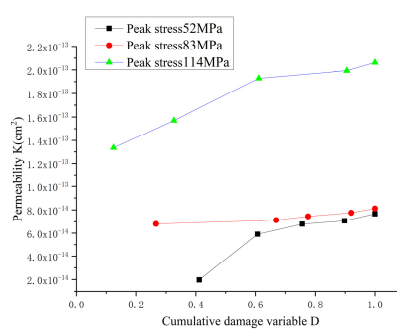
Fig. 6. Permeability versus cumulative damage variable for specimens with a grout curtain at different peak stress levels

Fig. 6 shows the permeability versus cumulative damage variable curves for different peak stress levels. At a given peak stress level, cyclic loading-unloading of rock specimens containing

a grout curtain leads to the initiation and propagation of microcracks, and permeability increases with increasing cumulative damage variable. At different peak stress levels, as the peak stress increases, the permeability of specimens containing a grout curtain exhibits an increase-decrease-increase trend with increasing cumulative damage variable. This suggests the existence of a critical peak stress threshold. When the stress level applied to the specimen containing a grout curtain is below this threshold, the rate of permeability change with respect to the cumulative damage variable is relatively slow. Conversely, when the applied stress level exceeds this threshold, the rate of permeability change significantly increases. Determining this peak stress threshold value requires additional experimental investigation. Due to the complexity and significant operational difficulties involved in this permeability-damage coupling test, conducting the three-stage graded cyclic loading-unloading was already challenging. Consequently, no further tests were conducted to determine this threshold value.

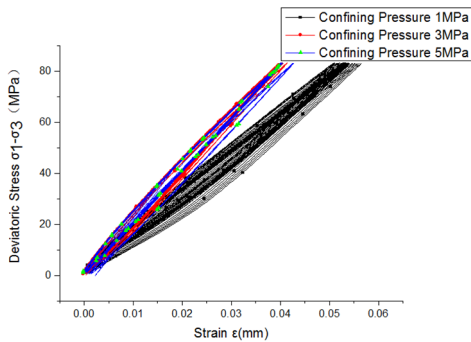
As shown in Fig. 7, the deviatoric stress-strain curves under cyclic loading-unloading at different confining pressures are presented. Under the same confining pressure level, the mechanical properties of rock specimens containing a grout curtain deteriorate during cyclic loading-unloading. That is, the deformation produced by the specimen gradually increases when subjected to the same stress magnitude. However, increasing the confining pressure and reapplying cyclic loading eliminated the mechanical degradation effect induced at the lower confining pressure.

Fig. 7. Deviatoric stress-strain curves for specimens with a grout curtain under cyclic loading-unloading at different confining pressures

Fig. 11 shows the deviatoric stress-strain curves under cyclic loading-unloading. These curves demonstrate significant mechanical degradation in specimens containing a grout curtain during this test. The maximum strain method was therefore employed to characterize the cumulative damage variable under cyclic loading-unloading. Fig. 12 presents the cumulative damage variable versus number of cycles. As shown, the damage variable $D = 0$ for undisturbed specimens. During the first six loading-unloading cycles, damage development through microcrack initiation and propagation occurs rapidly. Subsequently, the rate of cumulative damage accumulation decreases progressively. Within a specific cycle range, the cumulative damage variable increases approximately linearly – a finding consistent with the experimental results shown earlier in Fig. 7.

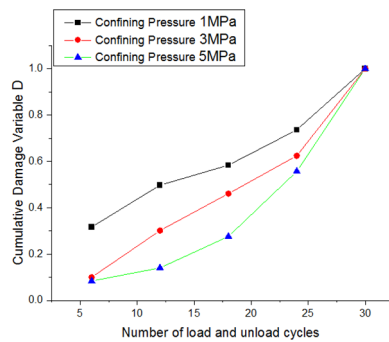
Fig. 8. Cumulative damage variable versus number of cycles for specimens with a grout curtain under fatigue loading at different confining pressures

Fig. 8 shows the cumulative damage variable versus number of cycles at different confining pressures, illustrating the evolution of the cumulative damage variable under fatigue loading at varying confining pressures. When the confining pressure is relatively low, the first loading-unloading cycle significantly influences the damage in specimens containing a grout curtain. Subsequently, at the same peak stress level, the crack propagation rate in these specimens rapidly decreases to a slow development phase. When the specimen reaches the fatigue failure point under cyclic loading-unloading, the damage variable increases abruptly. At the same peak stress level but higher confining pressure, the initial cyclic loading-unloading disturbance has minimal effect on the damage variable. As the specimen approaches the fatigue failure point, the damage variable increases rapidly.

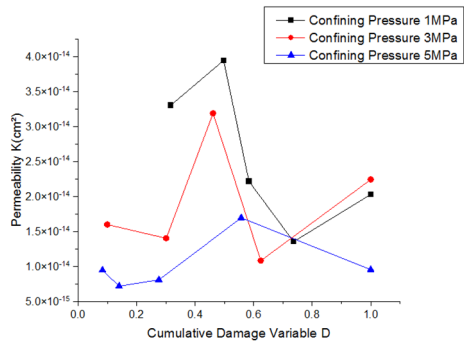
Fig. 10 shows permeability versus cumulative damage variable curves for grouted specimens under different confining pressures. Comparison of Fig. 9 and Fig. 10 reveals similar permeability evolution patterns at identical confining pressures, demonstrating that the cumulative damage variable effectively substitutes cycle number in characterizing permeability evolution under cyclic loading-unloading. Furthermore, Fig. 10 indicates that identical cumulative damage values are achieved with fewer cycles under low confining pressures compared to high pressures. This implies greater sensitivity and larger variation amplitudes in permeability response to damage accumulation at low confining pressures, whereas high confining pressures yield slower permeability changes and gradual damage development.

Fig. 10. Permeability versus cumulative damage variable for specimens with a grout curtain at different confining pressures

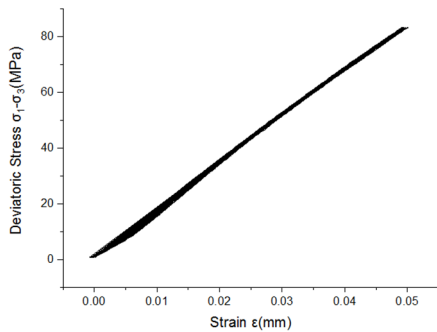
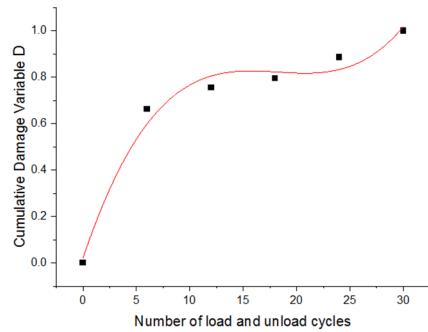
Fig. 11. Deviatoric stress-strain curves for specimens with a grout curtain under cyclic loading-unloading **Fig. 12.** Cumulative damage variable versus number of cycles for specimens with a grout curtain

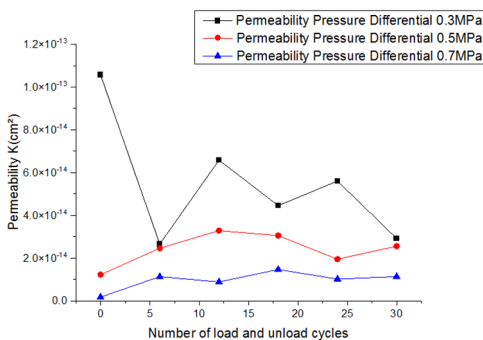
Fig. 13 shows permeability versus number of cycles for grouted specimens under cyclic loading-unloading at different seepage pressure differentials. When the differential is low

(< 0.3 MPa), the permeability curve exhibits significant fluctuations. As the differential increases (0.5-0.7 MPa), measured permeability decreases while test duration extends, yielding more accurate results due to stabilized flow conditions.

Fig. 13. Permeability versus number of cycles for specimens with a grout curtain at different seepage pressure differentials

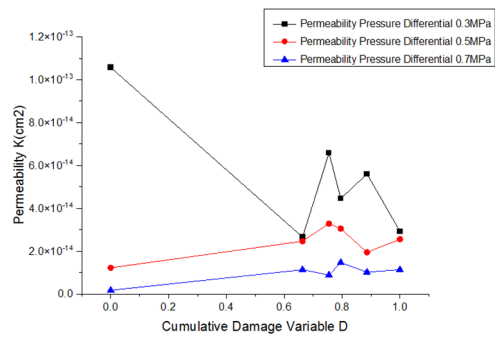
Fig. 14 presents permeability versus cumulative damage variable curves under cyclic loading-unloading at varied seepage pressure differentials. Tests with low differentials (0.3 MPa) show large permeability amplitudes and irregular damage-permeability relationships. This stems from the manual valve operation protocol: After applying equal water pressures to both specimen ends, differentials were created by sequentially 1) closing the upstream valve to establish hydraulic head, then 2) rapidly depressurizing and closing the downstream valve. The speed of the second valve closure critically controls differential magnitude – particularly at low pressures where human timing variability causes data scatter.

Higher differentials (≥ 0.5 MPa) significantly reduce measurement fluctuations. The 0.7 MPa differential proved optimal, providing: (1) Extended stabilization periods (> 120 s) for steady-state flow; (2) Minimal human operation interference; (3) High-quality pressure-time curves; (4) Accurate mid-test permeability calculations.

Fig. 14. Permeability versus cumulative damage variable for specimens with a grout curtain at varied seepage pressure differentials

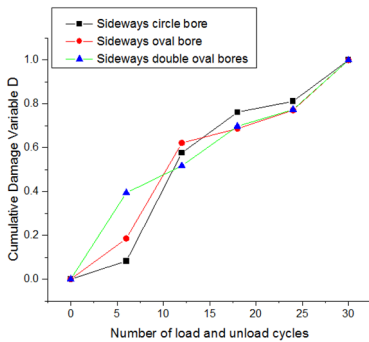
Test cases 4-6 investigated the water-blocking effectiveness of the three classified grout curtain configurations (Types II-A, II-B, and II-C, as defined in Section 2), which simulate karst cavities with increasing lateral flow path areas and grout filling ratios. Fig. 15 shows the cumulative damage variable versus number of cycles for specimens with different grout configurations under cyclic loading-unloading. Polynomial fitting revealed that damage

accumulation follows a characteristic trend: across the three configuration types, as the grout filling ratio increases from Type II-A (0.9 %) to II-C (3.96 %), the damage evolution curve transitions from a near-linear to a distinct S-shape. This indicates that specimens with higher filling ratios (Type II-C) experience accelerated damage evolution during the initial loading cycles. This indicates that higher filling ratios accelerate damage evolution during initial loading cycles.

Fig. 15. Cumulative damage variable versus number of cycles for different grout curtain configurations

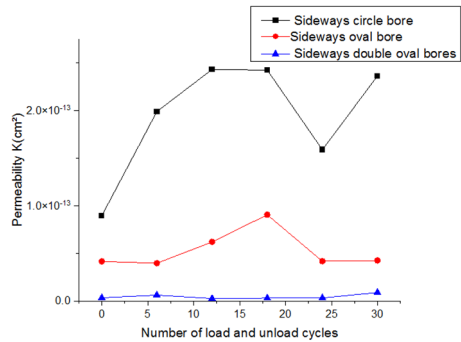
The permeability evolution for the three configuration types is presented in Fig. 16, which clearly quantifies the impact of defect geometry. The steady-state permeability decreases dramatically by two orders of magnitude across the series:

- Type II-A (Circular): 10^{-13} m/s.
- Type II-B (Elliptical): 10^{-14} m/s.
- Type II-C (Double-elliptical): 10^{-15} m/s.

This quantitative relationship demonstrates that increasing the lateral hole area (and thus the grout volume) is a highly effective strategy for reducing axial seepage. The reduction in axial permeability with increased lateral hole size can be attributed to three primary mechanisms: (1) enhanced lateral flow diversion, which redistributes the hydraulic head; (2) extended overall seepage paths; and (3) greater flow path tortuosity. These factors collectively increase the flow resistance and significantly degrade axial flow efficiency as the grout volume increases.

Fig. 16. Permeability evolution versus number of cycles for different grout curtain configurations

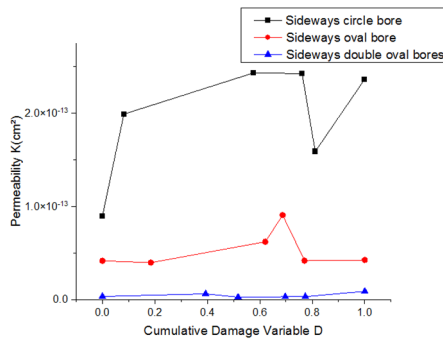
Fig. 17. Permeability versus cumulative damage variable for different grout curtain configurations

As shown in Fig. 17, the permeability evolution with cumulative damage variable exhibits similar trends to its evolution with cycle number for rock specimens with different grout curtain configurations under cyclic loading-unloading. Permeability undergoes a three-stage evolution: initial increase, subsequent decrease, and final resurgence with increasing cycle number. Furthermore, specimens with higher mass filling ratios demonstrate extended crack compaction phases within the grout matrix.

To address the reviewer's suggestion and enhance the quantitative rigor of the conclusions, the permeability (K) versus cumulative damage variable (D) data for different grout curtain configurations (Fig. 17) were fitted. The evolution follows a general trend that can be described by a piecewise or nonlinear function. For instance, the data for Type II-B specimens can be empirically approximated by the following relationship during the main damage accumulation phase:

where K_0 is the initial permeability, and α , β are fitting parameters. For Type II-B, $\beta > 1$, indicating an accelerating increase in permeability with damage. In contrast, Type II-C specimens exhibit a more complex trend with an extended plateau (low dK/dD), highlighting the prolonged crack compaction phase within the larger grout volume. This quantitative analysis confirms that not only the final permeability but also its evolution rate with damage is strongly governed by the initial defect geometry and grout filling ratio. The fitted relationships provide a basis for predictive modeling of grout curtain performance under cyclic loading.
